**MARINE ACCIDENT
INVESTIGATION REPORT**

Vessel type and name: Container Ship ESTELLE MAERSK

Vessel type and name: Container Ship JJ SKY

Accident type: Collision

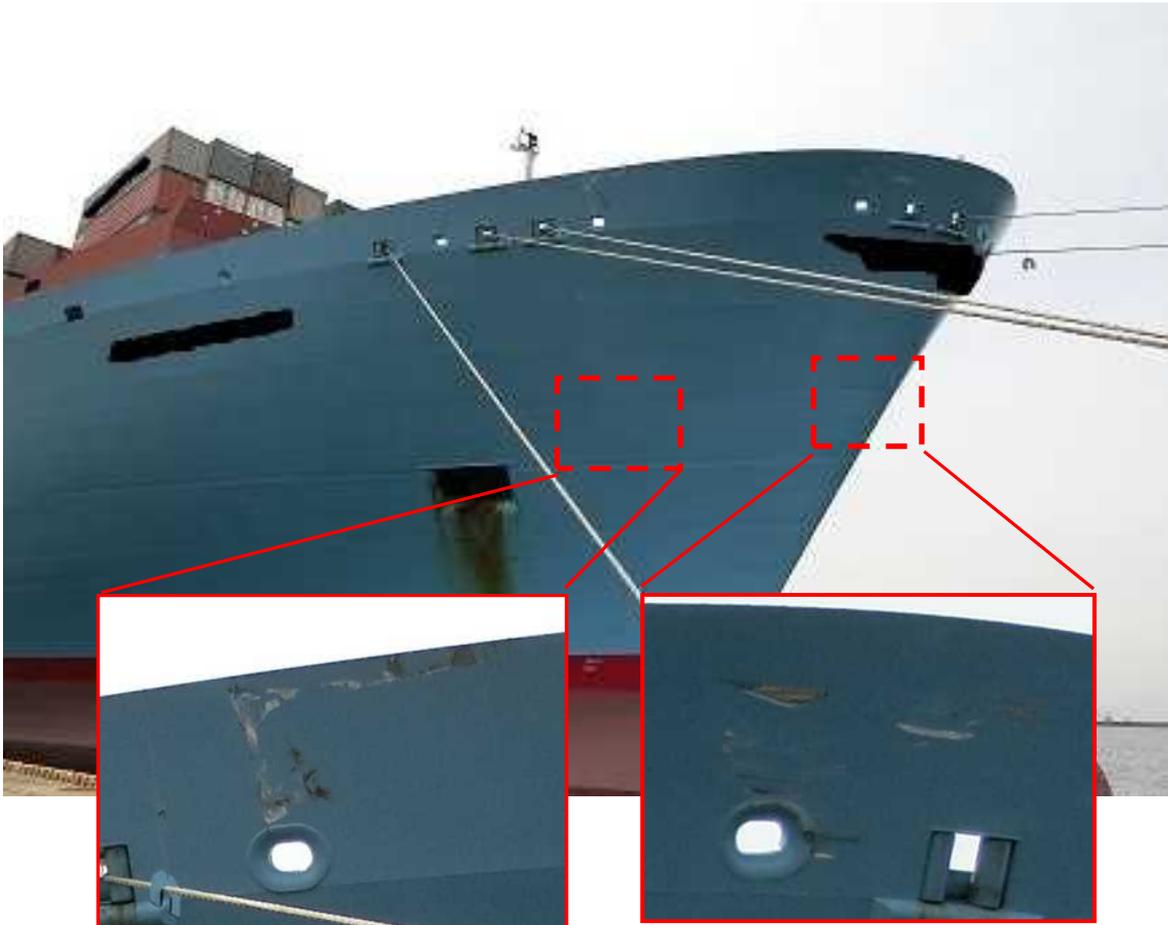
Photo 2.3-1 State of damage to Vessel A

- (1) Vessel A sustained abrasion damage on the shell plating of her starboard bow.
 - (2) According to a statement by the Port State Control Officer of Kobe District Transport Bureau, Vessel B sustained a pressure collapse on her bridge port-side wing.
- (See Photo 2.3-1, Photo 2.3-2)

- (1) Vessel A sustained abrasion damage on the shell plating of her starboard bow.
- (2) It is probable that Vessel B sustained a pressure collapse on her bridge port-side wing.

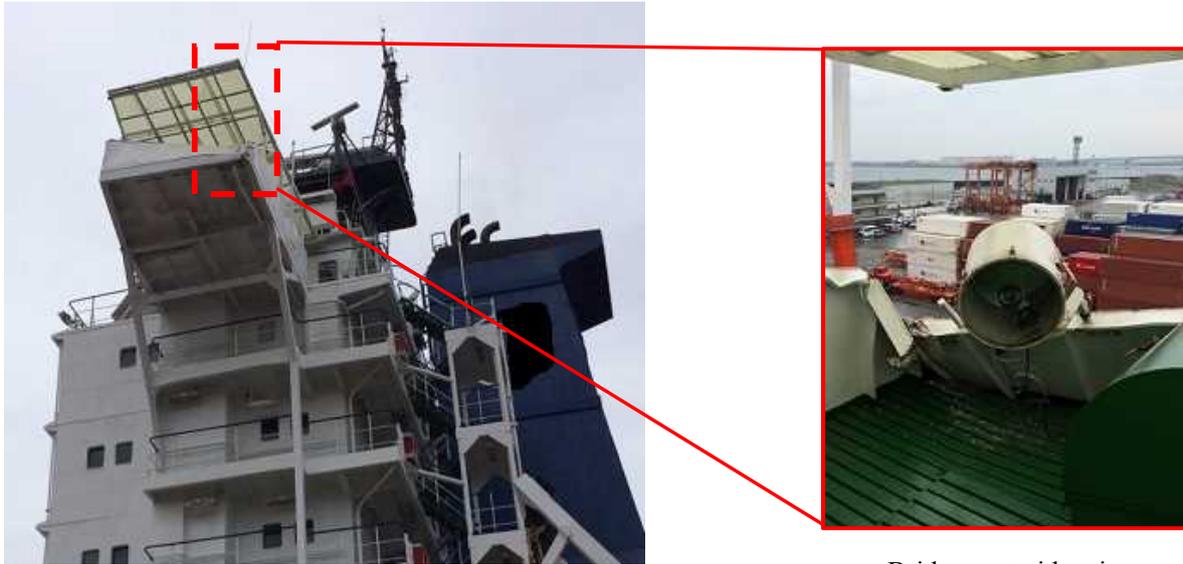
Photo 2.3-2 State of damage to Vessel B

Bridge port-side wing

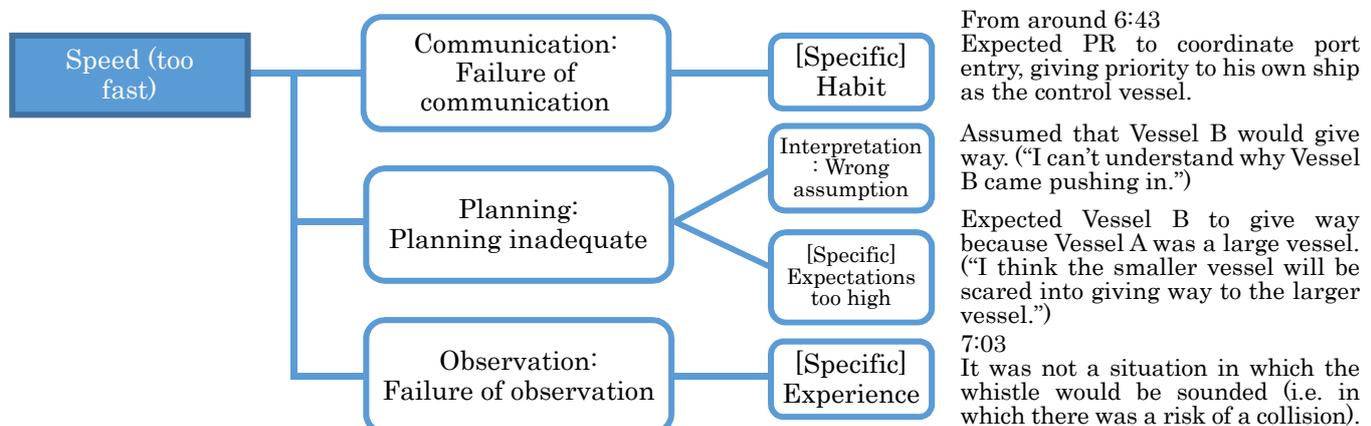
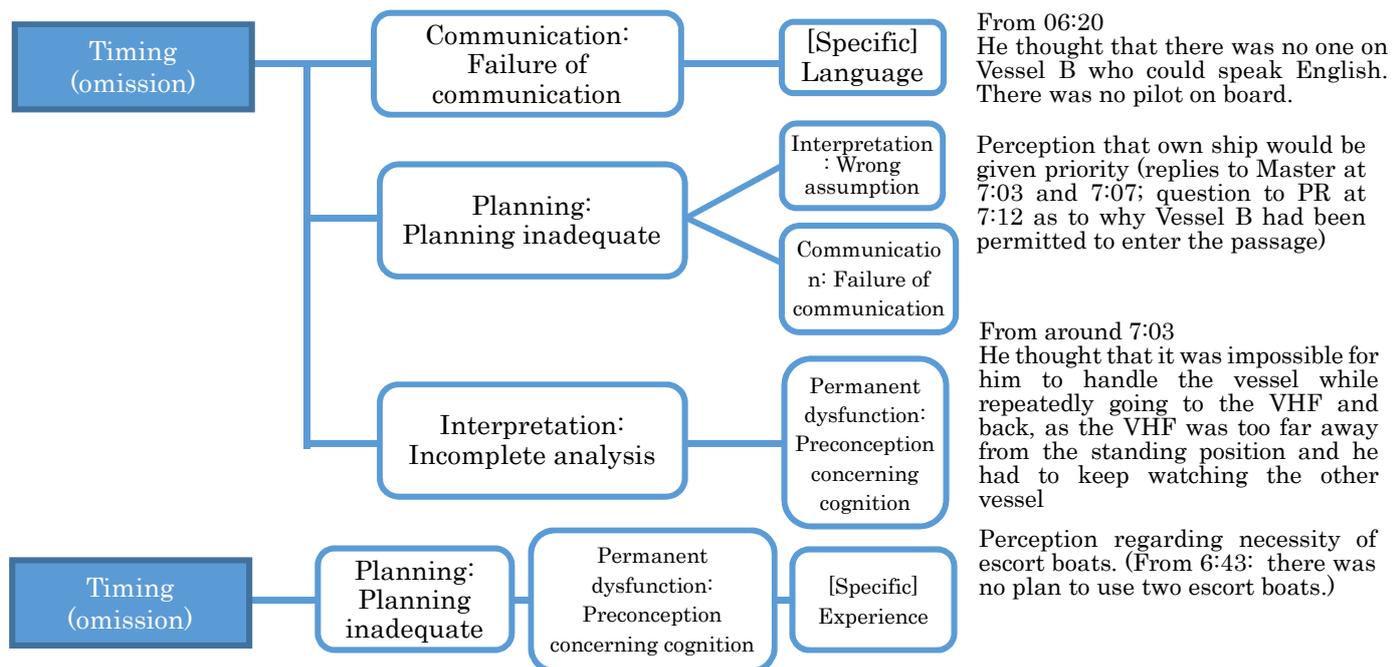
Fig. 15(a)(b) show the results of background factor analysis. On sighting Vessel B at around 06:55, the Pilot was aware that it was a vessel that tended to navigate dangerously. However, he did not expect Vessel B to force its way in, because he assumed that PR would coordinate port entry and because his own ship was a large vessel with poor rudder effectiveness that could only respond by adjusting speed. At around 07:03, therefore, he did not sense the risk of a collision. He was not maintaining communication with Vessel B or PR, although it is probable that this was because he thought that the VHF was too far away from the Pilot's standing position. Similarly, he also tended not to communicate very much with the watch personnel inside the bridge. Although he was aware that escort boats and tugboats had been arranged, and he had ascertained the positions of tugboats as he was planning to take a tug line, he had felt no need to use them. The Kobe Marine Casualty Prevention Institute had made it standard for massive vessels in the 400m-class to use two escort boats and one tugboat when entering the port.

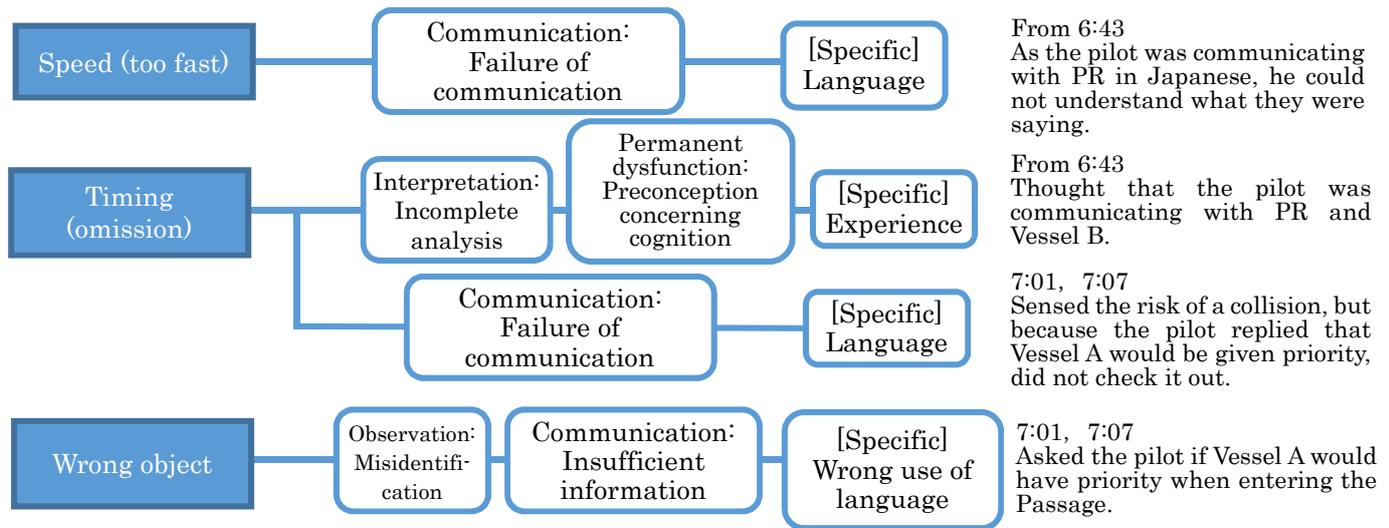
Fig. 16 Result of background factor analysis on the Master of Vessel A

Fig. 16 shows the result of background factor analysis. Although the Master had difficulty in grasping the situation because the Pilot and PR were communicating in Japanese and he could not understand what they were saying, he did not compensate for this by communicating with the Pilot. Due to his experience of entering ports outside Japan, moreover, he may also have mistaken Port Radio for a port authority possessing control functions, and he thought that, as a large vessel, his own ship would be given priority when entering the port. Although he checked

this point with the Pilot, the answer was ambiguous due to inadequate communication.

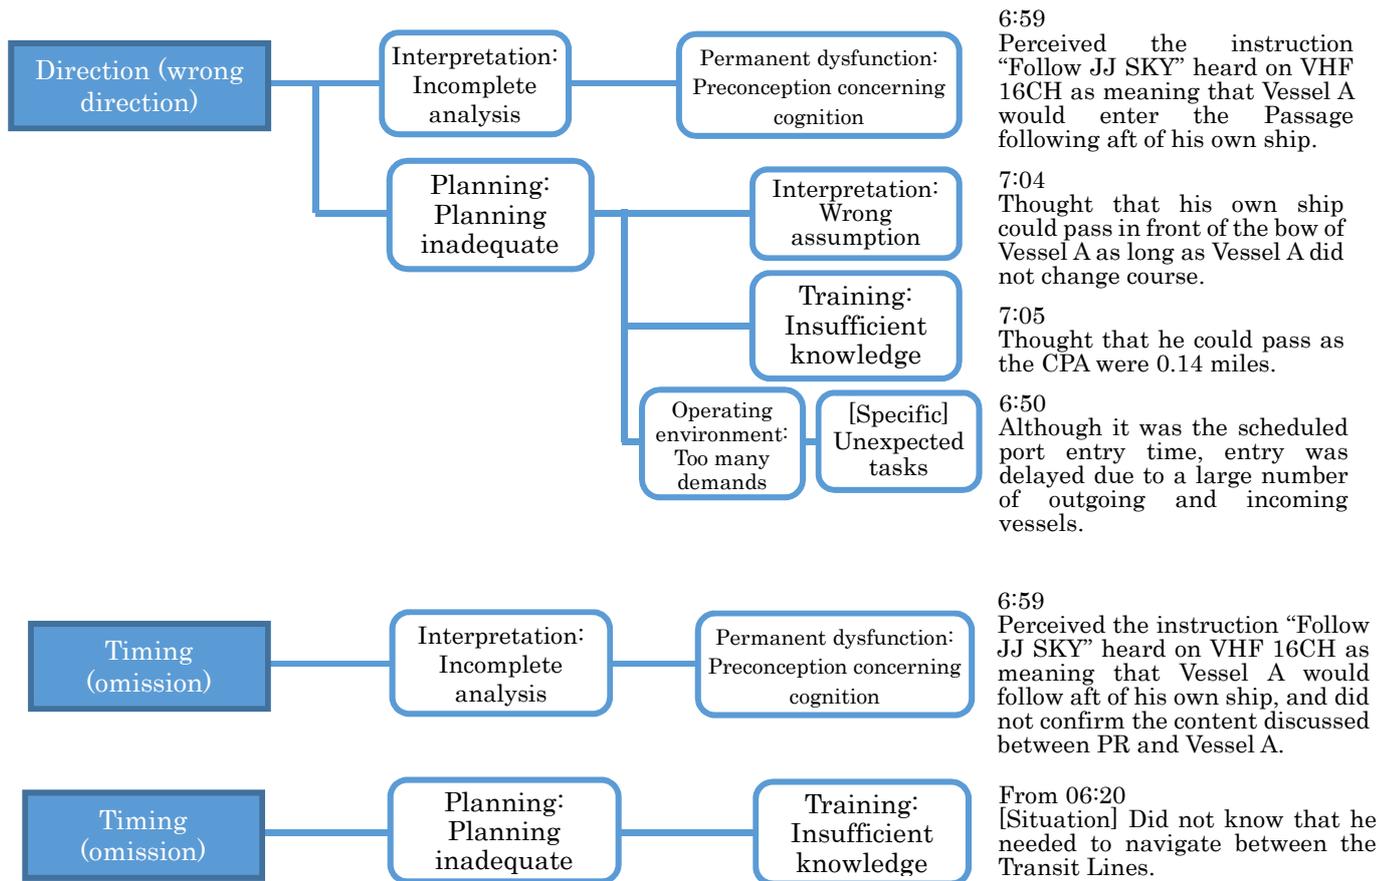
Fig. 17 Result of background factor analysis on the Master of Vessel B

Fig. 17 shows the result of background factor analysis. The Master was accustomed to navigating between Osaka Port and Kobe Port on a weekly basis. He had also navigated diagonally across the Passage before, in the same way as at the time of the accident, but had not previously experienced an accident. In the case of this accident, he had adopted the course of passing in front of the bow of Vessel A because he perceived the communication “Follow JJ SKY,” which he heard on VHF radio, as meaning that “Vessel A will enter the Passage following aft of your own ship.” Also, partly because the time of port entry was delayed, he increased speed and tried to pass in front of the bow of Vessel A. Besides this, he had seen the Port Entry Manual but had not sufficiently grasped its content; for example, he did not know about navigating between the Transit Lines.
