**MARINE ACCIDENT  
INVESTIGATION REPORT**

Vessel type and name: Container ship ACX CRYSTAL

Vessel type and name: Missile destroyer warship USS FITZGERALD

Accident type: Collision

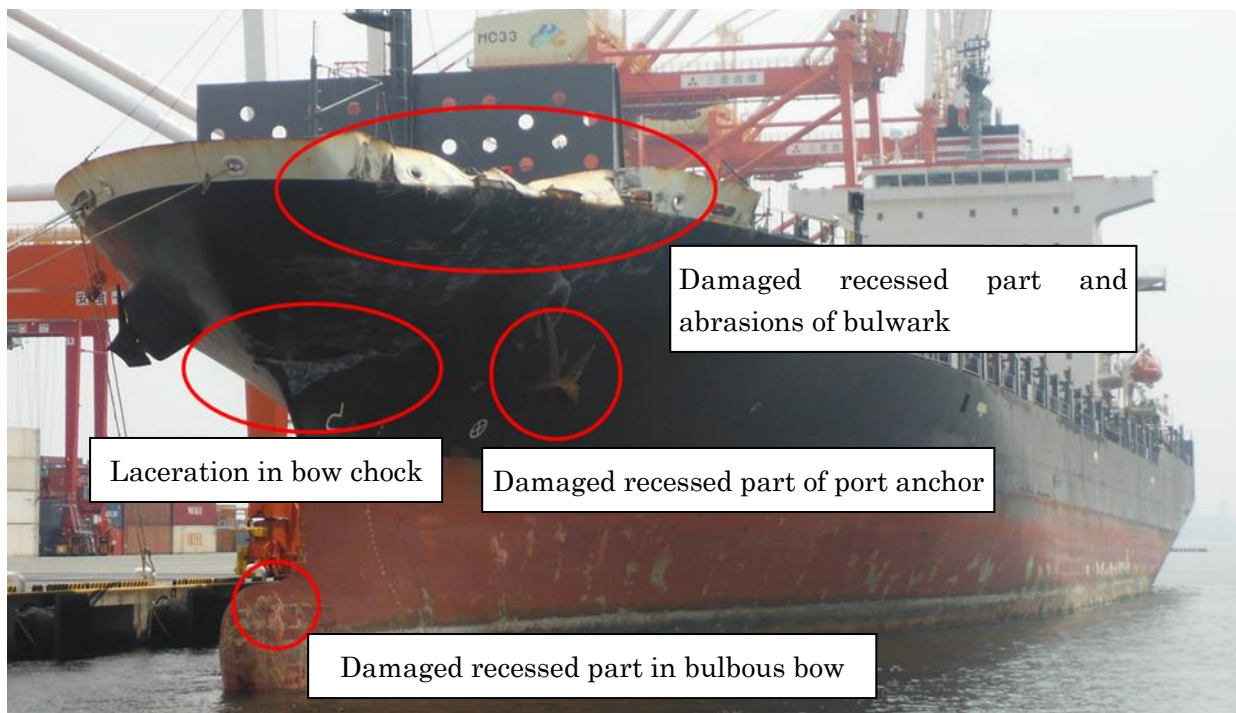
Figure 1: Damage of Vessel A (bow)

Damaged recessed part and abrasions of port bow bulwark, laceration in bow chock, damaged recessed part of port anchor and damaged recessed part in the bulbous bow (Refer to Figure 1 to Figure 3 and Attached figure 3: Damaged part of Vessel A (plan view and side view))

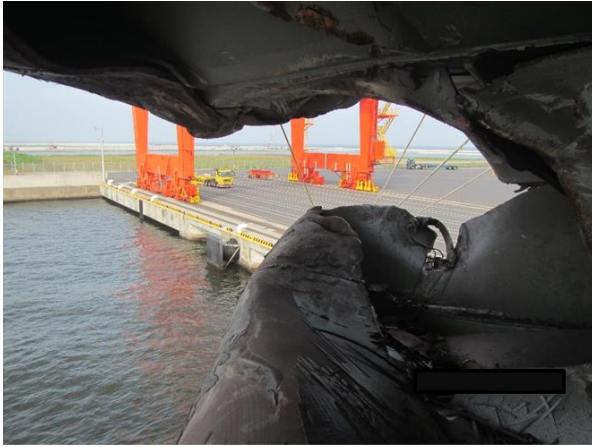
Figure 2: Damage of Vessel A (port bow)

Laceration in bow chock  
(from the inside of fore peak tank)

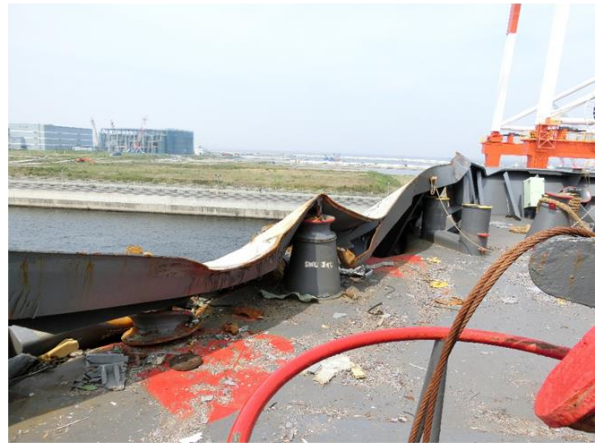
Damaged recessed bulwark

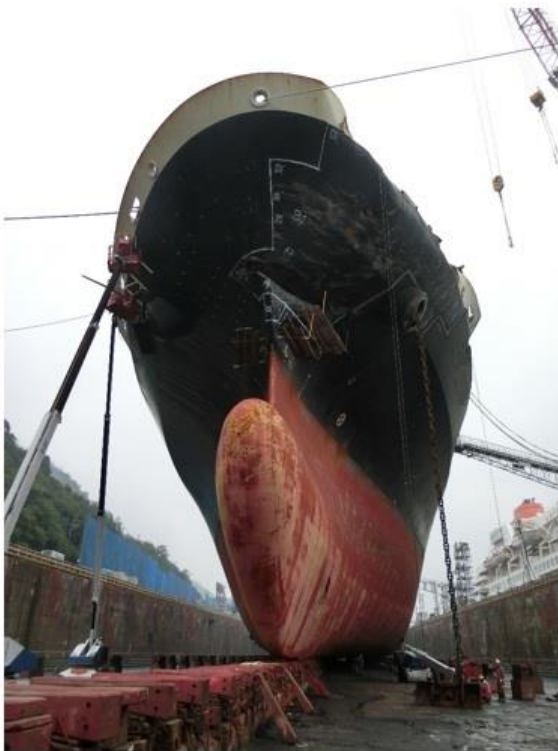
Figure 3: Damage of Vessel A (bottom section and anchor)

State in dock

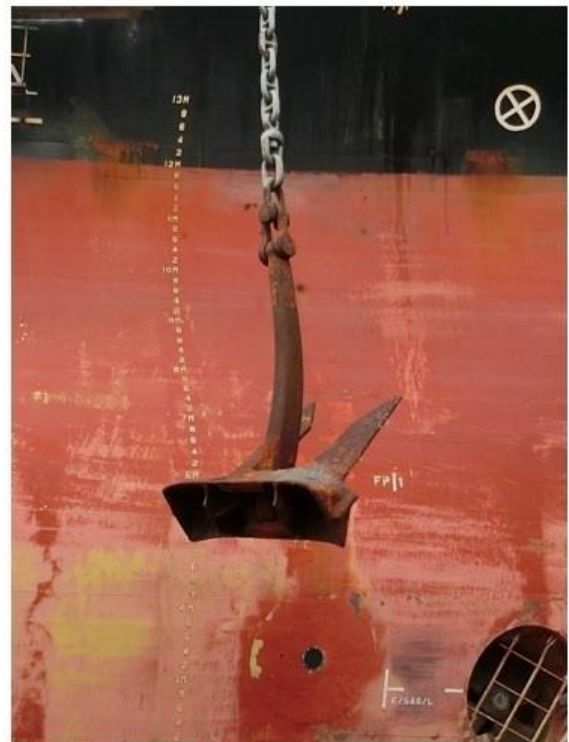
Damaged recessed port anchor shank

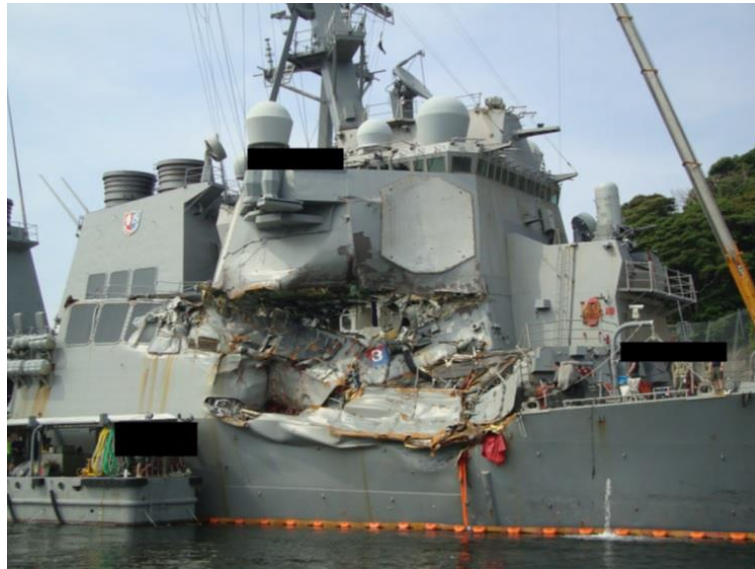
Figure 4: Damage of Vessel B (near the starboard midship front section)  
(provided by US Coast Guard)

Damaged recessed part and broken holes in the starboard midship front shell and in a second accommodation space of the starboard bow under water surface (Refer to Figure 4, Figure 5 and Attached figure 4: Damaged part of Vessel B (side view))

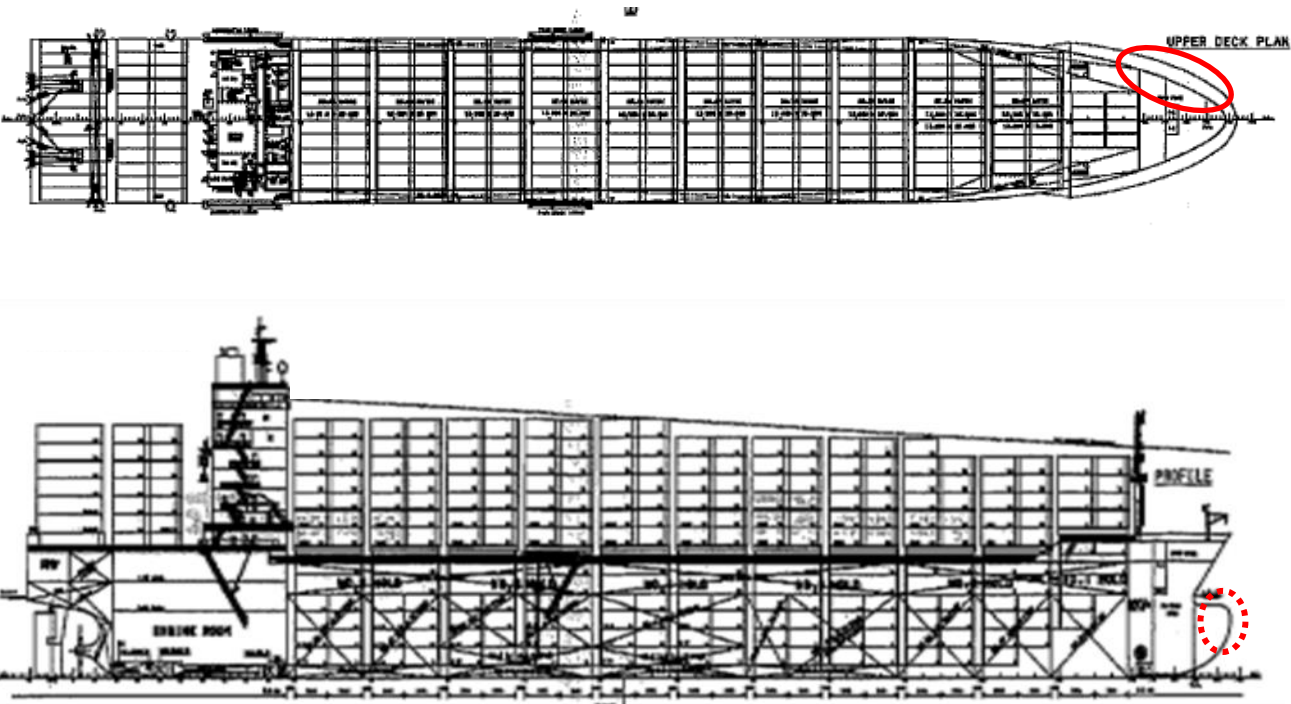
Attached figure 3: Damaged part of Vessel A (plan view and side view)

- (1) Vessel A had a damaged recessed part and abrasions of port bow bulwark, a laceration in bow chock, a damaged recessed part of port anchor and a damaged recessed part in the bulbous bow.
- (2) Vessel B had a damaged recessed part and broken holes in the starboard midship front shell and in the second accommodation space of the starboard bow under water surface.
