RA2013-1-I

Railway Accident Investigation Report

Train Derailment Accident in the premises of Sendai station of the
Tohoku Shinkansen of the East Japan Railway Company

Japan Transport Safety Board

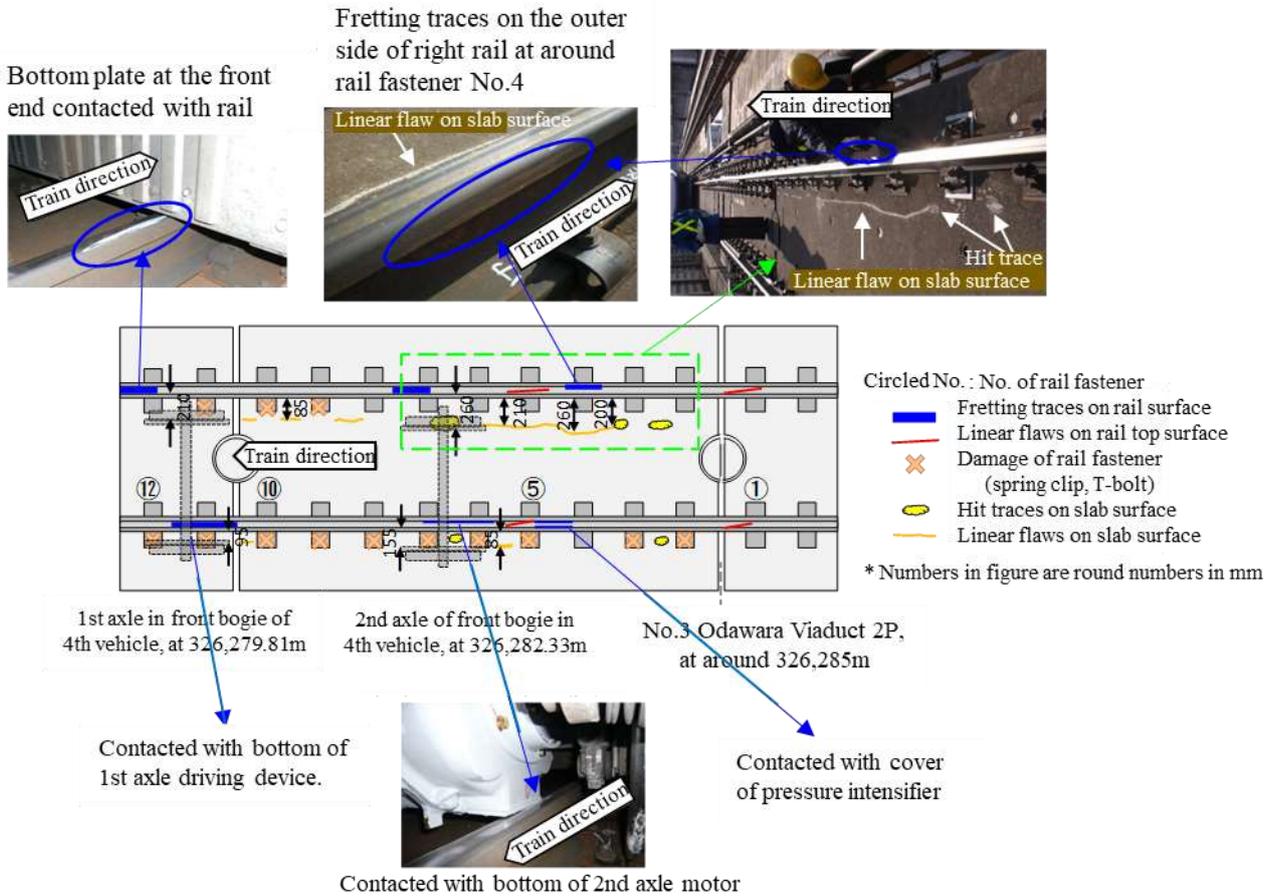
Figure 4. Status of the Major Damages in the Track (1)

(a) Damages, etc., found in rails

There were linear flaws considered as caused by wheels, from right to left on the top surface of right rail between 326,286.10 m to 326,285.70 m, and left rail between 326,285.89 m to 326,285.66 m, in around the rail fastener No.1. Here, the rail fasteners were numbered toward the train direction from the rail fastener No.1 where the first flaw was found on the top surface of rail. These traces started from top surface of rail and continued to left edges of top surface of rail.

There were linear flaws considered as caused by wheels, from right to left on the top surface of rail between 326,283.55 m to 326,283.10 m of right rail, and between 326,283.32 m to 326,283.07 m of left rail, in around the rail fastener No.5. The flaws in right rail started from top surface of rail, but the flaws in left rail continued from inside to outside of top surface of rail.

Furthermore, there were flaws considered as caused by the derailment of the accident train, as described in the following.

There was fretting trace being adhered with gray paint, on the top surface of left rail between the rail fastener No.4 and No.5, from 326,283.84 m to 326,283.32 m. There was fretting trace from rail surface to side of top surface of rail in the inner side of left rail in around the rail fastener No.6, and fretting traces caused by the contact between the motor of the 2nd axle and rail, on the inner side of top surface of left rail in around the rail fastener No.6.

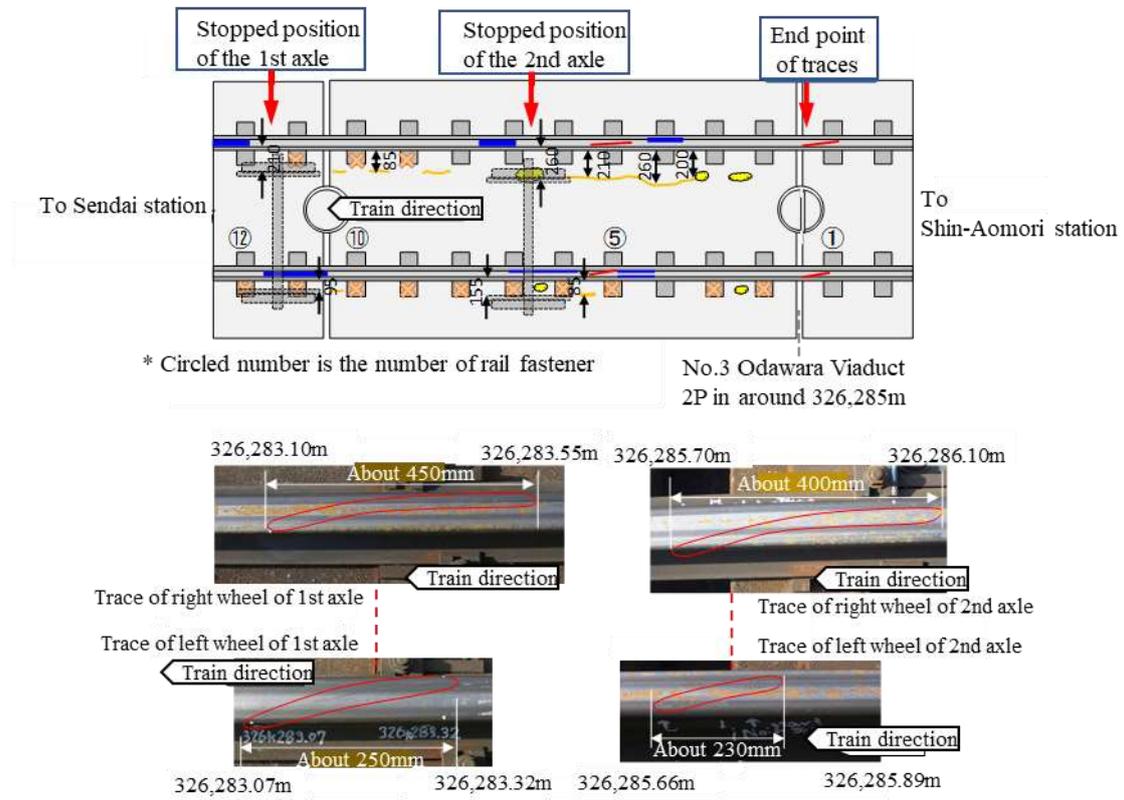
Figure 4. Status of the Major Damages in the Track (2)

(b) Damages found on slab surface and rail fasteners

There were hit traces and continuous linear flaws considered as caused by the derailed wheels on the slab surface inside of right rail, from around the rail fastener No.2 in around 326,285.1 m, to the stopped position of the 2nd axle in the front bogie in around 326,282.33 m.

There were the hit traces considered as caused by the derailed wheels between the rail fasteners No 2 and No.3, and between the rail fasteners No.3 and No.4. Among these, the linear flaw started from the hit trace between the rail fasteners No. 3 and No. 4, continued to the position where right wheel of the 2nd axle had stopped. The linear flaws gradually left from rail between around the rail fasteners No.3 to No.4, around 326,283.9 m, to about 260 mm apart from bottom of rail at around the rail fastener No.4, and about 200 to 210 mm apart from bottom of rail beyond around the rail fastener No.4 toward direction to Sendai station.

There was the hit trace considered as caused by the derailed wheels on the outside of left rail between the rail fasteners No.2 and No.3, beyond there in the direction to Sendai station, the damages of the rail fasteners considered as caused by the derailed wheels continued to the stopped position of the left wheel of the 2nd axle.

There were the hit traces considered as caused by the derailed wheels on the slab surface in the inside of right rail and outside of left rail at around the rail fastener No.7, beyond there to the position where right and left wheels of the 1st axle in the front bogie had stopped, the linear flaws on the slab surface and broken rail fasteners, both considered as caused by the derailed wheels, were existed discretely.

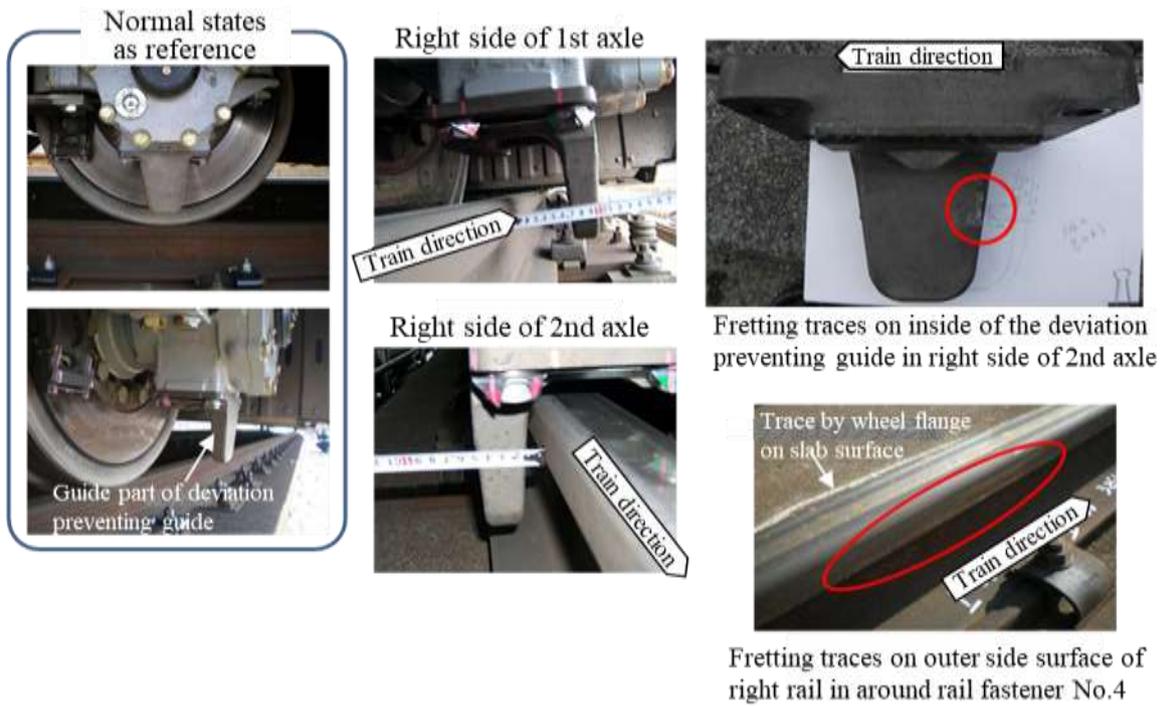
Figure 6. Status of the Deviation Preventing Guide

It is probable that the damage was not spread because the train was running in low speed just before the derailment by the operation of the system to stop trains earlier, and the derailed 4th vehicle did not deviate from the track seriously by the function of the deviation preventing guide.

The company attached the deviation preventing guide^{*8} to all the Shinkansen vehicles of the Company for the purpose of reducing damages when Shinkansen vehicles derailed.

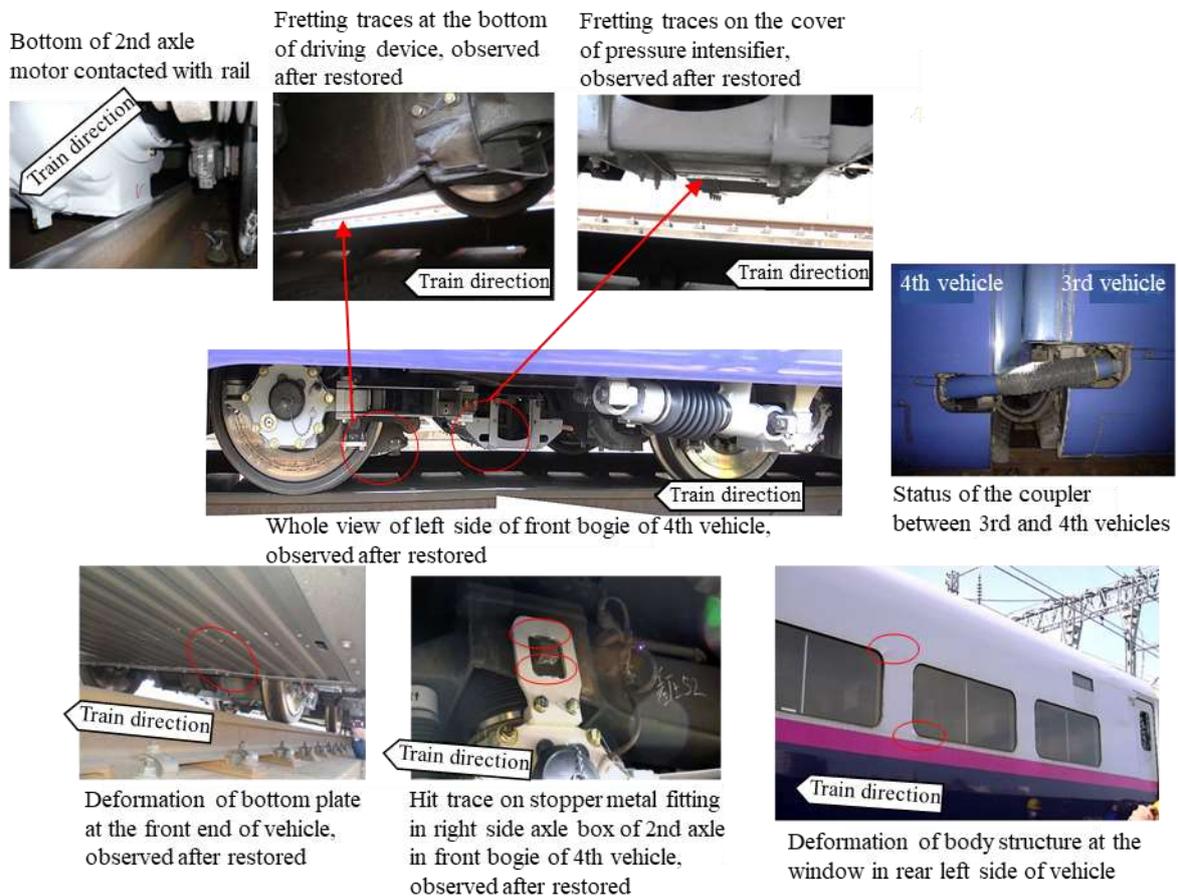
Figure 7. Status of the Major Damages in the Vehicles

Major damages in each vehicle were as follows.

(a) Three height controlling rods of the automatic level controlling devices, hereinafter named as the "leveling valve", had been bent and broken.

(e) All four height controlling rods of the leveling valve had been bent or broken.

(i) The worn particles of rubber considered as caused by large displacement, had been mixed to inside the air spring of the front bogie.

- (j) Pistons of the semi-active lateral dampers in the front and the rear bogies were damaged.
 - (k) There were traces considered as the single link had contacted with the cradle against abnormal rise stopper.
 - (l) The cradle of the lateral motion stopper was deformed.
 - (m) There were deformations considered as caused by being contacted with rail, in the bottom plate of front part of the front bogie.
- (3) The other vehicles

The height controlling rods of the leveling valves, *i.e.*, one rod in the 1st vehicle, four rods in the 5th vehicle, two rods in the 7th vehicle, all rods in the 8th vehicle to the 10th vehicles, had been bent and damaged or broken. Furthermore, there were deformations of cradles against lateral motion stopper in many vehicles. In addition, pantograph in the 6th vehicle had been dropped.

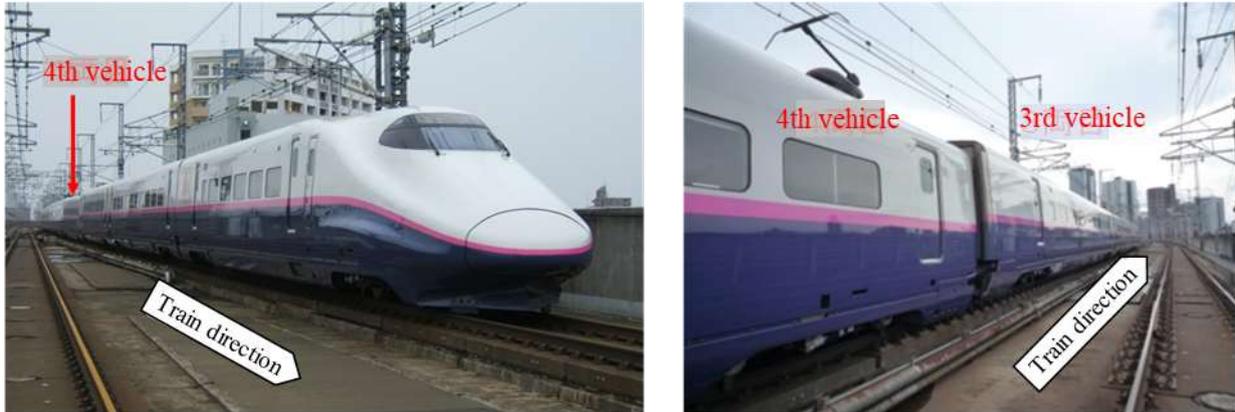
Photograph 1. Status of the Accident Train

While the train was entering to the premises of Sendai station at a velocity of about 72 km/h, the train driver felt the strong shake and simultaneously noticed the stop signal indicated in the cab signal device, and then he applied an emergency brake immediately. After the train had stopped, the train driver checked the situation of the train from inside and outside of the train and found that all two axles in the front bogie of the 4th vehicle had derailed to left.

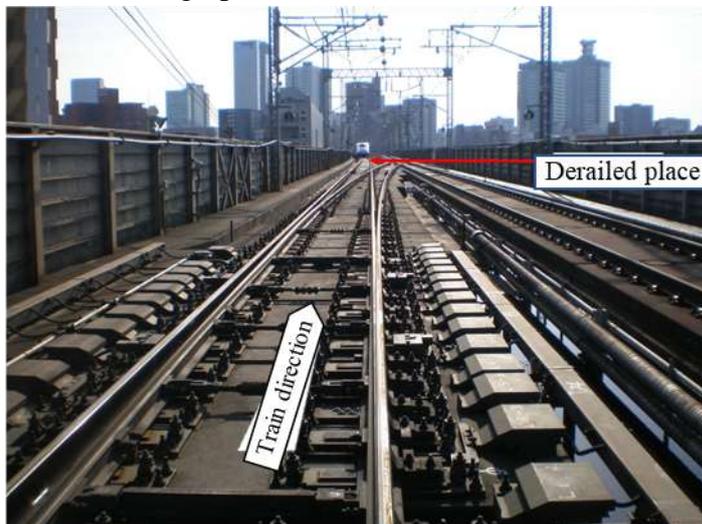
Photograph 2. Status of the Accident Site I

There were linear traces considered as caused by wheels on the top surface of right and left rails at around 326,283 m and around 326,286 m. Beyond there until to the stopped points of the axles in the front bogie of the derailed vehicle, there were damages considered as caused by wheels on the rail fasteners and surface of the slab tracks. The driving device of the 1st axle, the motor of the 2nd axle and the cross beam fitting the bottom plate in the rear part of the front bogie etc., had been stopped in the situation as being in contact with rails.
