# 四国航空株式会社所属ヘリコプター JA6522火災事故調査の進捗状況

## 1. 事故の概要

型式； ユーロコプター式AS350B3型

登録番号； JA6522

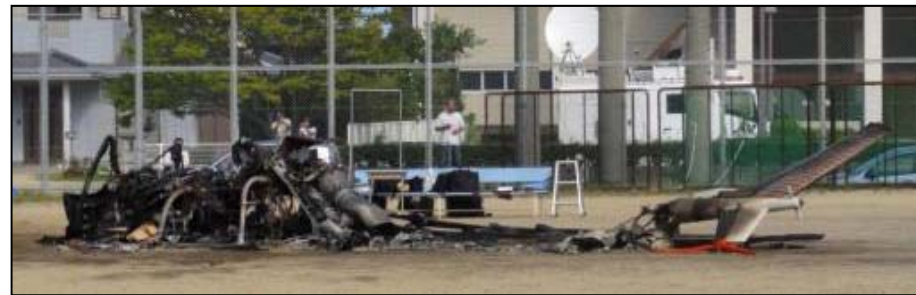
写真2 同機の残骸

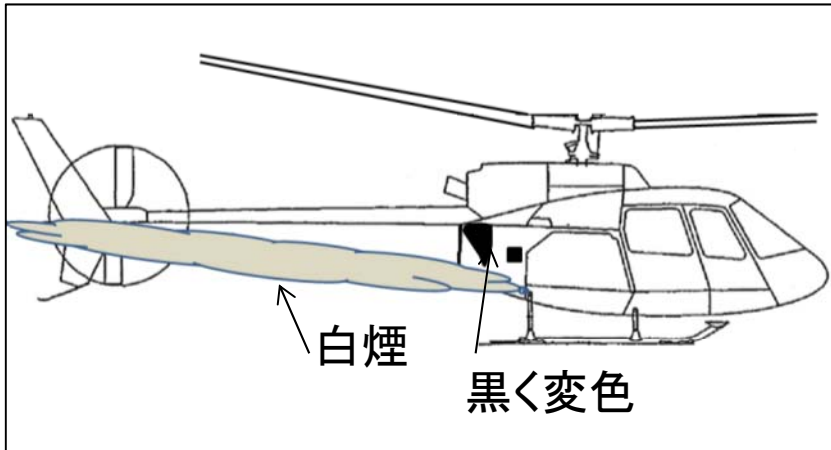
付図3 事故機の見撃情報(飛行中)

- ・後部荷物室の床付近から白煙
- ・後部荷物室外板が黒く変色

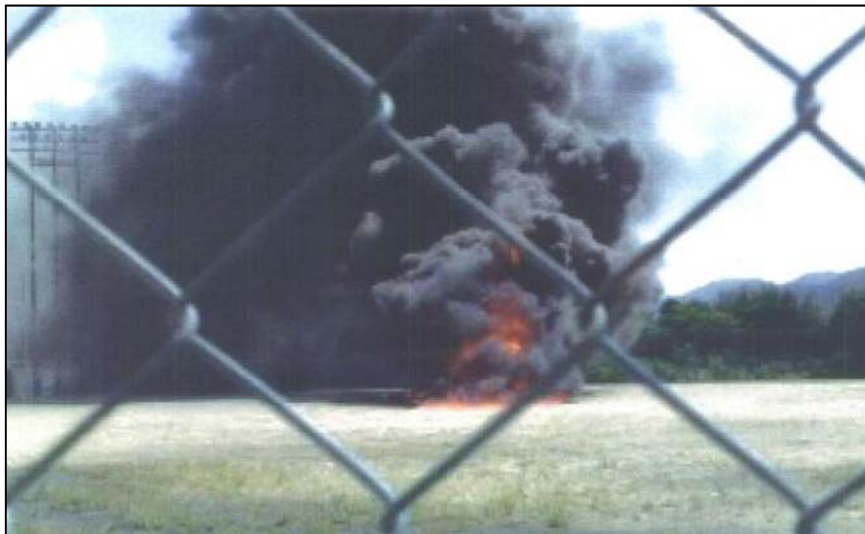
写真5 着陸後(10:23ごろ)

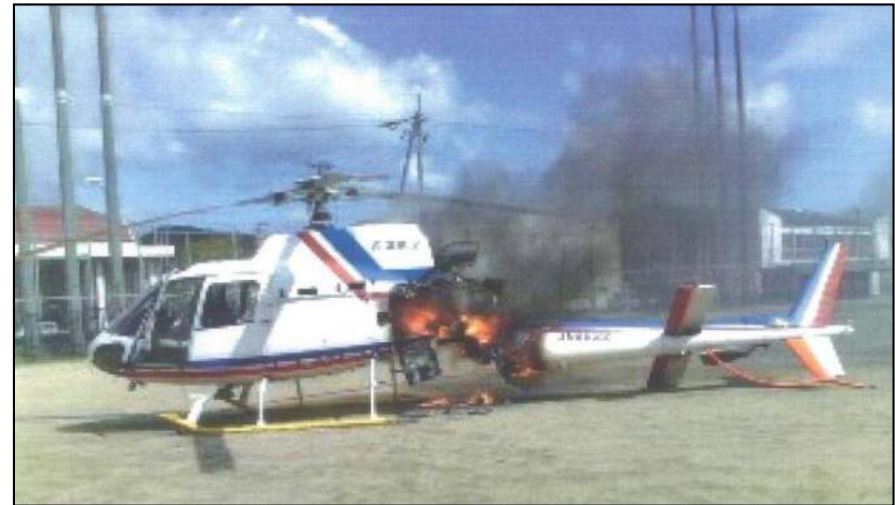
写真3 着陸後(10:13ごろ)

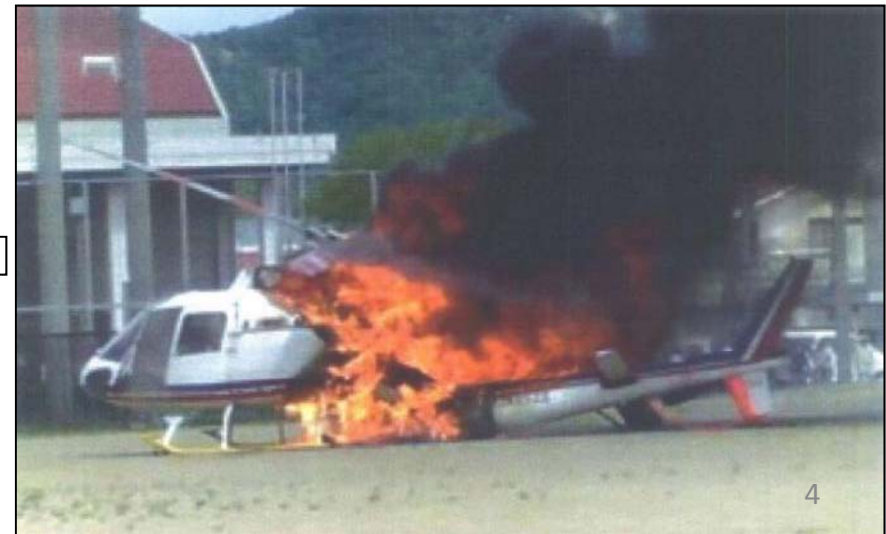
写真4 着陸後(10:19ごろ)

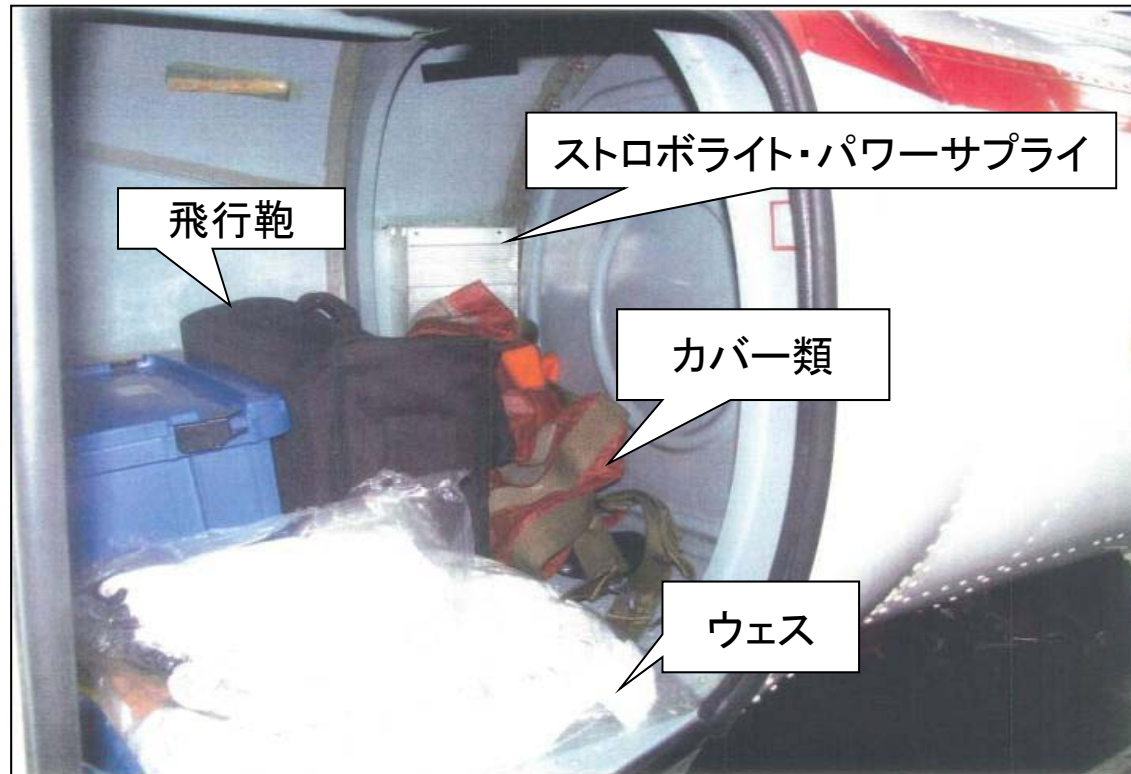
写真6 同型機の後部荷物室内(事故機と同じ積載状況)

※ 後部荷物室付近にはいくつかの電気装備品があり、後部荷物室には多数の可燃物が積載されていた。

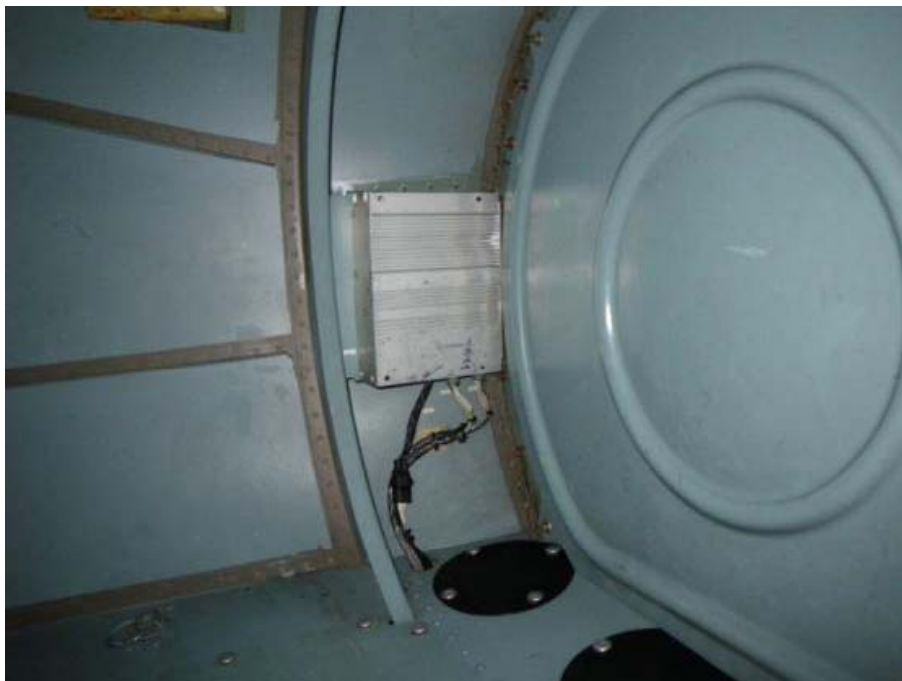
写真7 装備状況(同型機)

本体には、入力28VDC、出力400VDCの配線が接続している。出力側には保護装置(ヒューズ等)がない。

本事故を受け、当委員会に確認後、先月22日、EASA（欧州航空安全局）からEAD(Emergency Airworthiness Directive)、同日、製造者からASB(Alert Service Bulletin)、同26日、航空局からTCDが発出された。EADには、「本ADは、設計変更を行うまでの暫定的措置であり、更なるADの発行もあり得る。」との記載がある。EAD及びASBは、ストロボライトを使用停止するか、または使用する場合は繰返し点検を実施すること等を指示している。

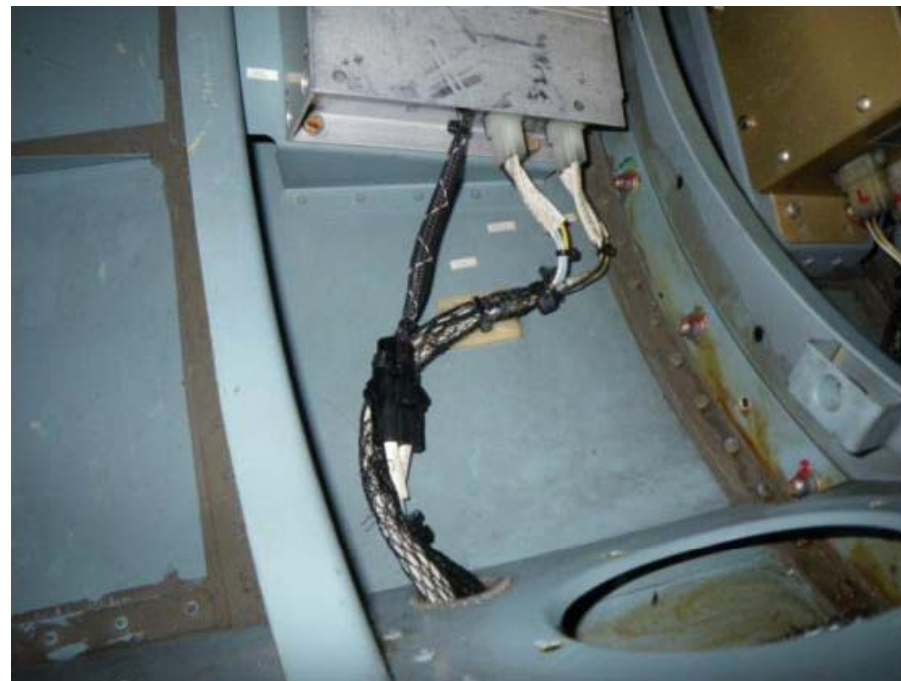
電気装備品名	特徴
ストロボライト・パワーサプライ	後部荷物室内右後方の壁面に取り付けてあり、床下に入出力の配線が伸びている。配線はほとんど保護されておらず、荷物の移動で損傷する可能性が十分考えられる。配線付近にカバー類を積載していた。
衝突防止灯パワーサプライ	後部荷物室と金属製隔壁で隔てられた後方の区画に装備されており、荷物の移動による影響はなく、発火しても後部荷物室に延焼する可能性は低い。
ELT (航空機用救命無線機)	後部荷物室内前方の壁面に取り付けてあり、荷物の移動による影響は少ない。また、電池は内蔵されているが、通常は作動していない。
FADEC (燃料コントロール)	後部荷物室内前方の壁面に取り付けてあり、配線の被覆が厚く荷物の移動による影響は少ない。配線の短絡が生じた場合は何らかのエンジン又は計器表示に異常が出るはずであるがそれはなかった。
マスターボックス (配電盤)	後部荷物室床下に取り付けてあり、荷物の移動による影響はなく、発火しても後部荷物室に延焼する可能性は低い。配線の短絡が生じた場合は何らかの計器表示が出るはずであるが、それはなかった。

写真8 配線の状況(同型機)
