四国航空(株)の航空事故に係る安全勧告に基づき講じた措置について(通知)

【航空事故の概要】(H23. 9. 22発生)

Subject: Safety recommendations related to the event to AEROSPATIALE - AS350 registered JA6522, on 22/09/2011, at Kagawa Prefecture - Japan

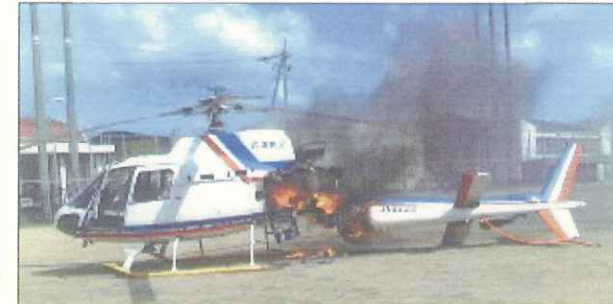
四国航空株式会社所属ユーロコプター式AS350B3型JA6522は、平成23年9月22日(木)、送電線監視飛行のため、09時23分ごろ高松空港を離陸し、送電線監視飛行を実施中、機内に焦げくさい臭い及び白煙が発生し、10時10分ごろ香川県東かがわ市引田所在の野球場に不時着した。

同機には、機長のほか、同乗者2名が搭乗していたが、死傷者はいなかった。
同機は、不時着後炎上し大破した。

当該事故機

本事故では、火災が発生した事故機の後方荷物室内に装備されたストロボライト・パワーサプライに接続する配線が、収納箱又は固い覆いで保護されていなかった。耐空性の基準(FAR27.855(b))には、荷物室内にある配線等は、積載物の移動により損傷を受けず、かつ、それらの破損又は破壊によっても火災発生の危険を生じさせないように、十分保護されない限り、荷物室に配置してはならないと規定されている。

したがって、ユーロコプター式AS350型系列機の後方荷物室内にある電気装備品及びこれに接続する配線が十分保護されるような改修の義務化を行うこと。

(1) 2013年11月27日、EASAは、事故直後、ストロボライトシステムの不作動又は繰り返し点検の実施を求めていた緊急AD(耐空性改善命令)を廃止し、配線とストロボライト・パワーサプライの保護覆いの設置を要求するAD 2013-0281を発出した。
