MARCH 2022

Japan Marine Science Inc.

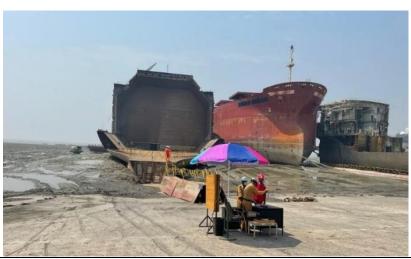
Establishment of entry points

We confirmed that in order to manage the number of people on board at the time of an emergency evacuation, PHP has established standards for entering a ship, maintained the posting of alerts and warnings, developed a system for the surveillance of safe work by the workers, and deployed people in charge for that purpose. On the other hand, one criticism was that we found room for improvement in the techniques for managing the number of people who have entered the ship. Furthermore, we confirmed through a witnessed inspection by the third party auditor that the removal/decontamination of explosive materials such as residual oil/sludge, etc. inside the oil tank zone and in the adjacent zones is being implemented appropriately before the hot work. Note that based on the criticism in the monitoring survey, regarding the ways of managing the number of people who have entered the ship, the PHP yard is newly considering the adoption of a system for managing the number of people using electronic sensors, and we confirmed that entry points for security checks have been established.

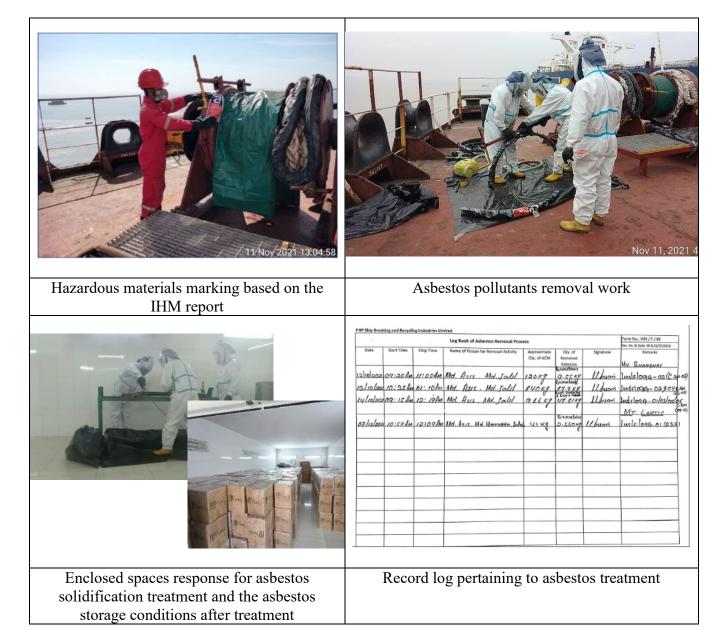
We confirmed that negative pressure chambers have been developed as equipment for the decontamination and solidification treatment of asbestos, and PHP is using said equipment to carry out the treatment appropriately. Furthermore, we confirmed regarding zones and pieces of equipment which are suspected to contain asbestos that PHP is posting alerts and warnings, workers wearing appropriate protective clothing are carrying out the removal work on the ships, appropriate solidification treatment is being implemented in the negative pressure chambers, and the treatment records are being stored appropriately.

Note that there are no facilities in BD which can treat asbestos waste, so the waste is stored inside the yard, and waste waiting for treatment is putting pressure on the warehouse, so the PHP yard is intending to ship it outside the country. On the other hand, regarding the storage conditions, damage in some of the wrapping of the block cylinders after solidification was found, so there was criticism that it should be protected appropriately. The ACMs for which said wrapping damage was identified are ACMs from materials which are difficult to scatter and were recovered from the winch brake lining system, but we confirmed that during the implementation of this monitoring survey PHP carried out additional measures to protect the cylinders by applying two layers of plastic sheet packing after the solidification treatment.

On the other hand, it is implementing solidification work even on ACMs which do not scatter much, and there is a possibility of overwork due to implementing work which is essentially not necessary, so we gave the advice that there is room for considering streamlining; for example, aim for responses commensurate with the capacity of the facility after appropriately understanding the properties of the asbestos-containing materials.

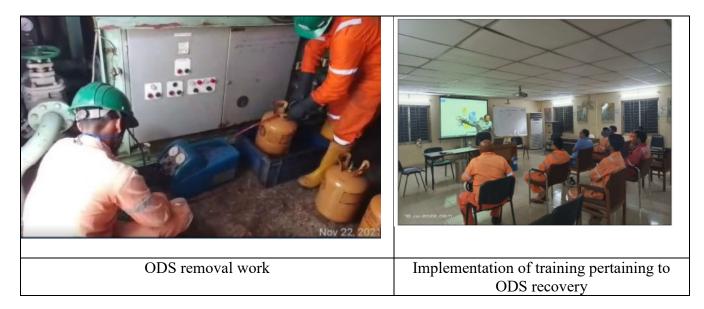
We confirmed that PHP is storing in bottles the gaseous ODS which were recovered from the compressors of the refrigeration system using recovery units. We confirmed that training pertaining to ODS recovery was implemented during the monitoring survey period while on the other hand we could not confirm any record of past training.

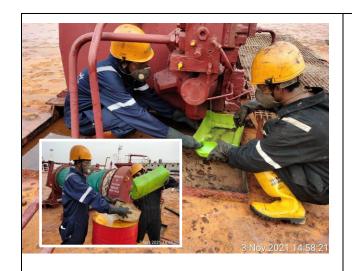
Waste work oil removal work

We confirmed that before the hot work the work of removing residual oil and sludge from fuel tanks, bilge tanks, etc. in order to prevent in advance fires and maritime oil spill contamination during the steel sheet cutting action is carried out as manual work, the oily waste generated by this tank cleaning, etc. is extracted for a fee by a certified external service supplier (commonly called a "vendor"), and the PHP yard carries out training for the waste oil transportation workers of the subcontractors. Furthermore, we confirmed regarding the waste oil inside the ships (including oily water mixtures (slop) and polluted mud (sludge)) that a team which has received training pertaining to such work is dispatched to recover all of it on the ships by putting it into steel drums, moving it to crude oil storage tanks inside the yard, and reselling it.

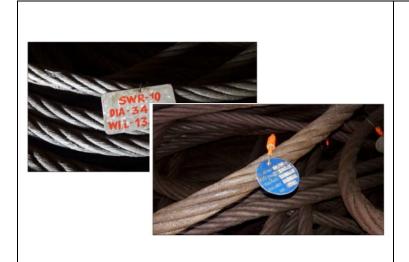
Tag management used in confirmations and inspections of the state of the wires

We confirmed through the load test certificates, certification, etc. that the machinery and devices were being tested and calibrated regularly by a third party testing institution. On the other hand, there were criticisms saying that PHP should thoroughly implement a policy of not storing unnecessary things in the oil recovery tools storage box in order to respond immediately when there is an emergency, and that it should add gloves and gumboots to the equipment list of the oil recovery tools. Furthermore, the wire ropes used in the winches were not identified individually, so the attachment of tags, etc. which can identify each wire rope in order to manage the inspection status of the wire ropes, etc. was encouraged.

We confirmed with an on-site investigation that in response to these criticisms, etc., the PHP yard has revised the inventory list of the oil spill kit in order to develop appropriate oil recovery tools, has newly introduced the proposed fixtures content, and has taken measures for improvement. Moreover, we confirmed that all types of haulage devices, including the winches and wires, are being regularly tested and verified, and that the HSE team is carrying out additional safety checks on wires which are found to have lost their tags.

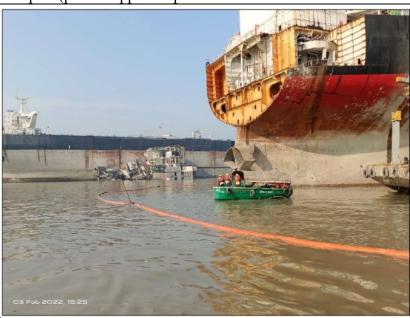
Oil spill response training based on the revised EPRP

Furthermore, we confirmed that the Emergency Preparedness and Response Plan (EPRP) has been developed appropriately and training (mock drills) is being implemented based on the plan, but there was the advice that the content of the plan should be organized in order to make the actions taken at the time of emergencies effective; for example, the stipulated instruction content should be made clearer, etc. We confirmed that in response to this PHP revised the EPRP taking into account said advice. Furthermore, we confirmed that it took the measures of translating the incident reports/near misses into the local language and posting them on the bulletin boards.
