Sasago Tunnel Ceiling Collapse
on the Chuo Expressway
(Sequence of Events and Countermeasures)

Ministry of Land, Infrastructure, Transport and Tourism
(MLIT) of Japan

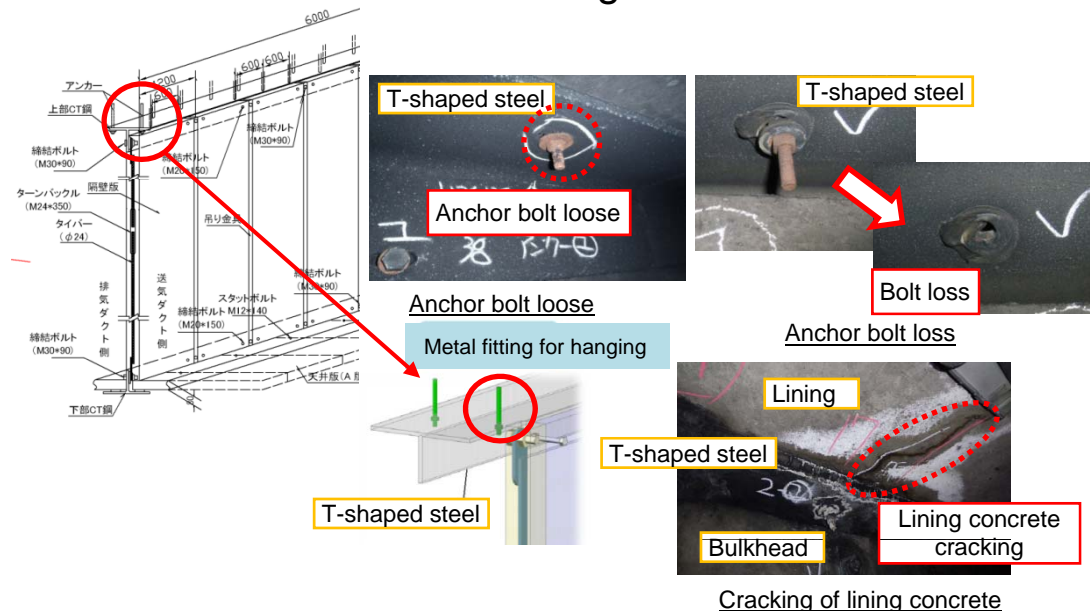
Defects found in Sasago Tunnel

Found 632 anchor-bolt-related defects. Tunnel's safety was secured by removing the ceiling panels

Found 1,028 anchor-bolt-related defects. Tunnel's safety was secured by removing the ceiling panels
