**Interim Report
of Committee on Large Container Ship Safety**

In December 2013

Committee on Large Container Ship Safety
Japan

The Bahamian flagged large container ship (8,000 TEU class) "MOL COMFORT" (herein referred to as "The Ship") experienced a fracture amidships while transiting the Indian Ocean from Singapore to Jeddah (Saudi Arabia) on 17 June 2013. Following this, The Ship split into two halves, which were adrift before sinking. Thanks to the swift rescue efforts of ships navigating the area and Indian disaster relief authorities, no loss of life occurred in this accident. We express our gratitude to those involved in this rescue.

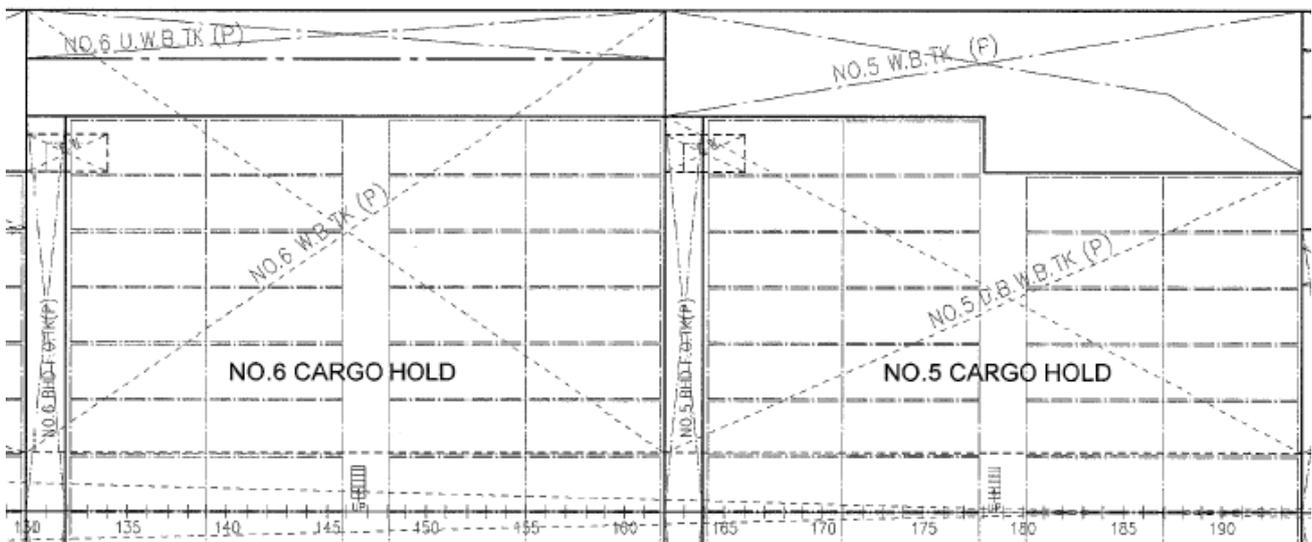
Tank Top Arrangement of No.5 & No.6 Cargo Holds (Port Side)

The Ship experienced hogging (convex deformations in the longitudinal direction), causing the ship's midship to fracture. According to observation of the progression following the outbreak of the accident, the upper deck area was the last part to fracture. From this, it can be assumed that the crack which triggered the fracture began below the waterline in the bottom part of the ship's hull and then progressed upwards along the side of the ship. The fracture is believed to have originated in the bottom shell plates of No. 6 Cargo Hold.

An investigation of The Ship's maintenance and inspections records also found buckling deformations on the bottom shell plates of the No. 5 Cargo Hold forward of the presumed fracture point.
