**Interim Report
of Committee on Large Container Ship Safety**

Committee on Large Container Ship Safety

The Bahamian flagged large container ship (8,000 TEU class) "MOL COMFORT" (herein referred to as "The Ship") experienced a fracture amidships while transiting the Indian Ocean from Singapore to Jeddah (Saudi Arabia) on 17 June 2013. Following this, The Ship split into two halves, which were adrift before sinking. Thanks to the swift rescue efforts of ships navigating the area and Indian disaster relief authorities, no loss of life occurred in this accident. We express our gratitude to those involved in this rescue.

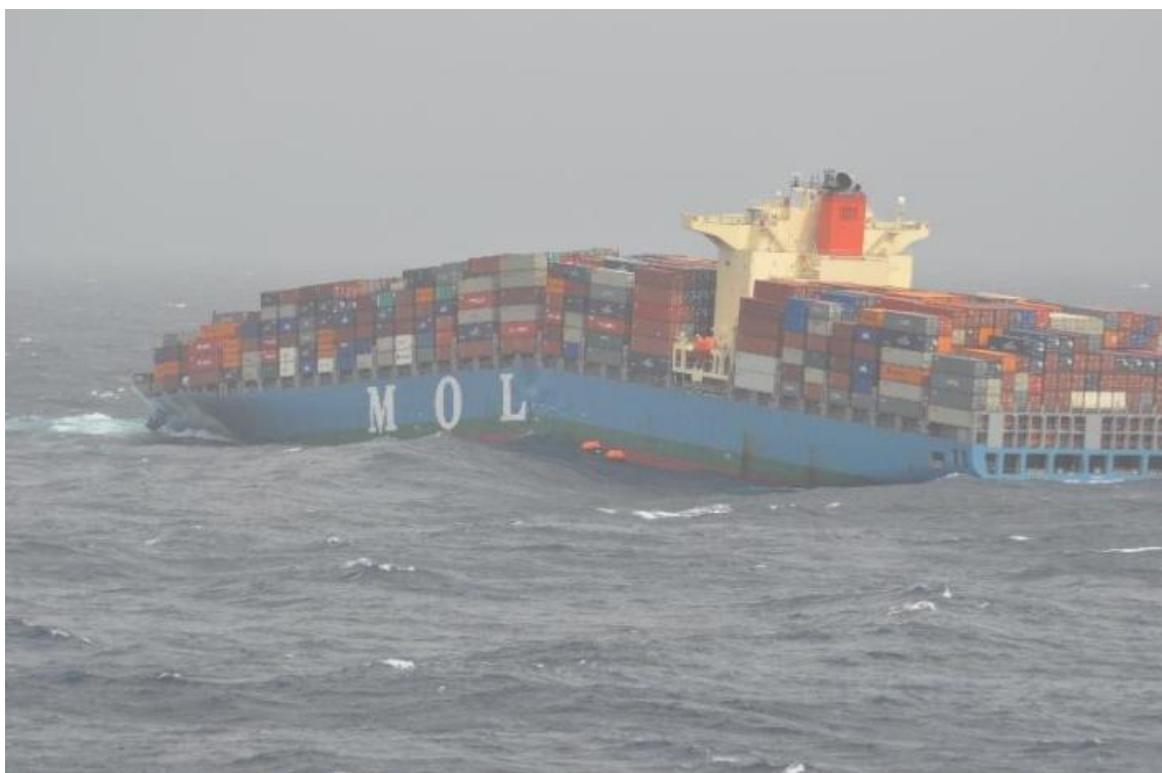
According to the operator of The Ship, a crack occurred amidships at about 07h45 (GMT + 5 hours) on 17 June 2013, while crossing the Indian Ocean on a voyage from Singapore to Jeddah in Saudi Arabia. The Ship was sailing at a speed of approximately 17 knots with the engine running at 79 rpm. The significant wave height at the time of the accident was 5.5 m with a south-westerly wind of Beaufort force 7. As a result of water ingress into the cargo hold, The Ship was unable to operate under its own power. The 26 crew members escaped by lifeboat and rescued. Subsequently, The Ship's hull split into two which then drifted apart, and subsequently sank in the open sea (3,000 to 4,000m in depth). Records on board, such as Voyage Data Recorder, Ship Log Book, and Ballast Log Book Record among others, were lost when The Ship sank.

Fig. 3.1 Condition of The Ship at the time of the accident (photo by Mitsui O.S.K. Lines, Ltd.)

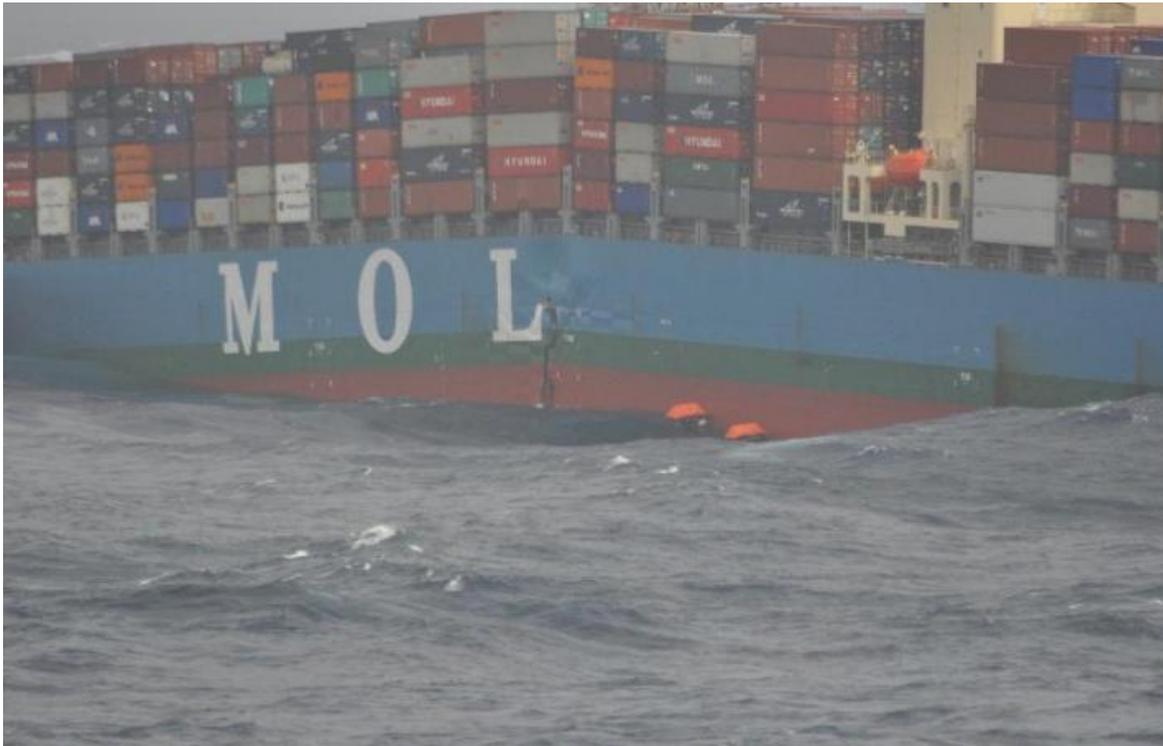
Fig. 3.2 Enlarged view: Direction of the crack progression (photo by Mitsui O.S.K. Lines, Ltd.)

Water ingress was first detected by the water ingress alarm in the Duct Keel located near the center line of the double bottom of The Ship. Approximately two minutes later, further water ingress was detected in No.6 Cargo Hold located on the double bottom amidships. From the enlarged view in Fig. 3.2, the direction of the crack progression ran upwards from the bottom of The Ship, at No.6 Cargo Hold. From this, it was assumed that the crack which triggered the fracture had originated in the bottom shell plate below No.6 Cargo Hold amidships.

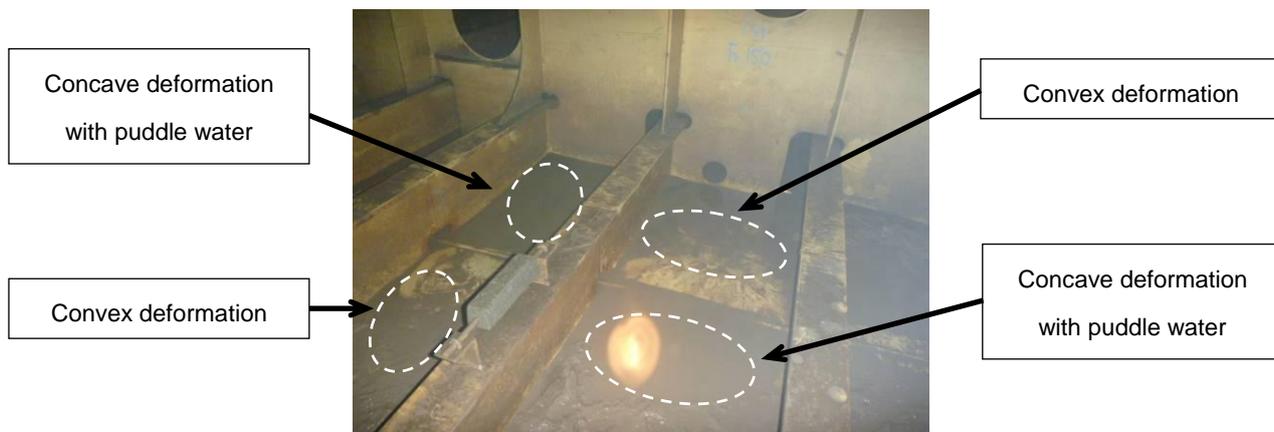
Fig. 4.1 Example of buckling deformation observed in the bottom shell plating under cargo hold amidships found on The Sister Ship operated by the same operator of The Ship (photo by Mitsui O.S.K. Lines, Ltd.)

Fig. 4.1 shows an example of deformation observed in The Sister Ship operated by the same operator of The Ship. The concave and convex buckling deformation of the bottom shell plating was observed between the bottom longitudinals which were not deformed. Fig. 4.2 shows method of the deformation measurement.

A safety inspection on the bottom shell plates to the extent possible should be conducted in order to verify the presence of buckling deformations. If such deformations are found during this inspection, consult a classification society regarding the proper measures to be taken.

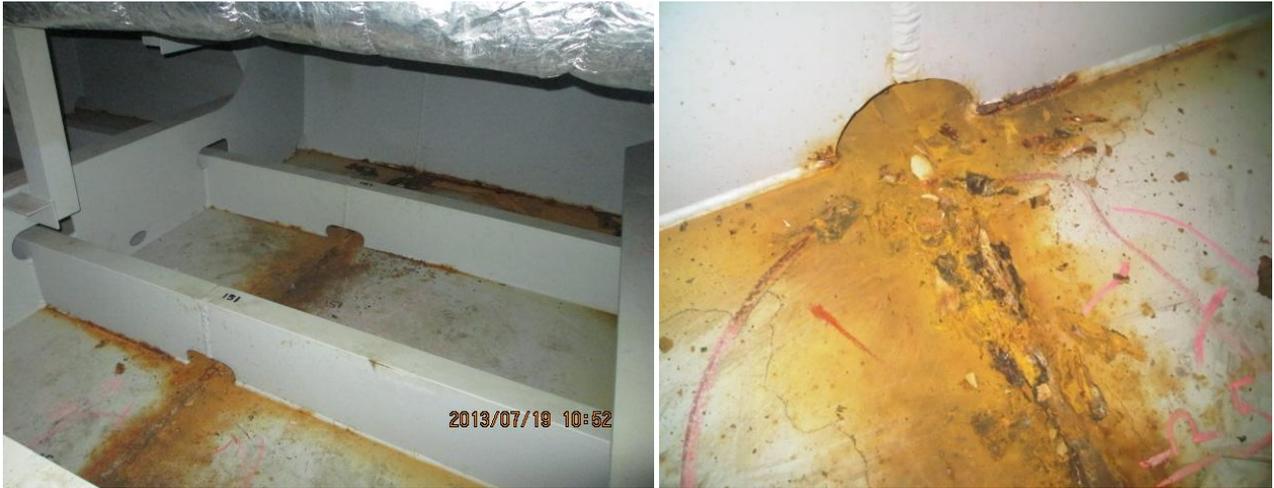
As shown in Fig. 4.3, a tear in the coating and rust were observed in the butt weld near Fr. 151 of the bottom shell plates along the transverse direction of the pipe duct near the ship center line in some of The Sister Ships, which was presumed to be where the fracture originated. The results of investigation show that similar tears in coating and rust in the butt joint near Fr. 151 of the bottom shell plates were observed in two of the six ships operated by the operator of The Ship. However, no tears in coating were observed in butt joints at other locations. Noticeable tears in coating and rust as shown in Fig. 4.3 are normally not observed in ships only five years operation after delivery. As this has occurred at a location assumed to be where the fracture was originated, the cause and effects of this phenomenon should be investigated.

Fig. 4.3 Tears in coating and rust of butt joint (Photo by Mitsui O.S.K. Lines, Ltd.)

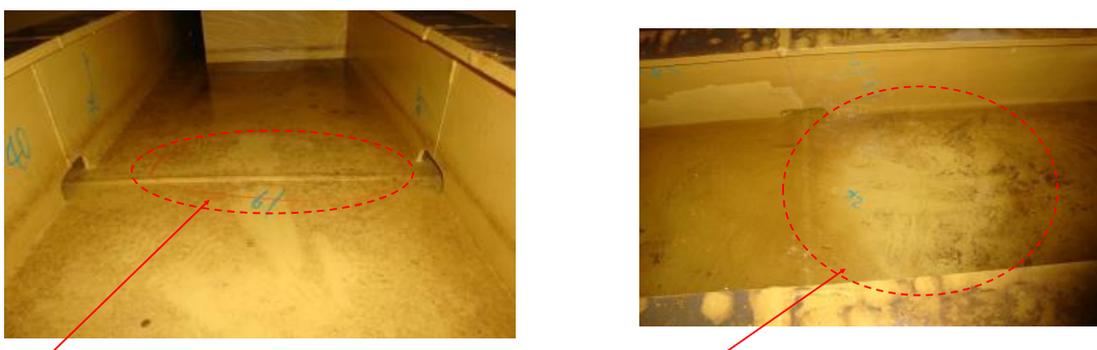
An investigation of The Ship's maintenance and inspections records also found buckling deformations on the bottom shell plates of the No.5 Cargo Hold forward of the presumed fracture point.

As the above paragraph was mentioned, such deformation cannot be always found and recorded. For example, in maintenance inspections by ship's staff after 4 January 2010, no deformation was found in the bottom shell plates near the butt weld in the vicinity of Fr.182.

Fig. 4.4 Deformation of bottom shell plate of The Ship
(area of butt weld in bottom shell plate near Fr.182 under the No.5 Cargo Hold)
(Photo by Mitsui O.S.K. Lines, Ltd.)

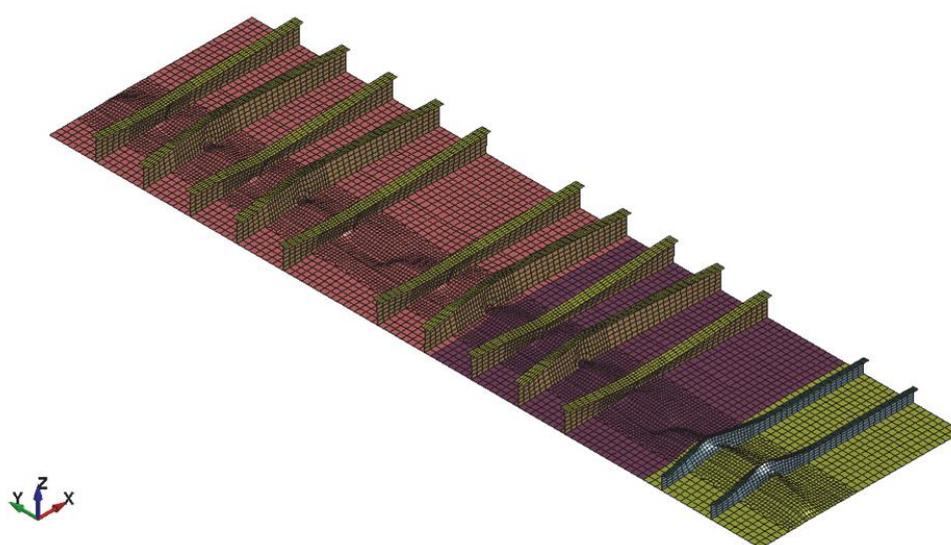
Hull structure strength (ultimate hull girder strength) of The Ship estimated by Elasto-plastic Analysis by 3 hold FE model	14.0×10^6 kN-m (Result of the simulation)
Hull girder strength required by the Rules	11.1×10^6 kN-m

Fig. 5.2.3 Deformation of bottom shell plates nearby hull structure strength (ultimate hull girder strength) (girders are not displayed for better understanding)

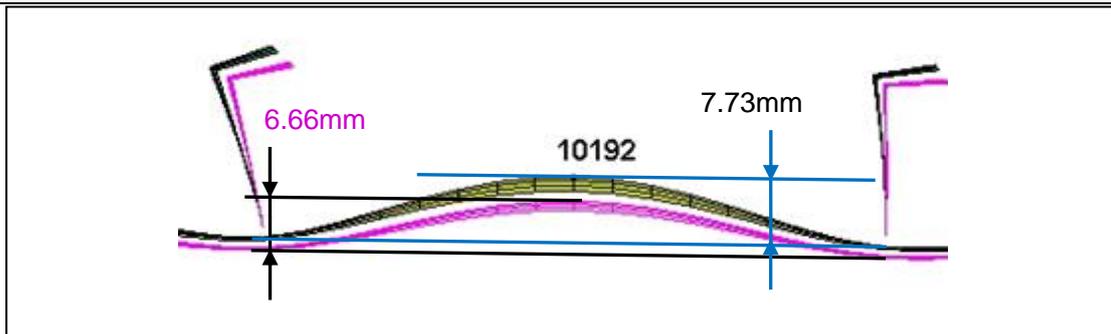
Comparison of deformation under still water condition and residual deformation after unloading from 14.8×10^6 kN-m to still water condition for the case when initial imperfection of “hungry-horse” mode was given (In the case of hull structure strength (ultimate hull girder strength) of 15.0×10^6 kN-m) (including initial shape imperfection of 3.14 mm at the relevant position)

Fig. 5.2.5 Reproduction of deformation of bottom shell plate (unloading from 14.8×10^6 kN-m to still water condition in the case when hull structure strength (Ultimate hull girder strength) was 15.0×10^6 kN-m)
