**Final Report  
of Committee on Large Container Ship Safety**

Committee on Large Container Ship Safety

The Bahamian flagged large container ship (8,000 TEU class) “MOL COMFORT” (herein referred to as “The Ship”) experienced a fracture of midship part while transiting the Indian Ocean from Singapore to Jeddah (Saudi Arabia) on 17 June 2013. Following this, The Ship split into two halves, which were adrift before sinking. Thanks to the swift rescue efforts of ships navigating the area and Indian disaster relief authorities, no loss of life occurred in this accident. We express our gratitude to those involved in this rescue.

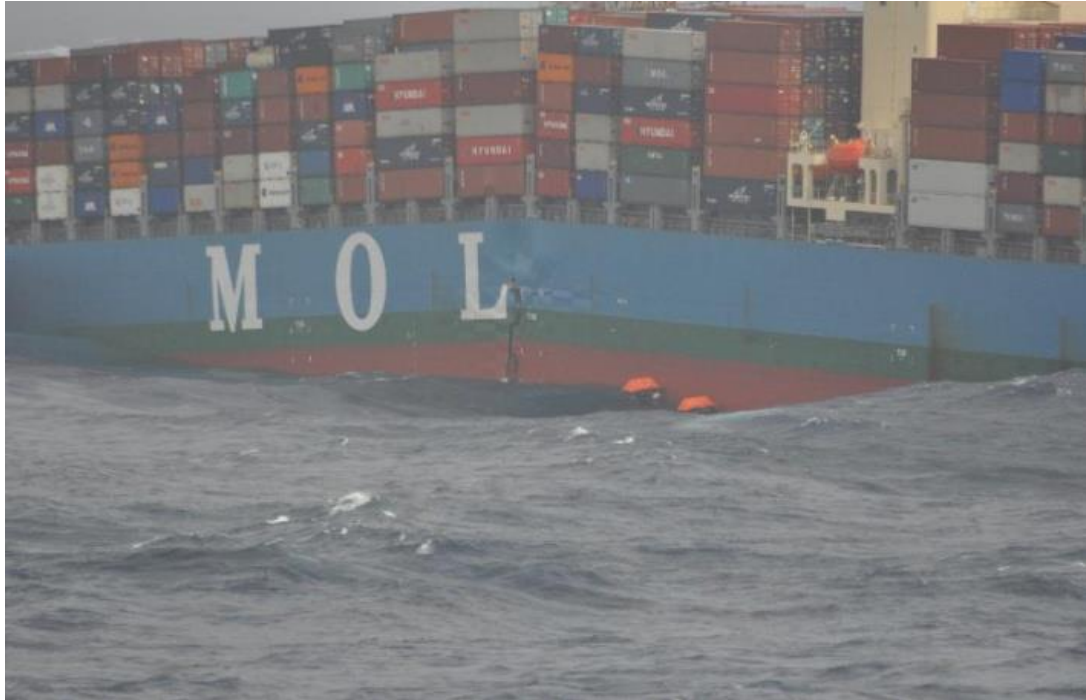
Water ingress was first detected by the water ingress alarm in the Duct Keel located near the center line of the double bottom of The Ship. Approximately two minutes later, further water ingress was detected in No.6 Cargo Hold located on the double bottom midship part. From the enlarged view in Fig. 1.3.1, the

crack progression ran upwards from the bottom of The Ship, at No.6 Cargo Hold. From this, it was assumed that the crack which triggered the fracture had originated in the bottom shell plates below No.6 Cargo Hold midship part.

Fig 1.3.1 Condition of The Ship at the time of the accident  
(Direction of the crack progression (photo by Mitsui O.S.K. Lines, Ltd))

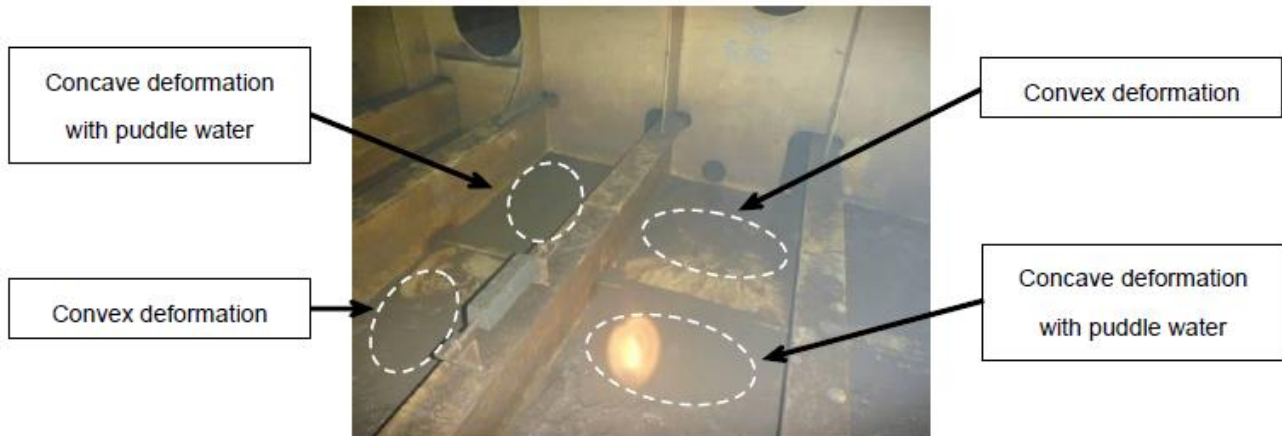
Fig 1.4.1 Example of buckling deformations observed in the bottom shell plates in double bottom midship part found on The Sister Ship operated by the same operator of The Ship (photo by Mitsui O.S.K. Lines, Ltd.)

Fig. 1.4.1 shows an example of deformation observed in The Sister Ship operated by the same operator of The Ship. The concave and convex buckling deformation of the bottom shell plates were observed between the bottom longitudinal stiffeners which were not deformed.

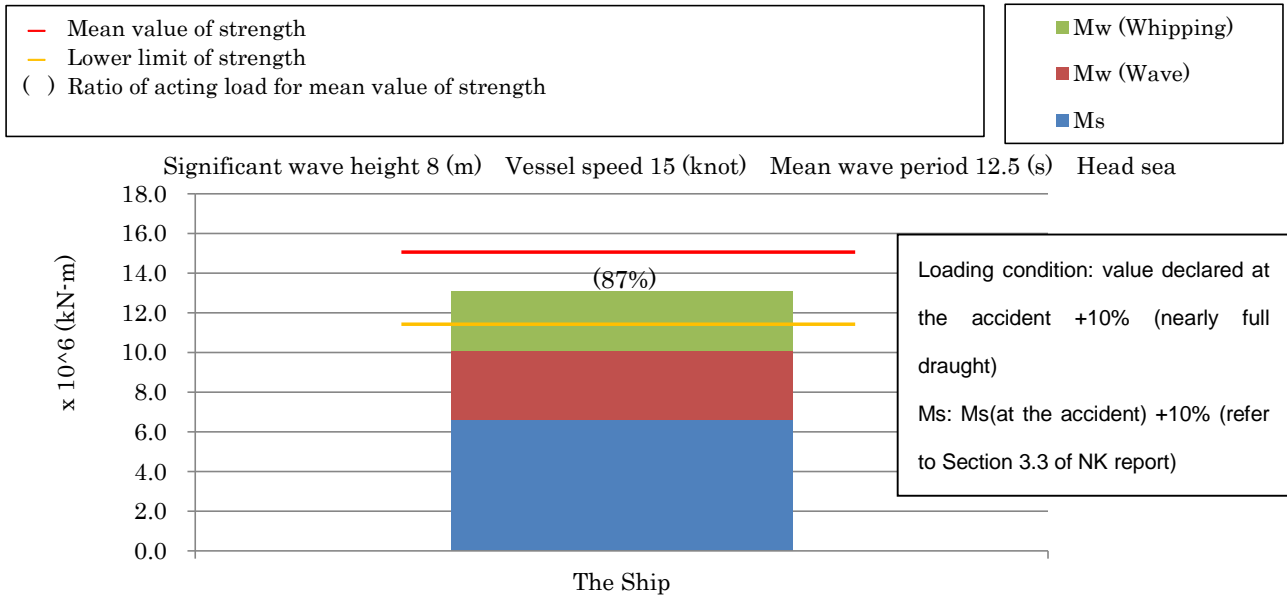
fracture occurred where the load of the vertical bending moment exceeded the hull girder ultimate strength at the time of the accident.

In order to verify the possibility of the accident, the simulation of acting loads was conducted by changing the condition of ship speed, significant wave height and mean wave period, taking into account deviation of the weather and sea conditions. And the result of this simulation was compared with ship structural strength simulated by calculation. In this simulation, ship speed and sea conditions (significant wave height, mean wave period and wave direction) were changed except for the wave direction in order to confirm that the condition, set in NK report which indicated the possibility of the accident, does not lead to peculiar results. Consequently, it was verified that it is actually possible that ship fracture happened where the load of the vertical bending moment exceeded the ship structural strength at the time of the accident as shown in Table 2.2.1 and Figure 2.2.1.

Figure 2.2.1 Consideration for possibility of the accident

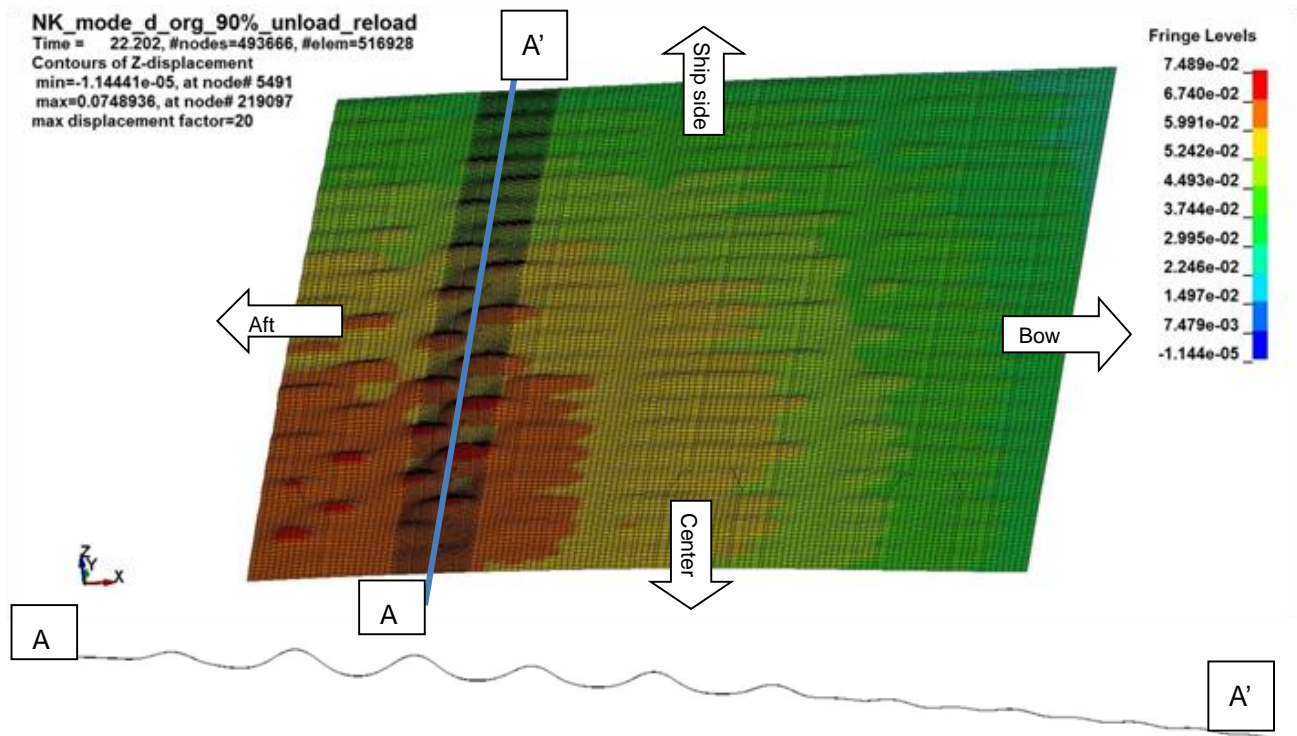
Maximum deformation 17.01 mm (double amplitude quantitative, deformation between longitudinal stiffeners would be about half of this double amplitude)

Figure 2.3.1 Sample of Simulation for Reproduction of buckling deformations on bottom shell plates (At Fourth unloading after repeatedly providing 90% of mean value of strength (95.2% of hull girder ultimate strength in case initial deformation (Annex 3) was provided))

As mentioned in paragraph 2.1, the values of the estimated hull girder ultimate strength of each The Sister Ship have the deviation. Therefore, the value of loads, which caused the buckling deformation, could not be definitely specified. However, it was found that buckling deformation of the bottom shell plates might occur in The Sister Ships although hull girder fracture did not occur.

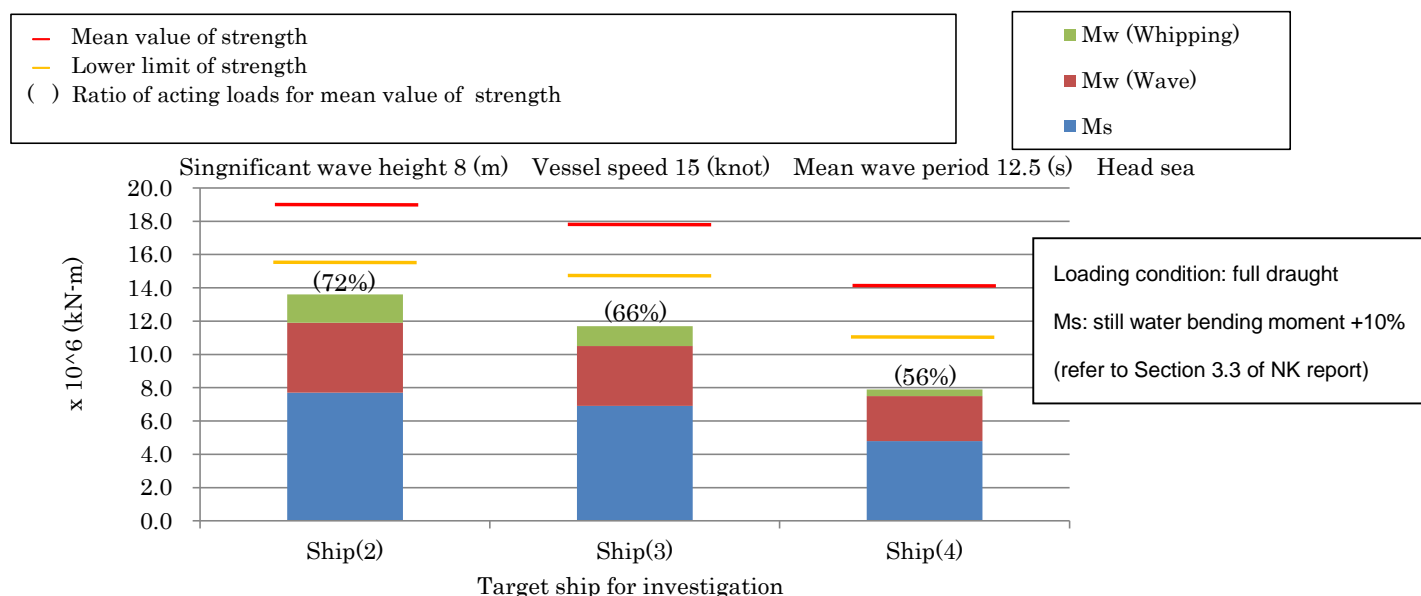
The results of the comparison between ship structural strength and acting loads are shown in Figure 3.3.1, which should be contrasted to Figure 2.2.1. It can be found that the large container ships except for The Ship (accident ship) had enough margins for ship structural strength compared to The Ship (refer to Figure 2.2.1).

Figure 3.3.1 Ship structural strength and acting loads for large container ships (other than The Sister Ships)

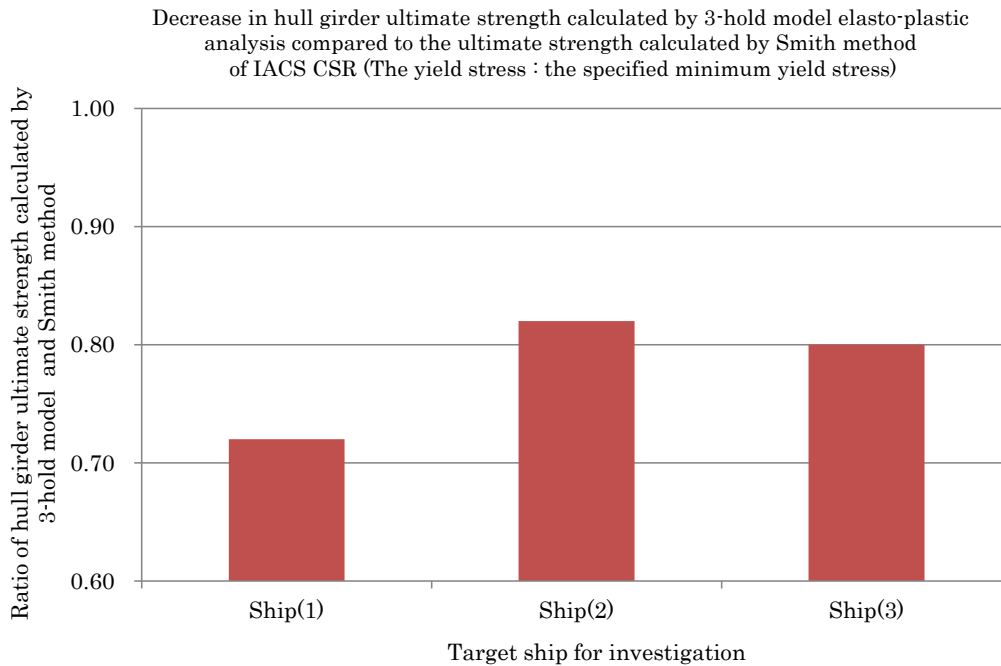
Ship structural strength (hull girder ultimate strength) should be considered, taking into account the decrease of The Ship structural strength by the effect of lateral loads, which induce bi-axial stress on the bottom shell plates. In order to prevent local buckling deformations detected in the bottom shell plates of The Sister Ships, sufficient safety margin should be considered in ship design from such a view point that the biaxial stress states induced by both the vertical bending stress and the lateral loads fall within the interaction curve of the buckling collapse strength of stiffened bottom panels (refer to Section 4.6 in NK report).

Figure 4.2.1 Decrease of structural strength by the effect of lateral loads (developed by Figure 4.4 NK report)

The effect of lateral loads on ship structural strength could be actually indicated by the method of this simulation (3 Hold FE Model). The transverse strength of double bottom construction against the lateral loads such as bottom sea pressure and container loads has close relationship to the ship structural strength (the hull girder ultimate strength). (refer to paragraph 4.2.3 in NK report)

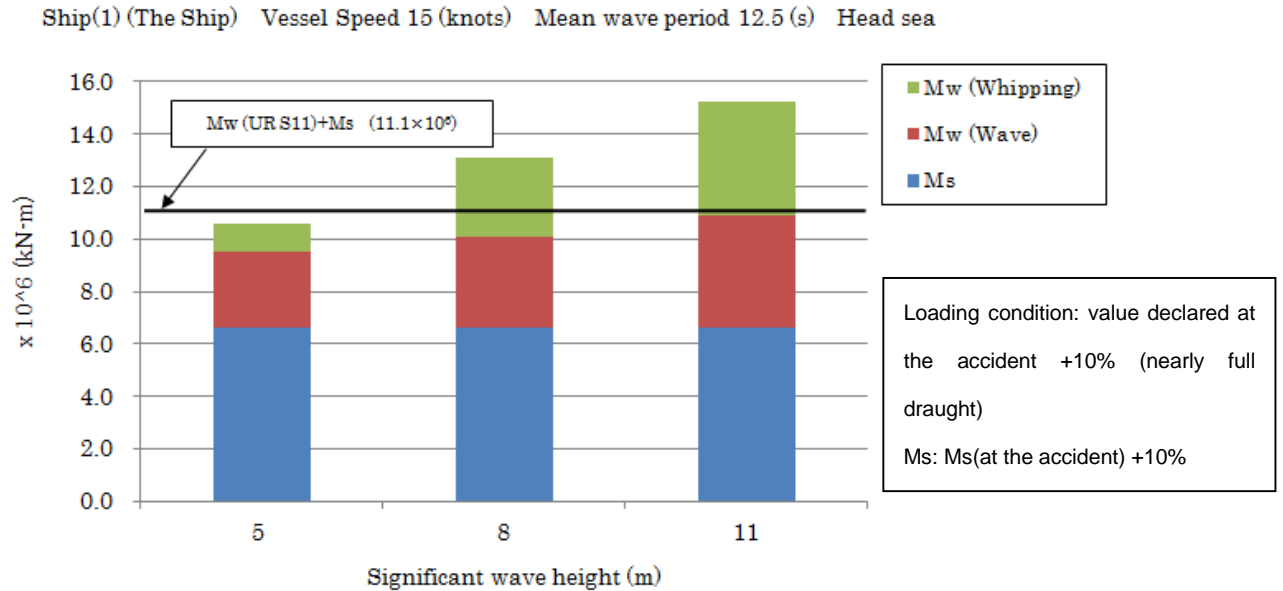
The acting loads may increase or decrease by sea condition and ship speed. On the other hand, wave-induced vertical bending moment in Longitudinal Strength Standard (S11) of IACS Unified Requirements is based on past operational results such as damage experiences, considering the effects operation such as rough sea avoidance,

but it does not explicitly take into account wave height, wave period and ship speed (refer to figure 4.3.3).

Figure 4.3.3 Relation to acting loads in IACS Unified Requirements (Mw(URS11))

Therefore, the representation of the technical backgrounds of requirements of longitudinal strength such as sea conditions, should be considered.

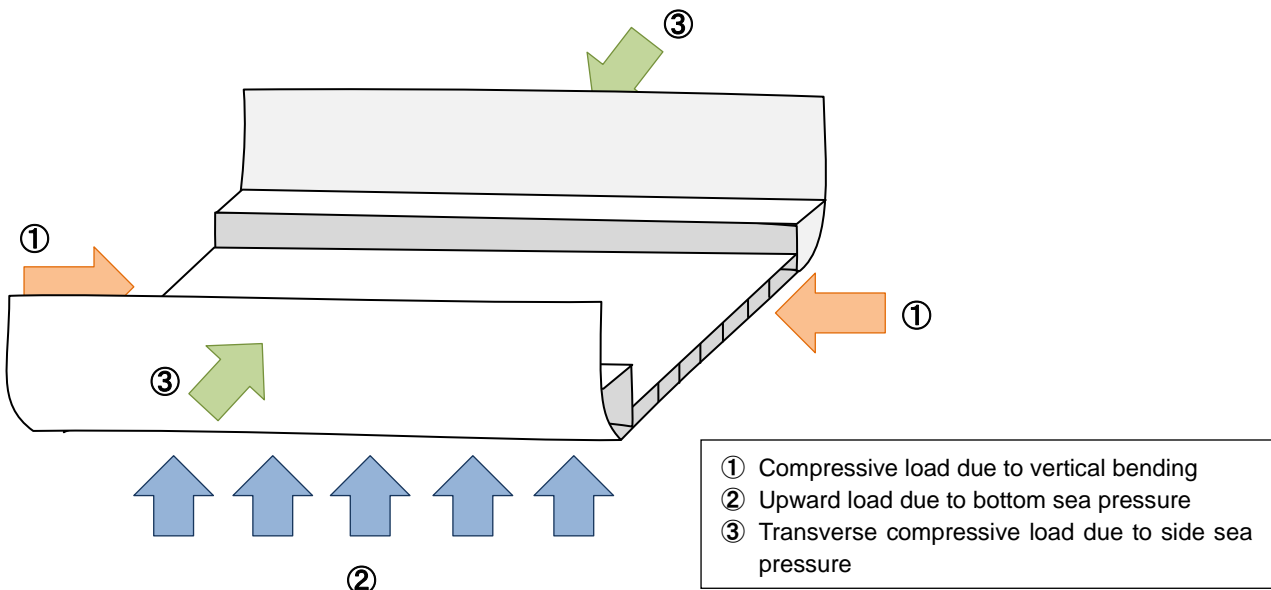
And the compressive load due to sea pressure acting on side shell is generated in the transverse direction. Hence, it can be said that the following 3 loads almost always act on the double bottom construction as shown in Fig. A2-1;

- ① Compressive load due to vertical bending
- ② Upward load due to bottom sea pressure
- ③ Transverse compressive load due to side sea pressure

Figure A2-1 Load acting on Double Bottom Construction of Container Ships

The compressive load due to vertical bending shown in ① causes longitudinal compressive stress to the bottom shell plates. And the transverse compressive load due to ③ causes transverse compressive stress to the bottom shell plates.

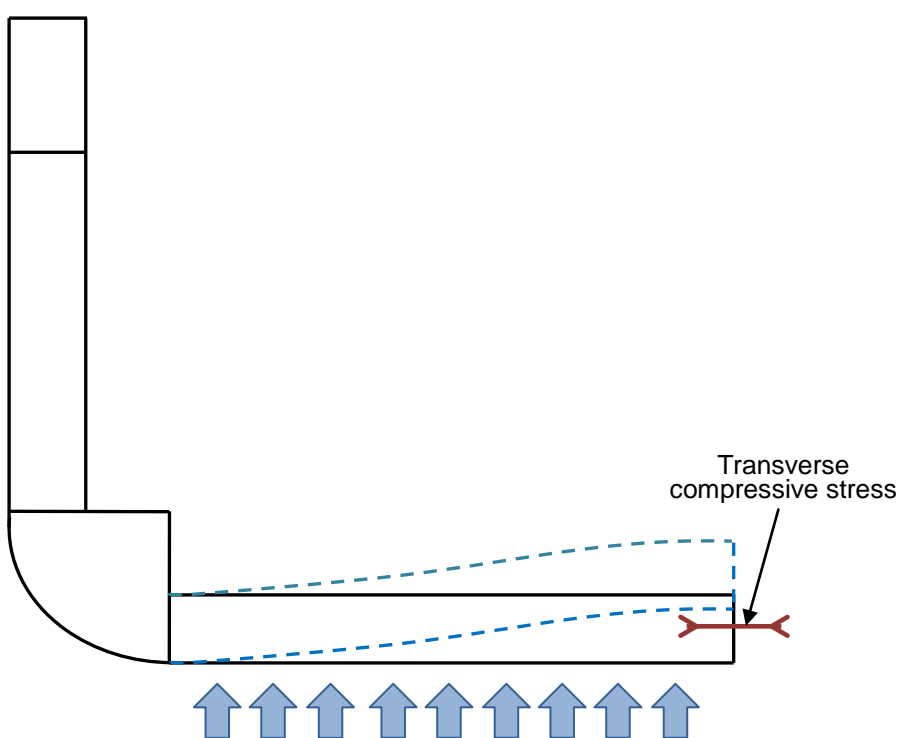
On the other hand, the upward load due to bottom sea pressure shown in ② makes convex deformation as shown in Fig. A2-2 on the double bottom construction consisting of bottom shell plates with bottom longitudinal, inner bottom shell plates with inner bottom longitudinal, girder and floor. As the result, transverse compressive stress on the bottom shell plates is generated near the center line. The deformation of the double bottom construction is maximized near the partial bulkhead within the longitudinal direction and therefore longitudinal compressive stress is generated in the bottom shell plates around the partial bulkhead.

Fig. A2-2 Stress generated in the Bottom Shell Plate due to Bottom Sea Pressure

Consequently, in the bottom shell plates at the center of the hold, i.e., near the center line and near the partial bulkhead, compressive stress due to ① (compressive load due to vertical bending) and due to ② (upward load from bottom sea pressure) are superimposed in the longitudinal direction, and compressive stress due to ② (upward load due to bottom sea pressure) and due to ③ (compressive load due to side sea pressure) are superimposed in the transverse direction.
