**PROJECT TO PROVIDE PLANNING GUIDANCE FOR
THE WATER SUPPLY PROJECT (PHASE-1)**

**PROJECT FOR WATER SUPPLY SYSTEM
RECONSTRUCTION ASSISTANCE
IN THE KINGDOM OF TONGA**

FINAL REPORT

MARCH 2023

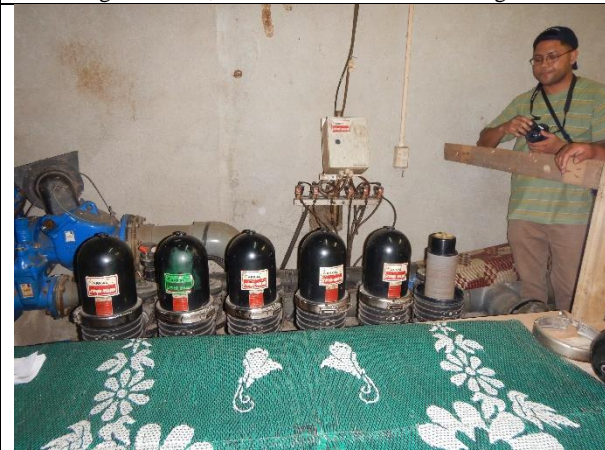
Photo-3: Failed membrane filtration system, Eua Island.

Membrane filtration systems were installed in 2008 with New Zealand assistance to treat high turbidity during the rainy season, but have failed and malfunctioned due to significant membrane blockages.

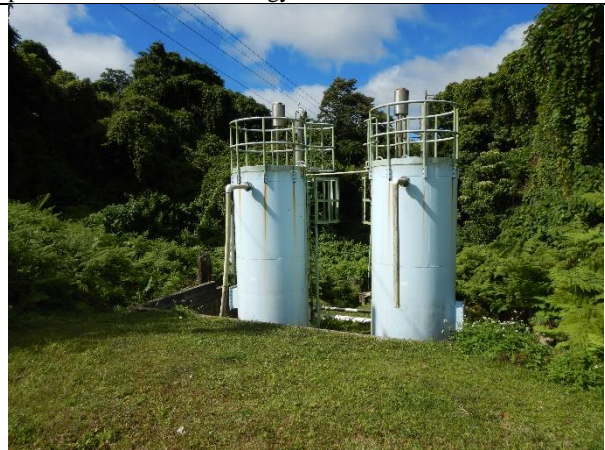
Photo-4: Broken filtration units, Eua Island.

The membrane filtration system failed and a filtration unit was installed in 2013, but is not currently operational. The installation height is lower than clear water reservoir and water cannot be stored in it.

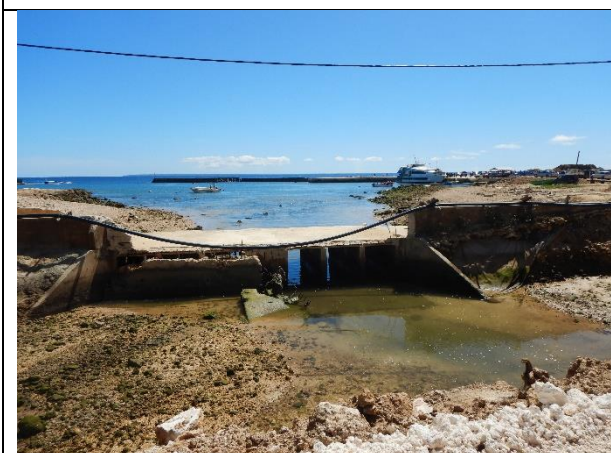
Photo-9: Water distribution pipes damaged by the tsunami, Eua Island.

Water distribution pipes damaged by the tsunami that followed the submarine volcanic eruption. It already has been restored.

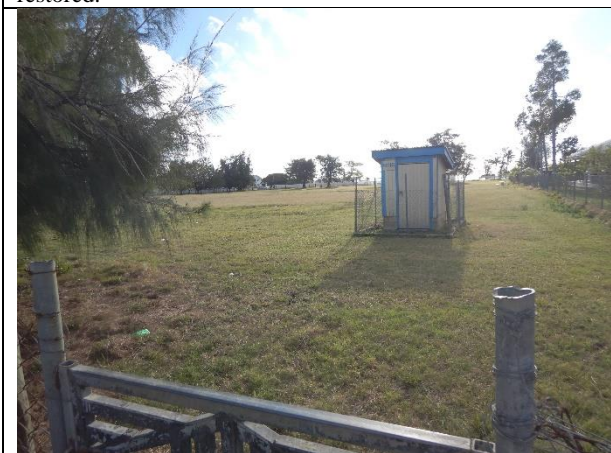
Photo-11: Pumping facility of infiltration gallery (1), Lifuka Island.

Diesel-driven pump (No. 116) located at the corner of a U-shaped infiltration gallery with an extension of approximately 100 m and a depth of 30 m in the Pangai area. The electrical conductivity was as high as 5,200 $\mu\text{S}/\text{cm}$ (August 2022), significantly exceeding the WHO's threshold limit.

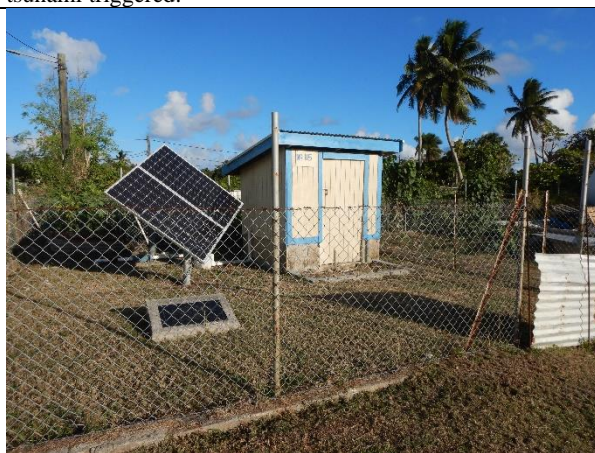
Photo-12: Pumping facility of infiltration gallery (2), Lifuka Island.

Pumping pump (No. 115) driven by solar power located at the corner of a infiltration gallery in the Hihifo area. Electrical conductivity was 1,380 $\mu\text{S}/\text{cm}$ (August 2022), which is below the WHO's threshold limit.

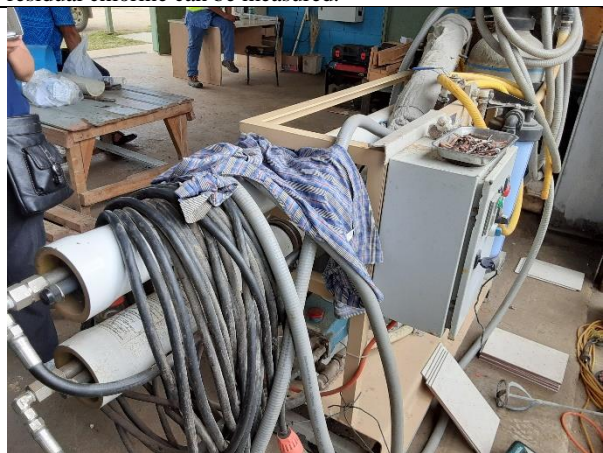
Photo-35: Broken seawater desalination unit, Tongatapu Island.

RO equipment provided by Australia in 2009, capable of producing 18 m³ /day of water. The equipment is currently out of service due to a breakdown, but before the breakdown it was transported to a remote island during the cyclone..

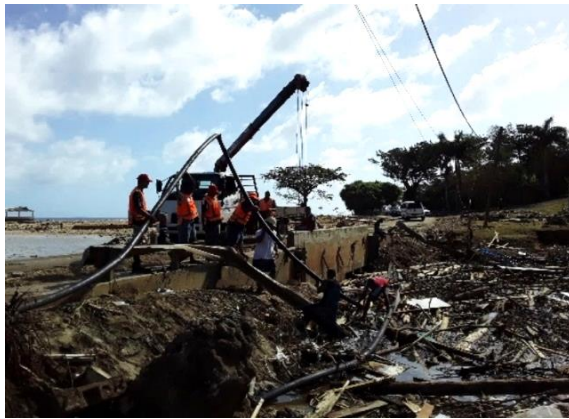
Distribution pipes damaged by the tsunami ('Eua)

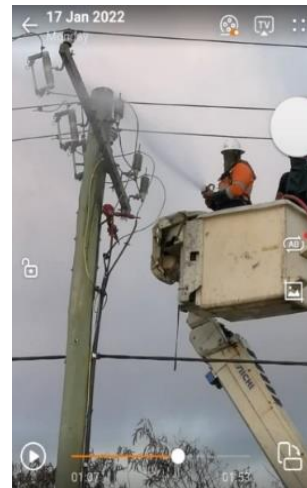
Removal of ash fall on power lines (Tongatapu)

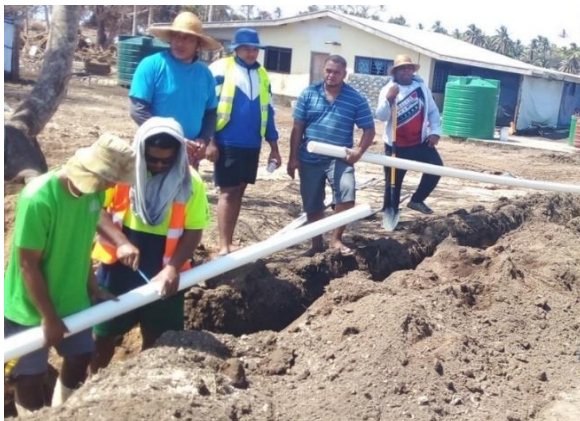
Repairing of distribution main damaged by the tsunami (Tongatapu)

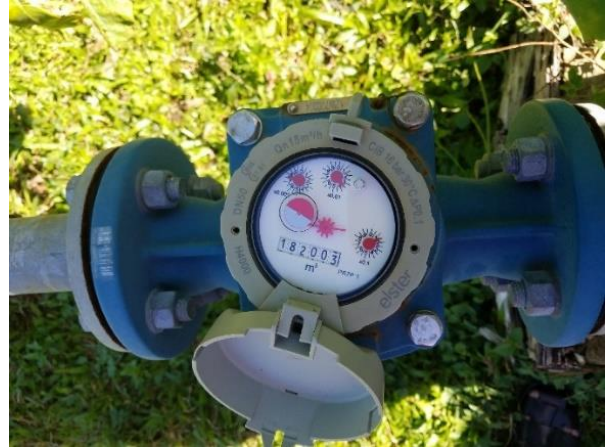
Photo 2.5 Broken Flow Meter

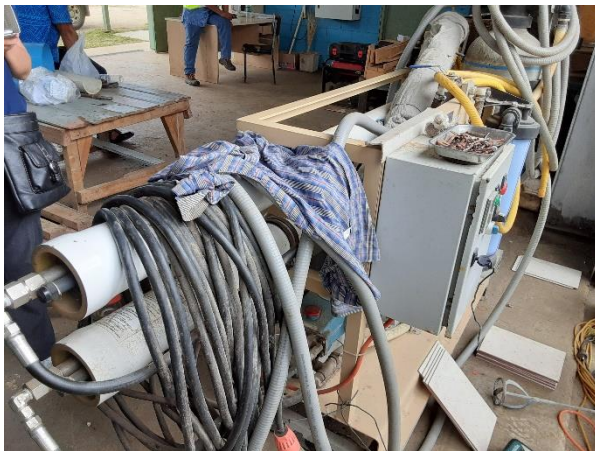
Photo 2.6 Broken Desalination Equipment

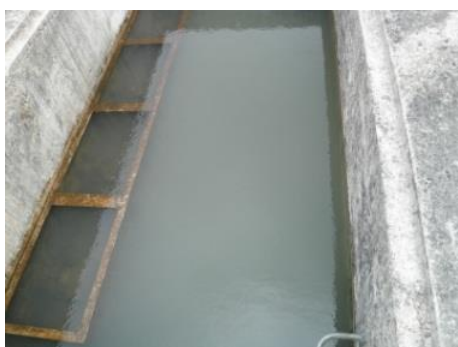
High turbid raw water after rainfall (sedimentation tank receiving chamber)
