## 自動運転実証実験中に発生した交通事故の概要

| 実施主体 | 日立市・茨城交通株式会社、産業技術総合研究所 |
| 事故発生日 | 令和2年12月14日 |
| 概要 | 中型自動運転バスによる実証実験(日立市・茨城交通)におけるガードレールとの接触事案について |

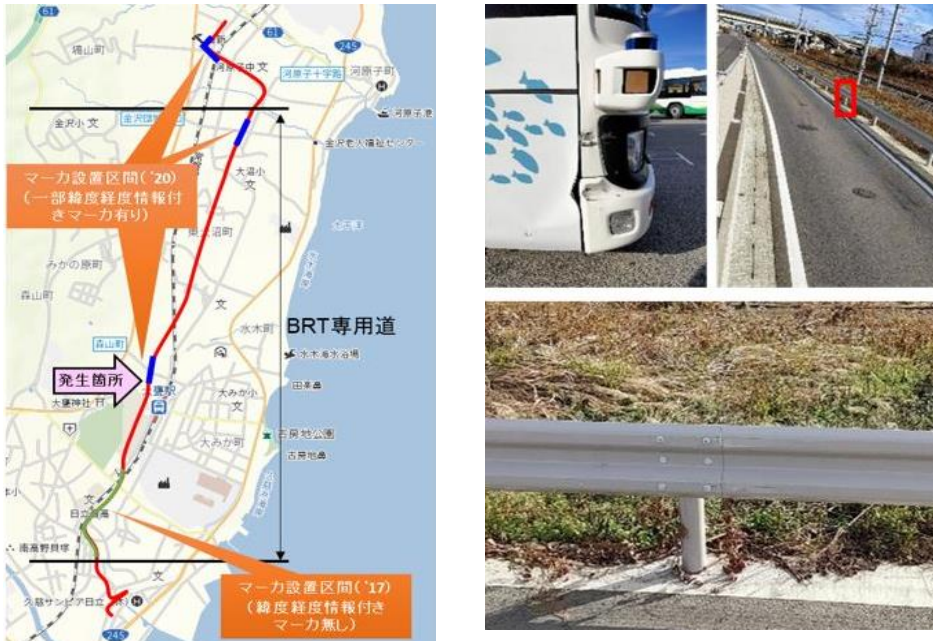
| 発生内容 | <p>2020年12月14日午前9時50分に大薮駅西口を出発。常陸多賀駅方面に50メートルほど走行したところで、バスの右前方部分が右側ガードレールに接触した。一般乗客は乗車しておらず、運転手含めた乗員3名にもけがなし。</p> <p>今回の走路ではその特性により二つの位置推定手法(※)を使い分けているが、事案発生地点はそれらの位置推定手法が切り替わる地点であった。</p> <p>※GNSS方式とGNSSの受信がしにくい地点では磁気マーカー方式により位置を推定。</p> <p>約30km/hの速度で自動走行中に、当該地点は直進区間であったが、ハンドルが右に急旋回し、運転手が速やかにブレーキ及びハンドル操作による介入をしたものの、間に合わずガードレールへの接触に至った。</p> |
| 要因 | <p>車両開発事業者が走行前に自動運転システムを設定したが、位置推定を行うための情報(車両の位置や方向に関わる情報)を取得する二つの機器(※)の再起動が必要であるところ、一つの機器の再起動を行っていなかった。そのため、再起動を行っていなかった機器で車両の位置や方向に関する情報を取得できず、情報が更新されていなかった。</p> <p>※GNSSの受信機と磁気マーカーの受信機。今回、磁気マーカーの受信機の再起動を行っていなかった。</p> <p>その結果、事案発生地点で位置推定手法の切り替えが生じた際に、更新される前の車両の位置や方向に関する情報が使用され、それに基づき車両制御が行われ、ハンドルが誤って急旋回したことが事案発生の原因。ハンドルが急旋回した際、運転士が接触回避しようと咄嗟にハンドルを逆方向に切ったが間に合わない状況であった。なお、この原因については、現場での検証を行い、再現を確認した。</p> |

| 対策 | <p>今回直接的な原因となった車両の位置や方向に関する二つの機器については、一つの機器の再起動時に、もう一つの機器の再起動の確認を要求する表示を出すようにシステムを改善する。</p> <p>走行速度が速い場合や走路が直進である場合には、自動運転システムによるハンドル操舵量が大きなものにならないよう、走行速度や走路に応じた操舵量の指示や制御の制限を行う。</p> <p>また、実証実験を行う上では本対策も含め必要な安全対策を実施するとともに、事業化に向けては、自動運転システム全体について事業を行っていく中で生じる様々なリスクを洗い出し、必要な対策を行っていく。</p> |
