航空事故調査委員会が行った建議

日本航空株式会社所属ダグラス式MD-11型JA8580の
航空事故に係る建議について (建議第10号)

アメリカ合衆国国家運輸安全委員会 (NTSB) の安全勧告

F C O M臨時改訂 2-767/2-784/2-826

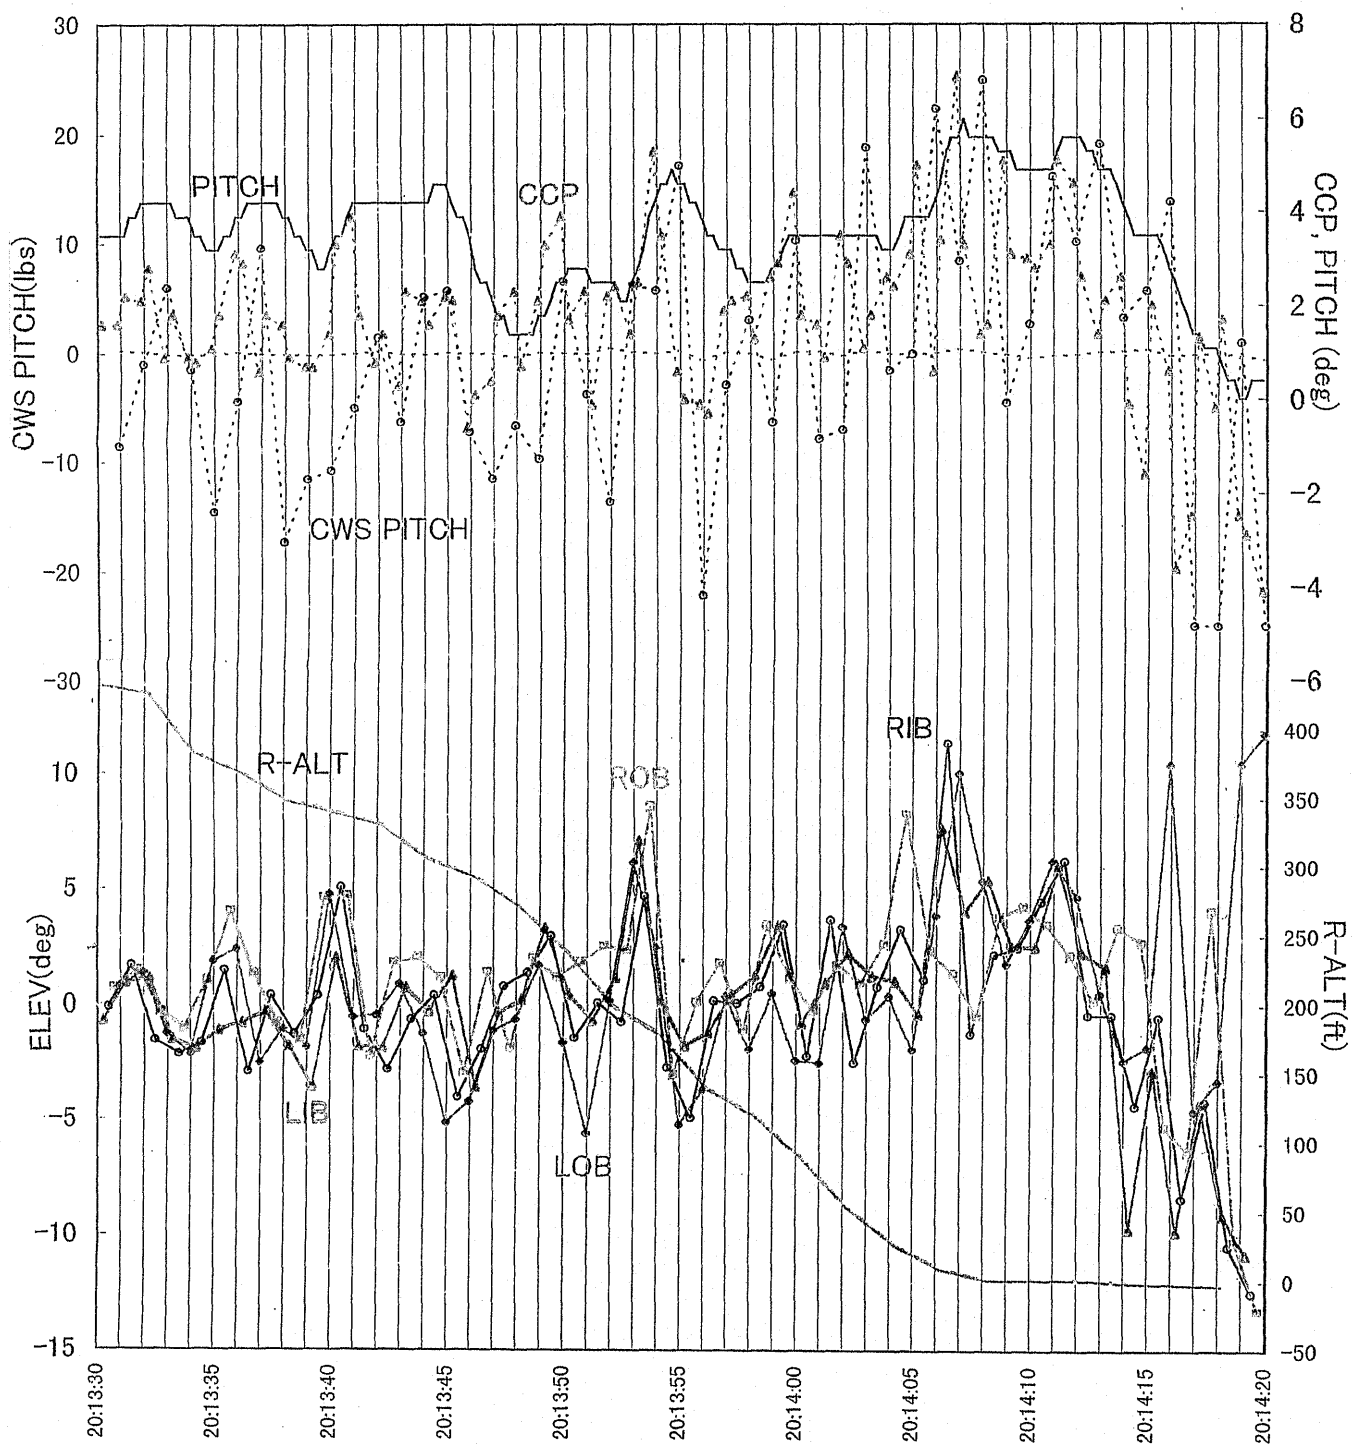
図A14 名古屋空港へのアプローチ中のCWS-PITCHとCCPの
記録時間関係

そこで、別添1のグラフが示すCWS-PITCHとCCPの時間関係が事故当時の特別な状況下で生じたものなのか、それとも、ADASの記録方式により通常生じるものなのかを調べるために、当該機の名古屋空港へのアプローチから着陸までのパラメータ（PITCH、CWS-PITCH、CCP、ELEVATORS）を別添1のグラフと同じ方法でプロットしたグラフを図A14に示す。

このグラフから分かるように、CWS-PITCHとCCPの動きの時間関係は、別添1のグラフに示すものと同一であり、このことから、CWS-PITCHとCCPの時間のずれは、データ・バスを含めた記録上の特性であることが言える。したがって、機構的な観点から、CWS-PITCHとCCPの作動は、同時に発生したものであると推定される。
