Chapter 3 Aircraft accident and serious incident investigations

3 Statistics of investigations of aircraft accidents and serious incidents

Aircraft accident investigation reports published in 2017

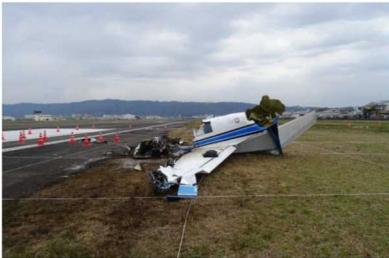
Summary	<p>The aircraft bounced while landing on Runway 27 of Yao Airport and attempted go-around, but stalled during climbing and went into spin, and then crashed into the south side shoulder of the runway. A captain and three passengers were on board and all of them were fatally injured. The aircraft was destroyed and a fire broke out.</p>

Probable Causes	<p>In this accident, the aircraft bounced while landing and attempted a go-around, and it made an abnormal nose-up continued and decelerated, and then the stall could not be avoid in a situation where it imminent; consequently, it is highly probable that it stalled and went into spin, and finally it had crashed.</p> <p>Regarding the reason why the stall could not be avoid in the imminent situation, it is somewhat likely that the captain or passenger A who maneuvered the aircraft could not suppress the excessive nose-up movement because it was exceeding the maneuverable range and others. All members of the aircraft on board were died; accordingly, the investigation was unable to determine the causes.</p> <p>Besides, the aircraft had overweight and aft CG location for the aft limit corresponding to the maximum weight. It is somewhat likely that these condition affected the controllability and the stability, and contributed to the bounce on touchdown, the abnormal nose-up posture during a go-around, the decreased stability at low speed flight and the occurrence of stall and spin.</p>

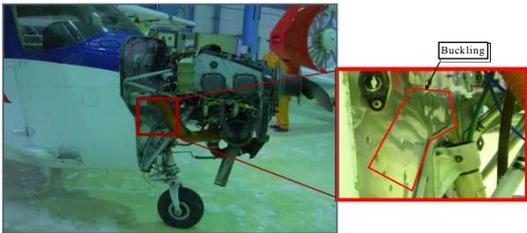
Probable Causes	<p>In this accident, when the aircraft landed, it is probable that it made a dropped landing and bounced; subsequently, it strongly grounded again from the nose landing gear, the empennage struck the runway due to its reaction and the go-around operation, and then the airframe was damaged.</p> <p>Regarding the reason why the aircraft made a dropped landing at its landing, it is probable that the Trainee continued a flare operation without executing a go-around to prevent a dropped landing, even though he felt that the altitude to commence a flare operation was slightly higher more than usual.</p> <p>Regarding the reason why the Trainee continued the flare operation without executing a go-around to prevent the drop-landing, it is somewhat likely that his maneuvering skill was not the level to operate a safe and stable landing including a flare operation. Moreover, the Company did not have a proper skill management system for flight trainees and it allowed the solo flight training even though the Trainee's skill did not fulfill the Safety Criteria for Solo Flight established by it; besides, the methods for a supervision to monitor and an instruction for a solo flight training were inadequate; accordingly, it is somewhat likely that they contributed to the occurrence of the accident.</p>

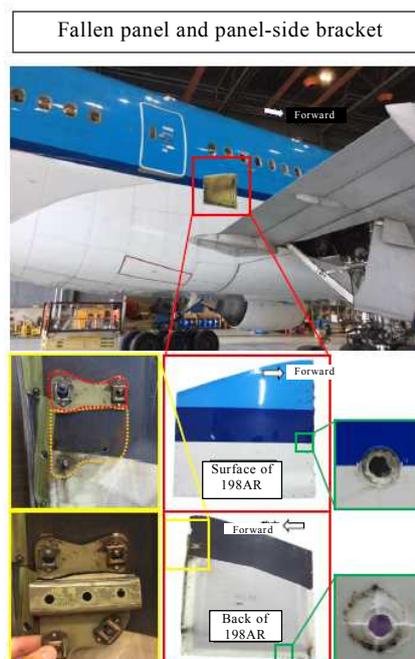
- Fractures found in the bracket (metal fitting P/N:149W5913-4) fixing the panel (198AR) to the fuselage

- After removing the bracket, bolts and screws fixing the panel to the fuselage were found fitted to the fuselage. But a wrong bolt was used.
- The panel had a hole with signs showing the passage of a bolt and a screw.

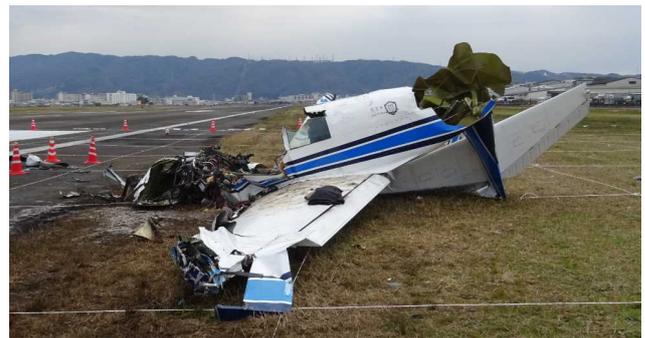
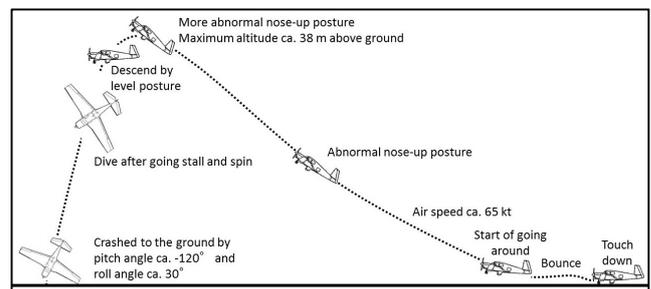
Situation of the crash (conceptual figure)

- the stability at low speed was reduced by the aft CG location.
- the aircraft approached the runway taking deep approach angle.

Probable Causes: In this accident, the aircraft bounced while landing and attempted a go-around, and it made an abnormal nose-up continued and decelerated, and then the stall could not be avoided in a situation where it was imminent; consequently, it is highly probable that it stalled and went into spin, and finally it had crashed.

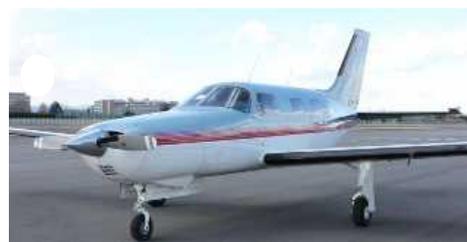
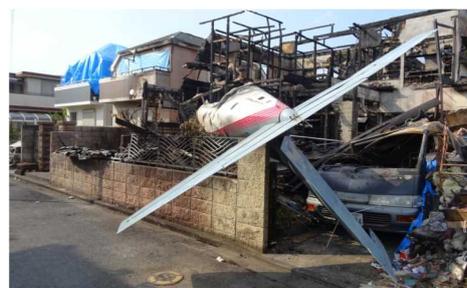
Probable Causes: It is highly probable that this accident occurred as the speed of the Aircraft decreased during takeoff and climb, which led the Aircraft to stall and crashed into a residential area near Chofu Airport.

It is highly probable that decreased speed was caused by the weight of the Aircraft exceeding the maximum takeoff weight, takeoff at low speed, and continued excessive nose-up attitude.

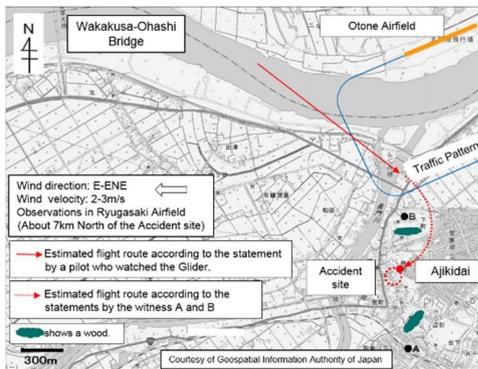
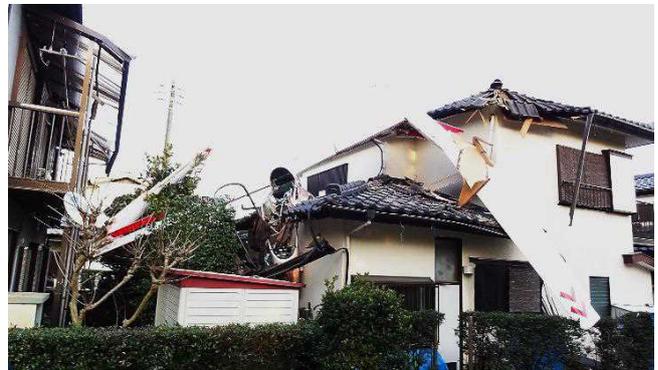
The glider had entered a spin since it was flying while rotating with the posture that the nose was so low.

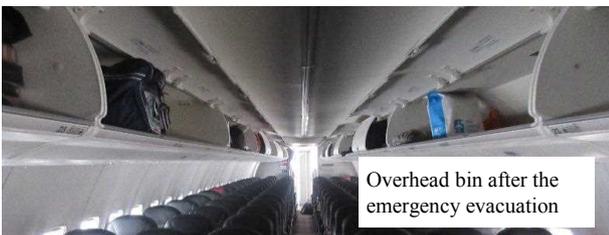
Overhead bin after the emergency evacuation

Many of passengers attempted to go down the slide with baggage not following instructions from the cabin attendants. The cabin attendants removed their baggage near the emergency exit and some of the baggage were piled up at the space in front of the cockpit door. The flight crews hesitated to move to the cabin fearing the risk of clogging the evacuation route for passengers

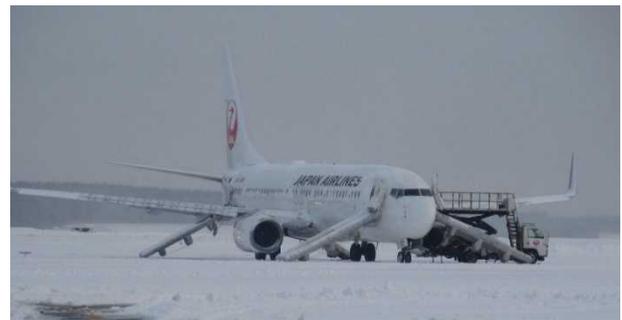
→One passenger suffered serious injury

Probable Causes: In this accident, it is probable that while holding on the taxiway to taxi following the heavy snowfall, odd smells and smoke were generated within the cabin, following these events, because the flame from rear of No.2 engine was continued, the flight crew conducted the Emergency Evacuation from the aircraft. At the time, a passenger descended the slide, fell down to the ground from the hip of the passenger and suffered serious injury.

Regarding the occurrences of odd smells and smoke in the cabin and the continuation of the flame at the rear of No.2 engine, it is probable that the Heavy Snow became intense due to the rapid weather deterioration, and because the icing was set at fan blades and low pressure compressor, the engine oil was leaked into inside of the engine and the oil vaporized into the cabin and the leaked oil was accumulated within in the tailpipe to catch the fire.
