Japan Transport Safety Board Annual Report 2019

ANNUAL REPORT 2019

Japan Transport Safety Board

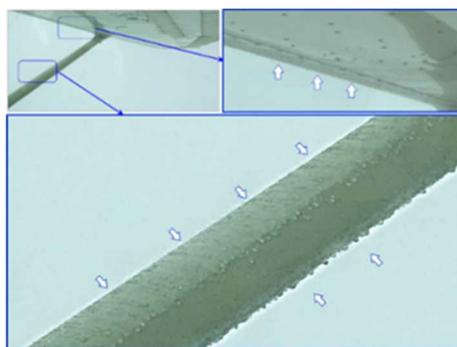
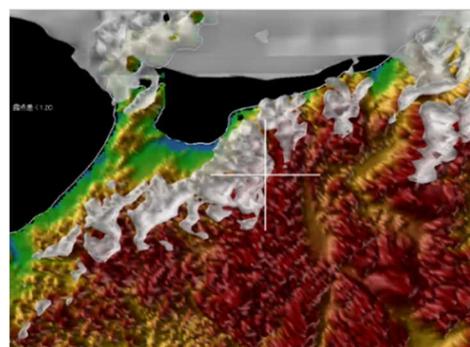
For this crash accident, photos recorded in the smartphone of a person on board the same aircraft revealed that the aircraft was flying in clouds at that time and that the pilot did not wear a harness. In addition, analysis of photo data indicated that icing had been observed on the aircraft which destabilized the flight.

Center to conduct numerical analysis, using a supercomputer, based on the numerical prediction model provided by the Meteorological Agency in order to visualize at high resolution the wind conditions and cloud amount at that time around the Tateyama mountain range. These analyses revealed that aircraft had flown in clouds, which had caused ice to form on a wing, resulting in significant degradation in flight performance.

Based on these findings, the board made recommendations to the Minister of Land, Infrastructure and Transport, requiring safety measures that prohibit light aircraft or the like incapable of in-cloud flight from flying into clouds.

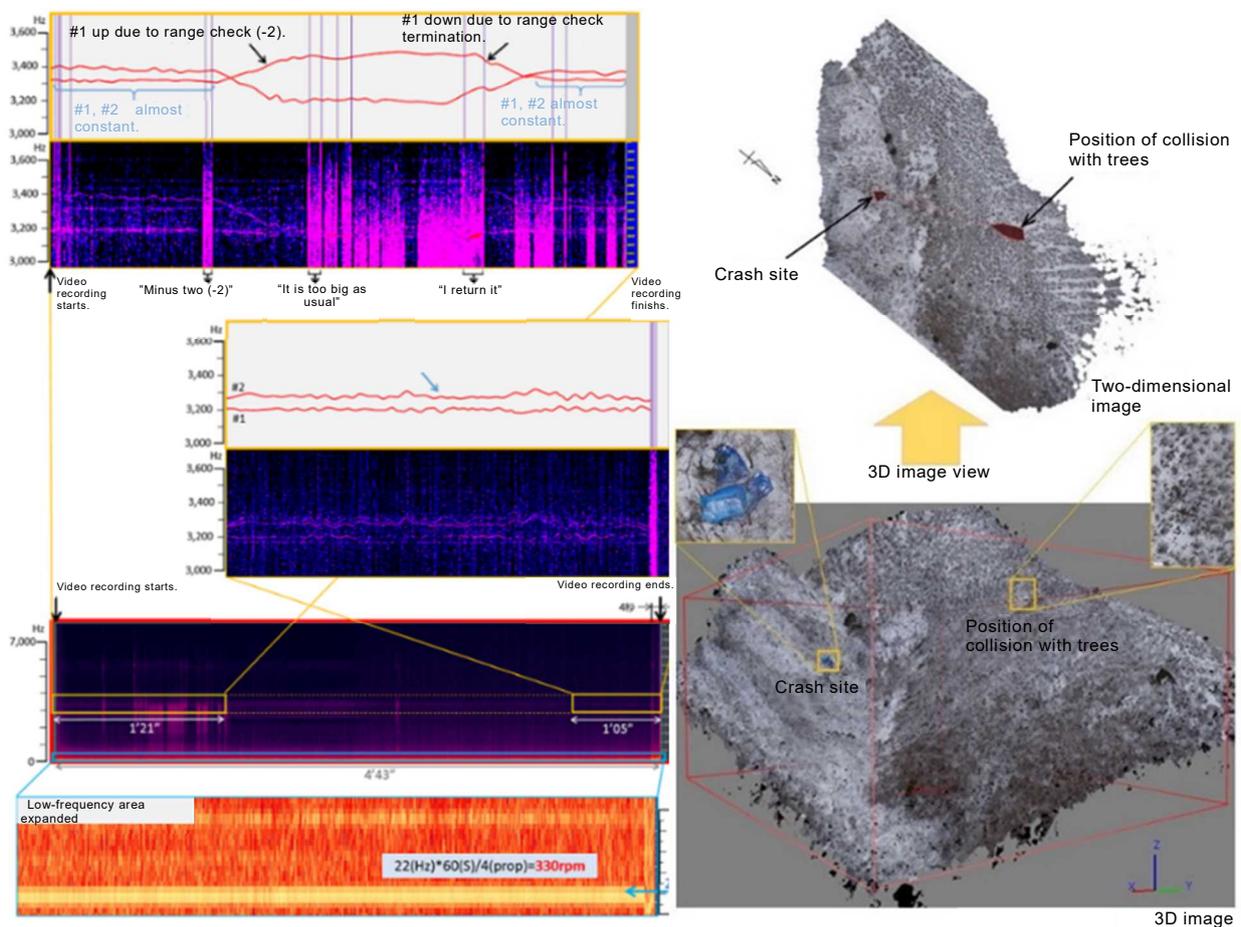
These analyses revealed that there had been nothing wrong with the aircraft until it collided with a

tree; that it was operated by one pilot; that the pilot had not stated his conditions correctly when applying for aviation medical certification; and that none of those on board had responded to the coming danger.

With these facts, the Fire and Disaster Management Agency decided to require fire-fighting disaster-relief helicopters to be crewed by two pilots and is trying to enhance the safety management system, training programs, and so on. In addition, the board required the Minister of Land, Infrastructure and Transport to instruct aircraft crews to report their health conditions correctly.

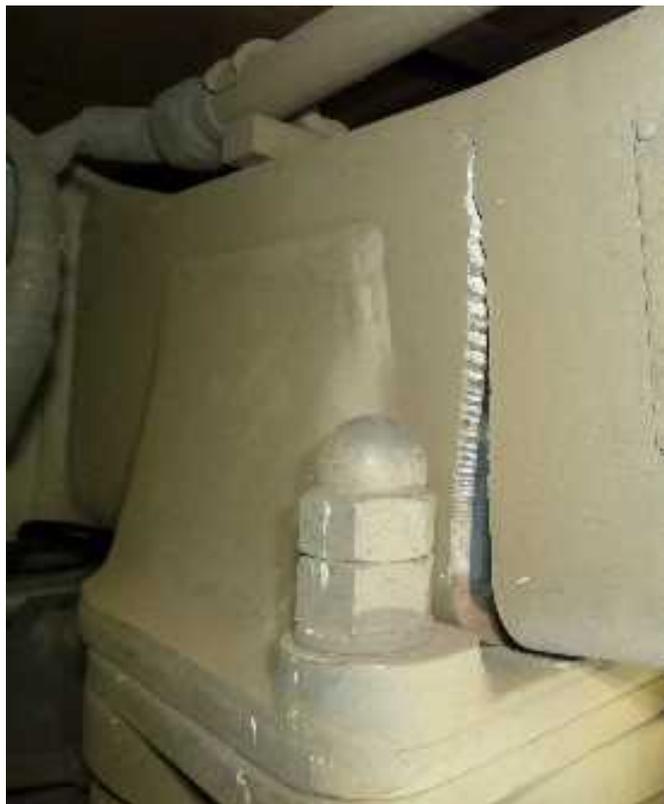
To identify what caused the crack in the flatcar in the investigation, we conducted fatigue and breaking tests using a test specimen, a simulation analysis to estimate how the crack developed, and a simulation analysis to estimate the points of the flatcar where a high level of stress is generated. In addition, from a new viewpoint, we analyzed the effect of the deformation and other factors of the flatcar frame based on the air pressure inside the air spring unit recorded in the rail car data recorder to present a technique for estimating the development of cracks.

These analyses revealed that the crack had been caused by improper treatment during the manufacturing of the flatcar frame and that the crack had developed in a period shorter than the duration of the rail car life.

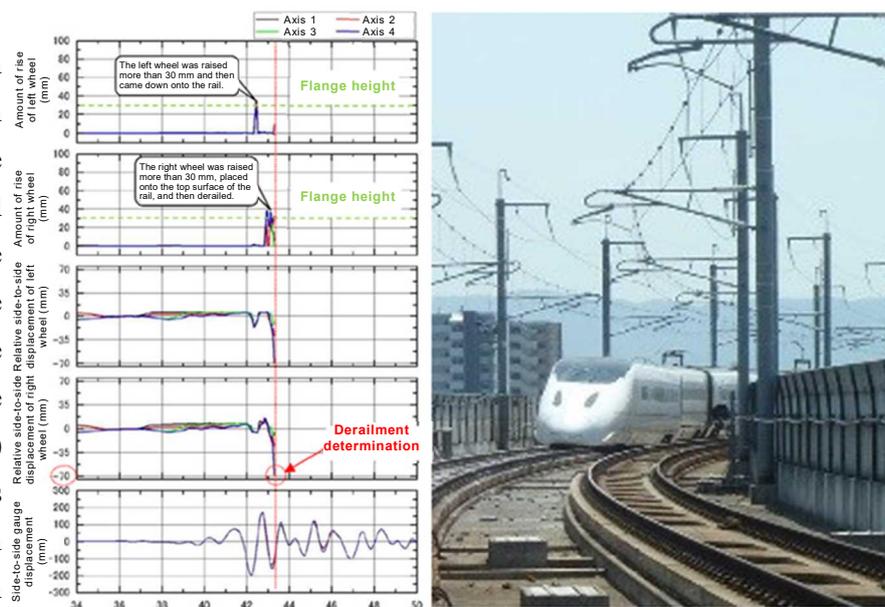
In the simulation, based on the seismic vibration observed when the earthquake occurred and the conditions of the ground, we estimated the earthquake wave immediately below the structure (elevated bridge) where the train was derailed and even estimated the vibration on the elevated bridge to analyze the behavior of the rail cars.

Based on these analysis results, the board requested in the accident investigation report further promotion of measures against derailment and deviation as preventive measures. The railway operators that run shinkansen are conducting studies to promote measures against earthquakes with preventive measures taken into account.

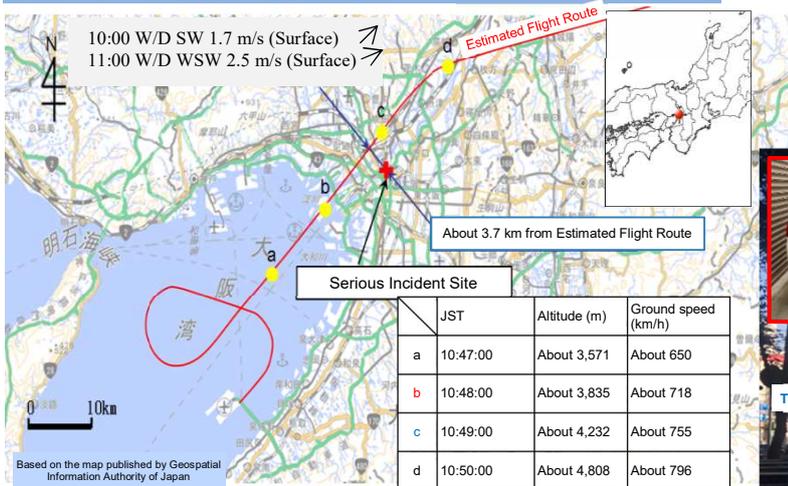
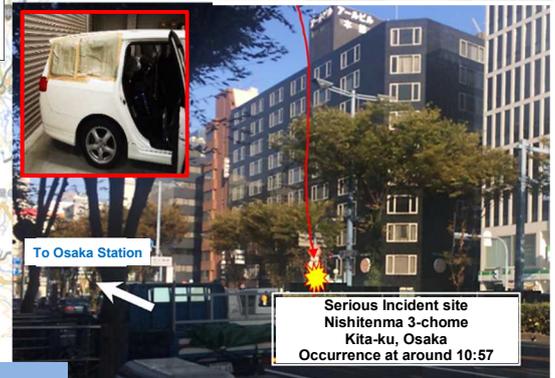
Damage condition of the bracket used and falling panel

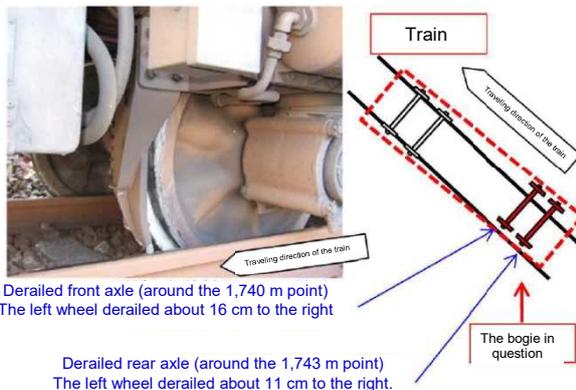
Based on the facts that oil-like substance was adhered on the right rail up to the rear axle gear case of the bogie in question and that the gear case was damaged, it is probable that the train was running while the gear case kept in contact with the right rail.

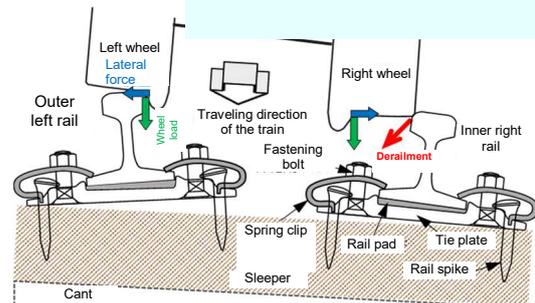
Probable Causes: It is probable that the accident occurred as the right wheel in the 1st axle of the front bogie of the 2nd vehicle fell off to the inside of the gauge and continued running being spread gauge, and then the left wheel flange in the front bogie climbed up to outer left rail and derailed to left, because the gauge was widened while the train, the electric and track inspection cars, was passing in the 160 m radius right curved track.

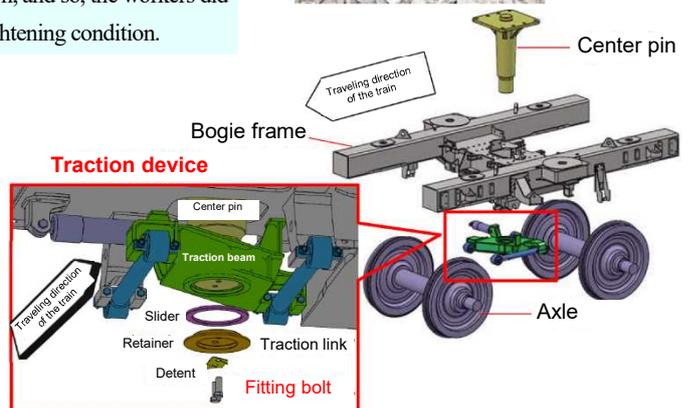
Probable Causes (excerpt): It is probable that the accident occurred as all axles, i.e., the 5th and 6th axles, in the rear bogie in the 1st vehicle, i.e., the locomotive, of the freight train derailed because the traction device had hung down due to the removal of two fitting bolts fastening the center pin and the traction device in the rear bogie during running operation, following the process described in below.

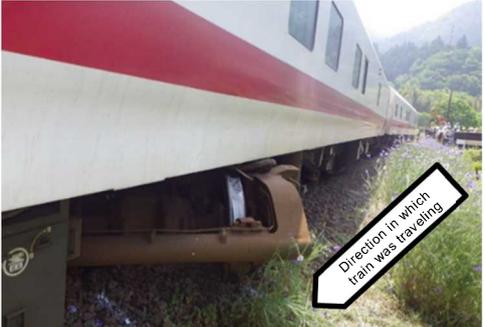
<p>1st axle of the front bogie of the 2nd vehicle Left wheel</p>

<p>Probable Causes</p>	<p>It is probable that the accident occurred as the right wheel in the 1st axle of the front bogie of the 2nd vehicle fell off to the inside of the gauge and continued running being spread gauge, and then the left wheel flange in the front bogie climbed up to outer left rail and derailed to left, because the gauge was widened while the train, the electric and track inspection cars, was passing in the 160 m radius right curved track.</p> <p>It is probable that the gauge widening was caused by the rail tilting etc., due to lateral forces accompanied with train running in the curved track where the continuous defective sleepers and rail fastening devices were existed.</p> <p>It is somewhat likely that the existence of significantly large gauge widening to cause derailment was related with that the proper track maintenance had not been implemented because the danger against gauge widening by the continuous defective sleepers and rail fastening devices had not been recognized in the periodic inspection etc., and the proper operation control and the track maintenance had not been implemented even though the remarkably large irregularity of gauge had been detected in the measurement by the track inspection cars just before the accident.</p>
