Chapter 2 Summary of recommendations and opinions issued in 2020

1 Recommendations

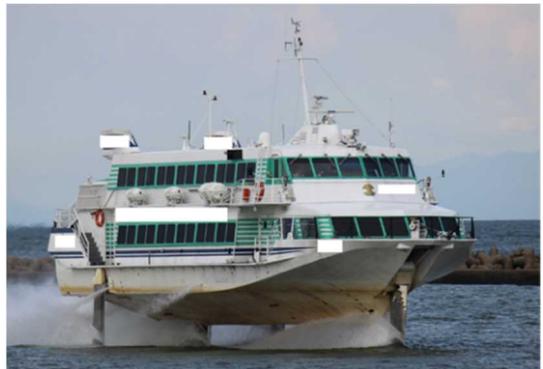
This accident caused a breach in GINGA's starboard quarter.

It is probable that, after GINGA passed through the deceleration zone located off the eastern coast of Himesaki, it accelerated and headed westward in a foilborne state, when the captain noticed floating objects in the direction of the port bow (front left side) of the ship and attempted to avoid a collision but was not successful. As a result, some objects probably hit the rear hydrofoil wing, resulting in many lumbar fractures among passengers.

Regarding the probable cause of many passengers' lumbar fractures: After the rear hydrofoil was hit, the fuse pins sheered off, causing the rear hydrofoil to swivel backward with the points still attached to the ship body acting as pivot points. This lowered the stern and at the same time, the rear hydrofoil pulled the ship body into the sea due to the resulting resistance. As a result, it is probable that the bottom of the stern struck the sea surface, generating significant upward and backward acceleration resulting in a strong impact on the passengers.

(1) The following measures must be taken to mitigate damage to passengers including lumbar fractures to the extent possible in case of collision with a marine animals, driftwood or other objects during the foilborne navigation of a jetfoil.

i) Shipowners should take into account the situation of passenger injuries including lumbar fractures resulting from this accident and take countermeasures such as ensuring that passenger

seats and seat cushions can adequately absorb a strong impact.

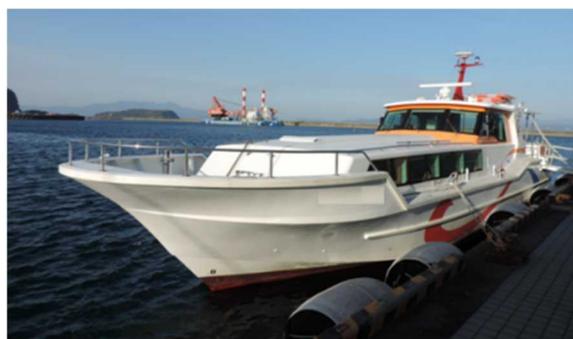
On December 2, with the captain, ordinary seamen and 55 passengers on board, passenger ship Nankyu No. 10 departed Nejime Port, Minamiosumi-cho, Kagoshima Prefecture and was taking a north-northwest course. At around 16:24, the ship encountered severe upward and downward pressures from incoming tidal waves. As the bow lifted, seated passengers were lifted upward and then slammed down onto their seats, resulting in 14 passenger injuries.

Port in spite of weather and hydrographic conditions having reached the standards for departure and navigation cancellation conditions (specified by the safety management manual of Nankyu-Dock Co., Ltd.) and continued navigating outside the port at about 12 knots while taking a north-northwest course, which was further north from the standard navigation route. The bow of the ship was probably hit and lifted by oncoming tidal waves, which lifted the seated passengers upward and then slammed their buttocks down onto their seats, resulting in injuries.

1. Transportation business operators shall provide the following instructions to captains and relevant crew members:
 - i) When a ship oscillates due to wave impact, the operator shall decelerate to a speed that is adequate to prevent the passenger injuries.

- ii) When significant up-and-down motions of a ship are anticipated with a strong wind and high-seas warning issued, the captain and relevant crew members shall guide passengers to take the suitable seats (e.g. rear seats in cases in which a ship’s center of gravity is located in its rear section) beforehand so that risks of being ejected from the seats and suffering violent impacts are minimal.

2. Transportation business operators shall recheck the possibility of topographical, tidal, tidal waves or heavy swell effects for standard routes, departure and arrival ports and share such information with captains and relevant crew members.

3. Transportation business operators shall regularly instruct captains and crew members to ensure compliance with the standards judgement as to whether departure and standard navigation are possible as specified by safety management manual.
