Chapter 4 Railway accident and serious incident investigations

The investigation reports on railway accidents and serious incidents published in 2020 are summarized as follows.

Railway accident investigation reports published in 2020

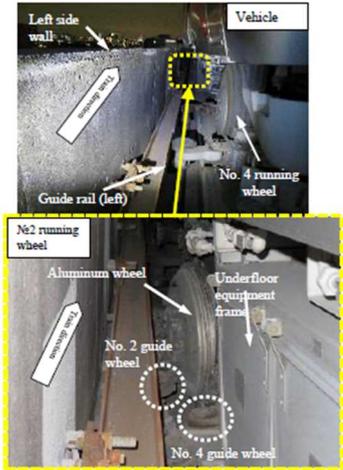
1	Date of Publication	Date & Accident type	Railway operator	Line section (location)
	October 29, 2020	January 16, 2019 Train derailment	Saitama New Urban Transit Co., Ltd.	Between Kamonomiya Station and Tetsudohakubutsukan Station on the Ina Line, Saitama Prefecture
	Summary	<p>The train departed Kamonomiya Station on time. The driver of the train was traveling at a speed of about 30 km/h between Kamonomiya Station and Tetsudohakubutsukan Station when he heard a strange "bong" sound from the rear of the train and then applied the brakes. After stopping, the situation was confirmed through the inside of each vehicle, and when the sixth car was seen from the gangway behind the fifth car, the front part of the vehicle body of the sixth car was tilted to the left and shifted by about 50 cm.</p> <p>The attendant who arrived after receiving a call from the control center confirmed that the left front of the sixth car had made contact with the side wall of the viaduct, and the left tire of the first axle had been damaged and had deviated from the running track. The coaxial right tire was also damaged.</p> <p>About 100 passengers and one driver were on board the train, but no one was injured. Unlike railways with steel wheels, this accident occurred on a railway that used rubber tires as wheels.</p>

Probable Causes		<p>It is highly probable that the accident have occurred when the air pressure suddenly dropped due to damage to the left tire on the front axle of the vehicle, and the vehicle traveled with the damaged tire, which damaged the Nakago(safety wheel), causing the guide wheels to move off the guide rail downwards and the running wheels to deviate from the track, resulting in derailment.</p> <p>As for the damage to the tire, it is highly probable that the wires of the steel belt broke due to the train running with the inner surface of the tire and the Nakago(safety wheel) in contact due to extreme underinflation of the tire.</p> <p>With regard to the extreme underinflation of the tire, it is probable that the wires of the belt broke because the tire was run with the steel belt exposed due to wear of the tread, and some of the wires reached the inner surface of the tire, causing air leakage.</p> <p>As for the fact that the tires ran with the steel belt exposed due to wear in the tread area, it is probable that the depth of the main grooves was not measured during the temporary inspection, and the tires were not checked for wear during the train inspection, so they continued to be operated without sufficiently checking the situation where the main grooves in the tread area had disappeared due to wear.</p>

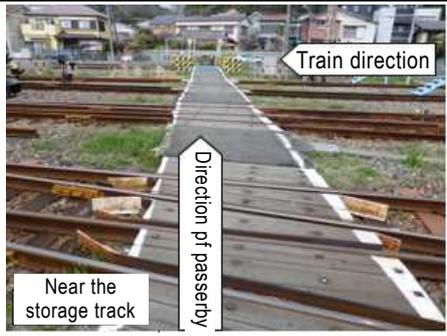
Probable Causes		<p>It is highly probable that the concerned accident was caused by that the pedestrian collided with the concerned train because the pedestrian passing Yamanone level crossing, the class 4 level crossing without automatic barrier machine nor road warning machine, entered the up track in the concerned level crossing in the situation that the train was approaching in the up track.</p> <p>It could not be determined the precise situation why the concerned pedestrian entered the up track in the situation that the train was approaching in the up track , because the pedestrian was dead, although it is likely that the pedestrian did not notice the approaching train , and that it was related with the difficult y to cross through the concerned level crossing only by the safety check when entered the level crossing as the structure of the concerned level crossing was in the status as the main track s could not be viewed by the parking vehicles depending on the</p>

circumstances, in addition there were many tracks to be crossed and the length of the level crossing road was long as 35.5 m.		
	Report	https://www.mlit.go.jp/jtsb/eng-rail_report/English/RA2020-2-1e.pdf (Synopsis) https://www.mlit.go.jp/jtsb/railway/p-pdf/RA2020-2-1-p.pdf (Explanatory materials (Japanese only))		
	Reference	Case Studies (page 99)		
3	Date of Publication	Date & Accident type	Railway operator	Line section (location)
	February 27, 2020	April 14, 2019 Train derailment	Konan Tetsudo Co., Ltd.	Between Chuo Hirosaki station and Hirokoshita station, Owani Line, Aomori Prefecture
	Summary	<p>While the train was passing through the 160 m radius left curved track between Chuo Hirosaki station and Hirokoshita station at the velocity of about 30 km/h, the driver of the train noticed a shock and applied the emergency brake to stop the train.</p> <p>After the train stopped, the driver checked the situation and found that the 1st axle in the front bogie of the forefront vehicle had been derailed.</p> <p>There were 10 passengers and the driver onboard the train, but no one was injured.</p>

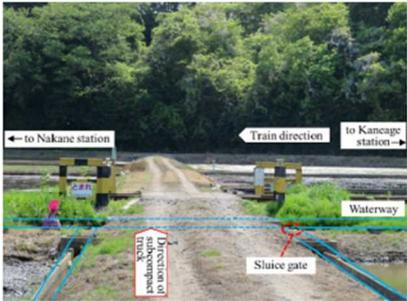
Summary	<p>While the train was running between Kaneage station and Nakane station at the velocity of about 60 km/h, the driver of the train noticed a subcompact truck entering Mitanda No. 1 level crossing, the class 4 level crossing, then applied the emergency brake and sounded the whistle immediately, but the train collided with the subcompact truck.</p> <p>The driver of the subcompact truck was dead and the fellow passenger of the subcompact truck was injured in the accident.</p>

Probable Causes	<p>It is highly probable that the subcompact truck collided with the train in the concerned accident because the subcompact truck entered Mitanda No. 1 level crossing, the class 4 level crossing without automatic barrier machine nor road warning device, in the situation that the train was approaching.</p> <p>It could not be determined the reason why the subcompact truck entered the level crossing in the situation that the train was approaching, because the driver of the subcompact truck was dead, although it is likely that the driver of the subcompact truck did not notice the approaching train.</p>

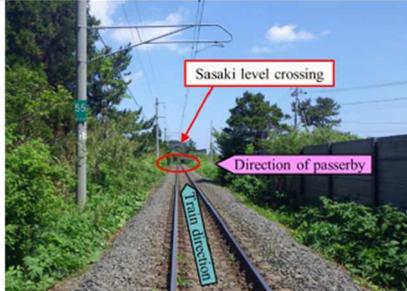
Probable Causes	<p>It is probable that the concerned accident was caused by that the passerby collided with the concerned train because the passerby entered Sasaki level crossing, the class 3 level crossing equipped with the road warning device in the situation that the road warning device had been operating responded to the approaching train.</p> <p>It could not be determined the reason why the passerby entered the level crossing in the situation that the road warning device had been operating responded to the approaching train because the concerned passerby was dead, although it is likely that the passerby did not notice the approaching train.</p>

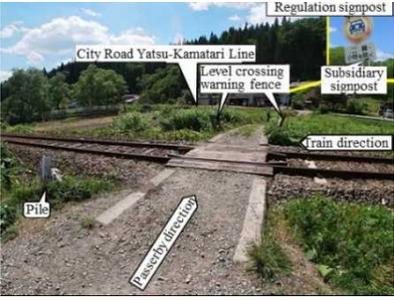
2020	Level crossing accident	Tetsudo Railway Co., Ltd.	class 4 level crossing without automatic barrier machine nor road warning device, between Ugo Nagatoro station and Yatsu station, Akita Nairiku Line, Akita Prefecture
	Summary	<p>While the train was running between Ugo Nagatoro station and Yatsu station at the velocity of about 80 km/h, the driver of the train noticed the agricultural apparatus, i.e., a rice planting machine, halting in Kamatari level crossing, at about 150 m before Kamatari level crossing, then sounded a whistle and applied the emergency brake immediately, but the train collided with the passerby riding on the agricultural apparatus.</p> <p>The passerby riding on the agricultural apparatus was dead in the accident.</p>

Probable Causes	<p>It is highly probable that the concerned accident was caused by that the train hit the passerby riding on the agricultural apparatus who had been halting in Kamatari level crossing, the class 4 level crossing without automatic barrier machine nor road warning device, in the situation that the train was approaching.</p> <p>It could not be determined the reason why the passerby had been halting in the level crossing in the situation that the train was approaching, because the passerby was dead in the accident.</p>

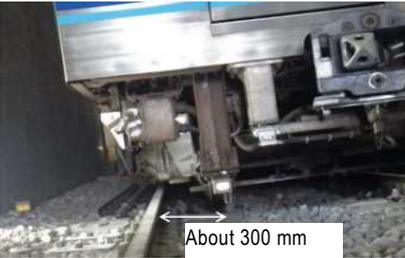
Probable Causes	<p>It is highly probable that the concerned accident was caused by that the plural right wheels of the concerned train ran onto the set-off rail and derailed to left, because the concerned train moved to the place where the works had finished as the set-off rail was covering right rail of the main track due to forget the put back procedure to put-back the set-off rail for the right rail of the main track, in the periodic inspection of the movable set-off device.</p> <p>It is highly probable that the set-off rail for right rail of the main track was forgotten to be put back, because the confirmation of the put back status of the set-off rail for right rail of the main track, which should be implemented when finished the works, was not implemented.</p> <p>In addition, it is likely that above situation was related with that the worker was convinced to confirm the put back status of the set-off rail by checking the turned off warning light, etc., because the concerned set-off device was composed as that the operation of the alarm lights, etc., could be stopped even in the status that the set-off rail had not been put back.</p> <p>Here, it is likely that the insufficient study and training to enforce the observance of the regulations, and the inadequate education etc., for the staffs who had not been charged in the periodic inspection for several years, were related to forget the confirmation procedure that should be implemented when finished the works.</p>

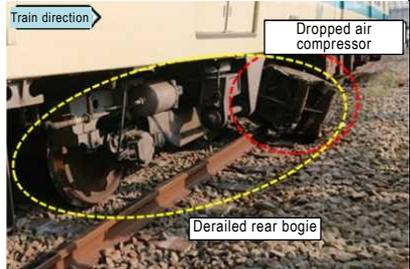
and road warning device, between Hon-Atsugi station and Aiko-Ishida station, Odawara Line, Kanagawa Prefecture
	Summary	<p>While the train was running between Hon-Atsugi station and Aiko-Ishida station at the velocity of about 100 km/h, the driver of the train noticed the standard sized automobile halting in Hon-Atsugi No.13 level crossing, the class 1 level crossing, then applied the emergency brake and sounded the whistle immediately, but the train collided with the automobile and all two axles in the rear bogie of the 1st vehicle derailed to left at Hon-Atsugi No.14 level crossing, the class 1 level crossing, located at 73 m beyond Hon-Atsugi No.13 level crossing.</p> <p>A passenger was injured in the accident.</p>

Probable Causes	<p>It is probable that the concerned train derailed at Hon-Atsugi No.14 level crossing, located at 73 m ahead of Hon-Atsugi No.13 level crossing, caused by the collision with the standard sized automobile which entered Hon-Atsugi No.13 level crossing, in the status that the road warning device was operating responded to the approaching train, and stopped in the level crossing because the crossing rod lowered before the concerned automobile went out of the level crossing, in the concerned accident.</p> <p>As for that the driver of the concerned automobile entered the concerned level crossing in the status as the road warning device of the concerned level crossing was operating, it is likely that it was the first time for the driver of the concerned automobile to pass the concerned level crossing by driving the concerned automobile, and his consciousness was not paid toward the on and off red flash lamps and the alarm sound of the road warning device in the concerned level crossing because his consciousness had been concentrated to drive the automobile carefully as the obstacle detection system of the concerned automobile uttered the warning sound when moved the concerned automobile into the concerned level crossing. In addition, as for that the concerned automobile stopped in the concerned level crossing, it is certain that the driver of the concerned automobile stopped the concerned automobile in the concerned level crossing because the driver of the concerned automobile did not know that the automobile can get out of the concerned level crossing as the crossing rod would be raised by pushing the cross rod by the automobile.</p>

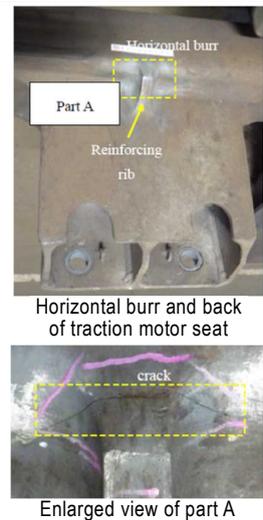
Probable Causes	<p>It is highly probable that this serious incident was caused by the cracks that occurred in the weld between the side of the bogie frame of the vehicle and the reinforcing ribs on the back of the traction motor seat, which developed due to fatigue and reached the outer surface.</p> <p>Regarding the fact that a crack occurred in the welded part between the side of the bogie and the reinforcing rib on the back of the traction motor seat, it is highly probable that it occurred because the groove processing was not performed when the manufacturer attached the reinforcing rib to the back of the traction motor seat, which resulted in the crack.</p> <p>Regarding the fact that the groove processing was not carried out, there is no description about the groove in the work plan issued by the bogie technical management office of the bogie manufacturer to the welding workplace where the groove processing is performed, and there is no clear work instruction. Therefore, it is probable that it was related to the fact that the workers in the welding workplace did not know that the groove had to be processed.</p> <p>In addition, the part where the crack occurred was not designated as a priority inspection part after reinforcement, and the magnetic particle inspection was not conducted, so even if the</p>

crack had already occurred at the time of the regular inspection, it is likely that this could not be found.
	Report	https://www.mlit.go.jp/jtsb/eng-rail_report/English/RI2020-2-1e.pdf https://www.mlit.go.jp/jtsb/railway/p-pdf/RI2020-2-1-p.pdf (Explanatory materials (Japanese only))
	Reference	Feature 4 (page 9), Case Studies (page 102)

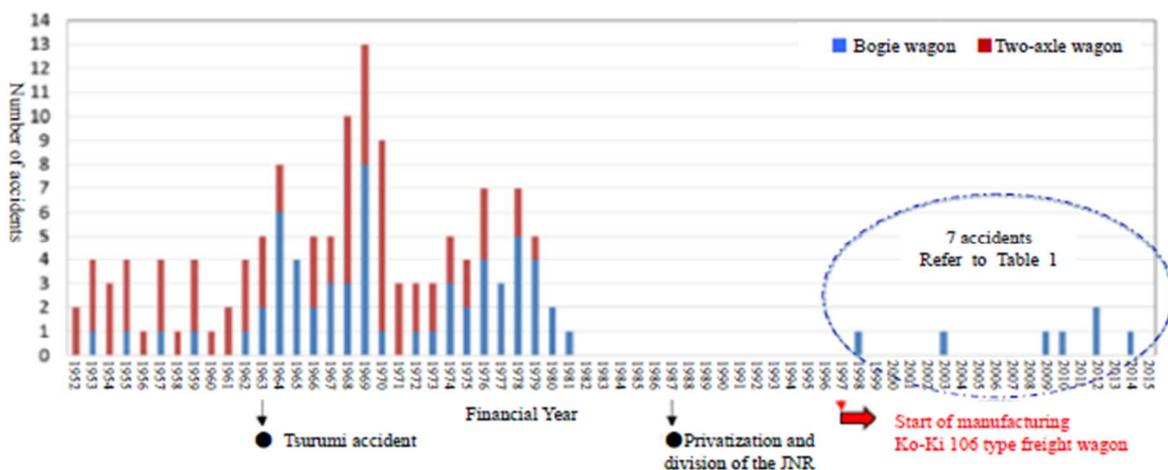
Figure 1 Changes of flange climb derailment and similar derailment accidents of freight wagon

after FY1952[4]-[6]. The flange climb derailment accidents of freight wagons at main tracks had occurred frequently until around 1980, and probable causes of these accidents were determined as combination of various factors while the vehicles and the tracks were maintained within the criterion values for control, and so called as "multiple-factor derailments". The Tsurumi accident, occurred in Tokaido Main Line in November, 1963, was the multiple collision accident originated by derailment of freight wagon, and became to the disastrous accident killing 161 people. To respond this accident, Japan national railway, at that time, established the investigate committee to conduct a variety of examination including on-track tests, and implemented the measures to prevent multi-factor derailments from the viewpoints of both vehicle and track[7], i.e., softened spring constants of the secondary suspension of the TR-41 series bogie, remodeled to use with oil dampers, added the combination of alignment and cross-level to the items in the management of track irregularity, etc. As the results of implementation of these measures, there was no multiple-factor derailment accident after FY1982, however, in recent years, the same sort of derailment accidents came to happen again.

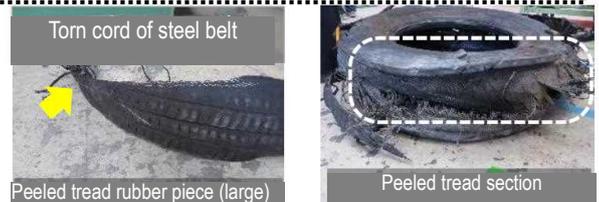
- A fracture on the carcass and peel-off of tread occurred.
- Damage was more conspicuous at the tread section than the side section. The whole inner surface of the tread was damaged.
- The steel belt was exposed due to tread wear.

It is highly probable that, after losing air pressure, the train kept running while the inner surface of the tire and the Nakago (safety wheel) were in contact with the rail, which ultimately resulted in damage to the Nakago.

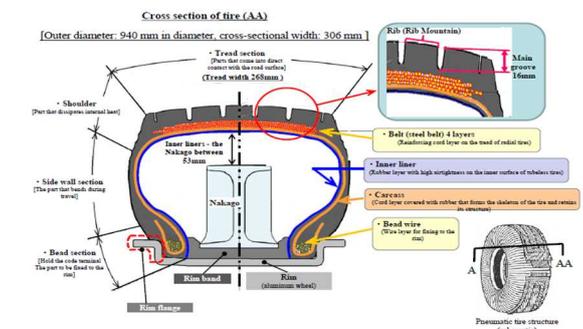
An image of post-accident tire without safety wheel

- Some tires with worn tread patterns were found on other vehicles.
- In the extraordinary inspection carried out nine days before the accident, the inspector did not measure the depth of the tread patterns and, after visual inspection, replaced only tires with exposed steel belts .

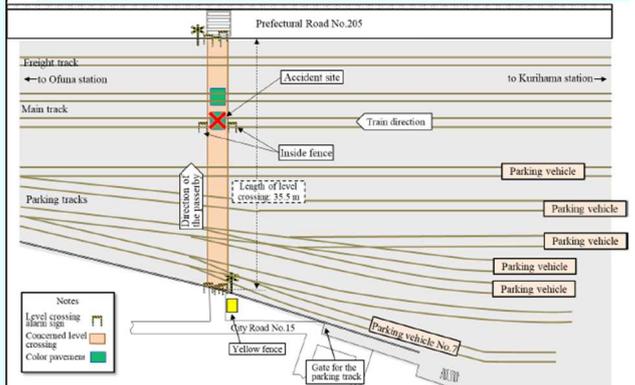
A prefectural road (without a sidewalk) running parallel with the railroad and located north of the level crossing has no place to install a level crossing safety appliance within the railroad yard.

Depending on the traffic situation (i.e., many parked vehicles), there are many potential blind spots for pedestrians.

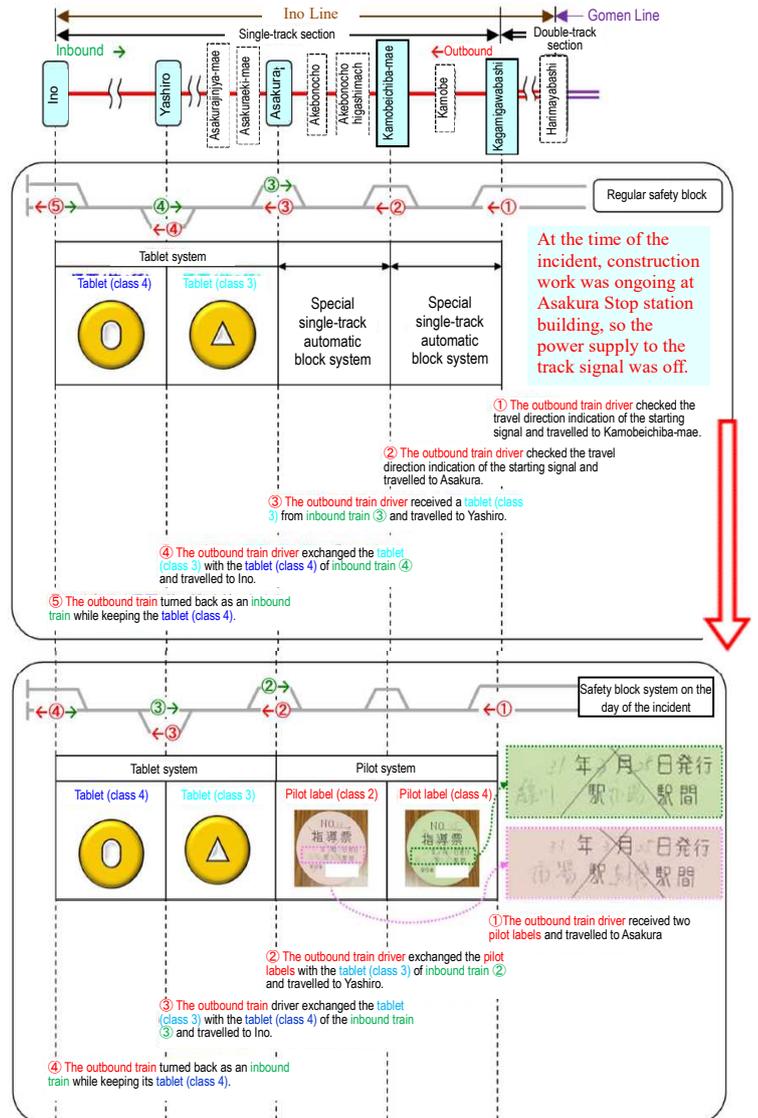
The video image recorded before the train A departed Asakura Stop shows that driver A picked up and checked the pilot label but failed to carry the tablet and perform “finger pointing and call” in front of the train operation timetable.

It is probable that driver A did not correctly understand the track section described in the pilot label and the operation notification ticket nor the meaning of “finger pointing and call” using the train operation timetable.

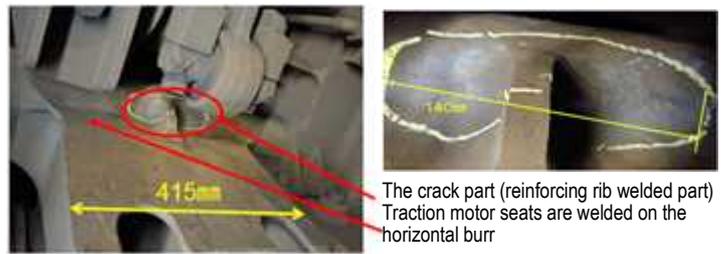
- A reinforcing rib was attached to the back of the main motor seat.

The crack part (reinforcing rib welded part)
Traction motor seats are welded on the horizontal burr

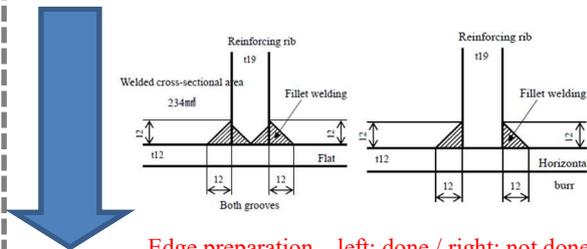
The procedure proposed to the weld shop did not mention edge preparation. It is likely that the bogie technology management office did not adequately explain edge preparation to the work manager. It is likely that the welder who was instructed by the work manager temporarily welded reinforcing rib (tack welding) in a way similar to normal reinforcement work and then welded it without edge preparation.

Edge preparation – left: done / right: not done

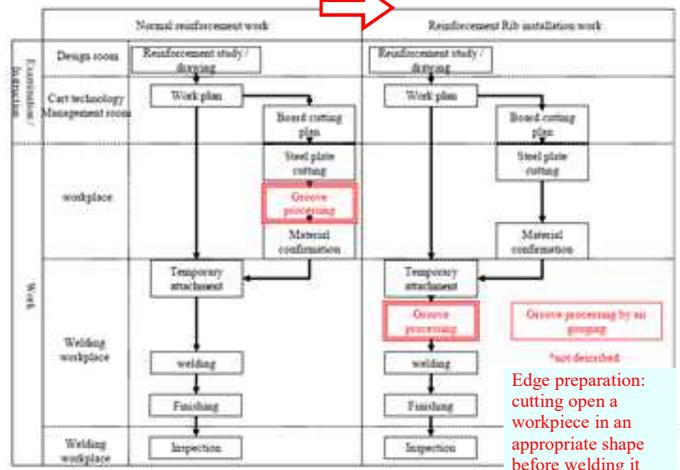
The member is too small for the equipment of the cutting workshop to process it.

Probable cause: It is highly probable that this serious incident was caused by the cracks that occurred in the weld between the side of the bogie frame of the vehicle and the reinforcing ribs on the back of the traction motor seat, which developed due to fatigue and reached the outer surface.
