JTTSB (Japan Transport Safety Board) DIGESTS

Digest of Aircraft Accident Analyses

Injuries suffered in Use of Evacuation Slides during an Emergency Evacuation

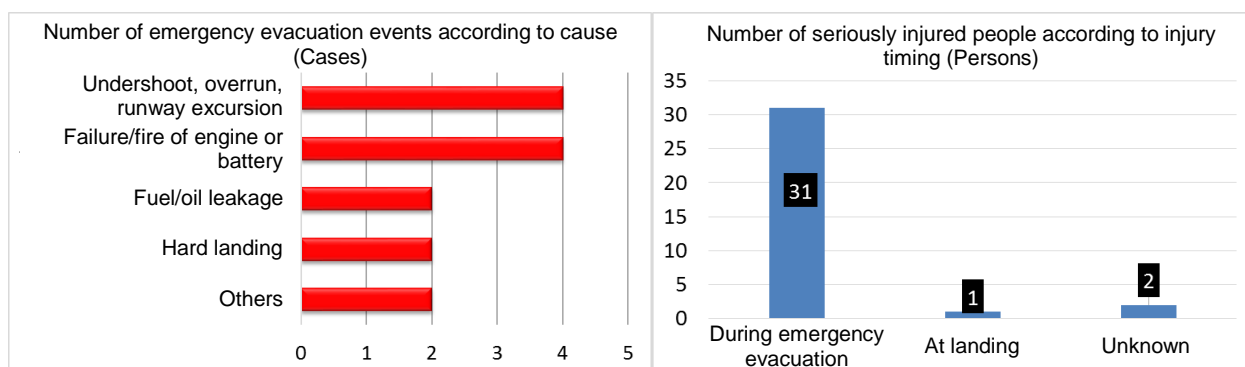
Fig. 1

According to the 14 cases of the accident investigation reports issued by JTSB and its predecessors (Table 1), emergency evacuation procedures were conducted not only in cases that a normal landing was not possible, such as an undershoot, overrun and runway excursion, but in cases that a fire occurred (Fig. 1). In most of such cases, passengers suffered injuries during evacuation (Fig. 2).

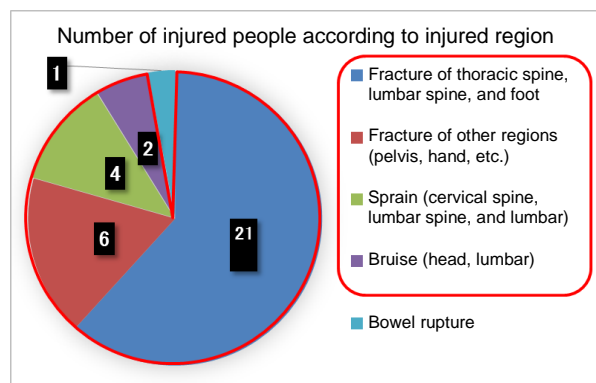
Fig. 3

In this chapter, the injury region of 34 seriously-injured persons, excluding slightly-injured persons, were analyzed and 27 injured person suffered a fracture of the thoracic spine, lumbar spine, pelvis, etc., and they account for nearly 80% of the total. (Fig. 3)

An analysis of the cases where serious injuries occurred during evacuation using evacuation slides revealed that, in each case observed the serious injured suffered in use of evacuation slides, the slides were deployed at a ground with a hard surface, such as a runway, taxiway, and aircraft

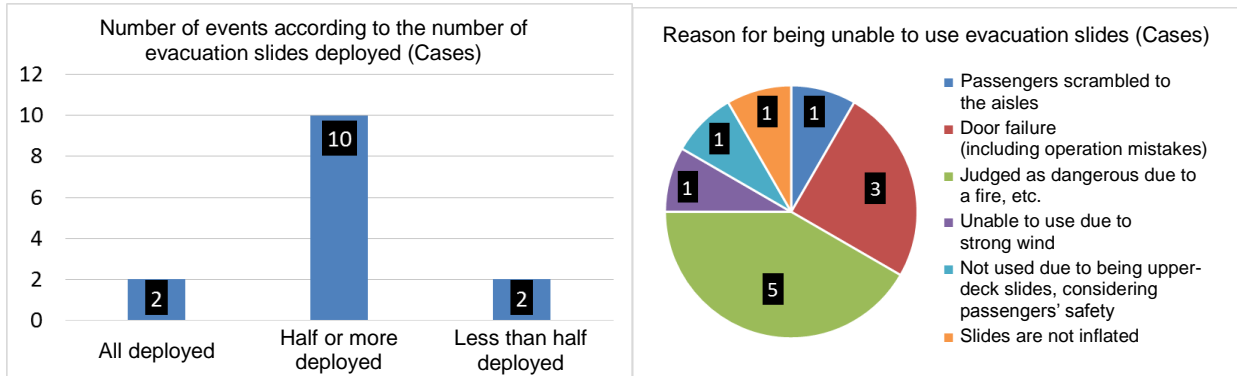
Fig. 6

The number of deployed evacuation slides is also an important factor for smooth evacuation. During an emergency evacuation, some emergency exits are judged as dangerous to use due to a fire, and thus not all slides can be used. (Fig. 6, Fig. 7)

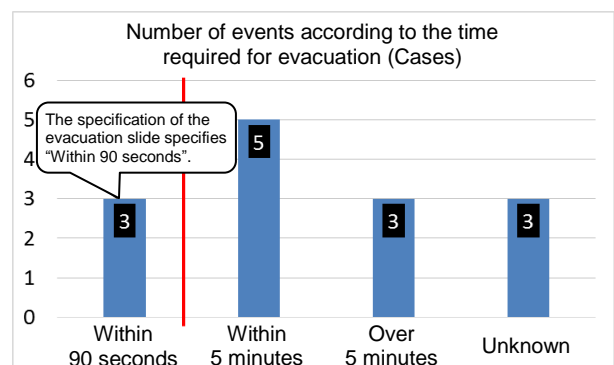
Fig. 8

Finally, as for the capability of evacuation slides, the design criteria for aircrafts stipulate that it must have been demonstrated that, by using the slide, all of the specified number of passengers can evacuate within 90 seconds under the specified conditions.

However, in an actual emergency evacuation, the required evacuation time depends on such factors as the weather at that time, the time zone, the number of evacuation slides deployed and the degree of emergency. (Fig. 8).
