## Case 4: Defects in Aircraft and Parts

Type: Sanyo Tekko EX-03C PUFFIN-LT447 (rudder surface controlled ultralight plane)

Summary of the Accident: The aircraft crashed during a jump flight at a temporary airfield. Only the pilot of the aircraft was on board, and was deceased.

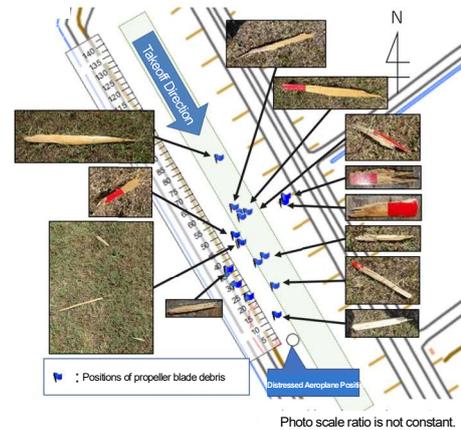
Figure 2 Distribution of Propeller Blade Debris

It is probable that the propeller blade was damaged after the takeoff run started, and some of the scattered debris hit the rear strut of the left wing, causing the strut to buckle and the forward joint of the left wing to separate during the subsequent ascent, resulting in the crash.
