3. Case studies of accidents caused by dozing

1. A case where BNWAS detected the operator's body movements though dozing, so the alarm did not work

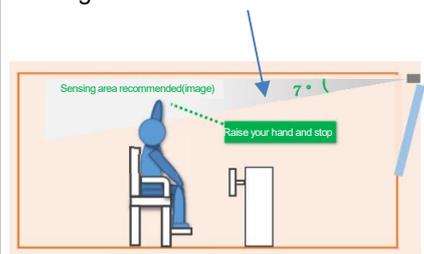
Position and angle at which the person cannot stop the alarm without raising a hand

Sensing area recommended by the manufacturer.

It is likely that **BNWAS did not likely raise the alarm because the sensor pointed lower than the manufacturer's recommended position and detected the body and leg movements of Master B, who dozed.**

- Operators should **have crew members take leaves at appropriate intervals** to let them perform their bridge watchkeeping duty properly and in good condition and **instruct them to get out of their chairs and into the open air to dispel any drowsiness** if they feel drowsy while on duty.
- Shipowners, masters and bridge watchkeepers of vessels equipped with a BNWAS **should not overconfidently depend on the system, endeavour to prevent sleep operation, thoroughly check the system working at departure and under sail, adjust the sensor conditions such as its mounting angle, and set the time (the alarm inactivation time) to be short as possible.**
