## Case 2

### Loss of visual contacts with the ground and following failure to maintain minimum safe altitude during a VFR flight led to the aircraft's crash into the tree canopies on the ridge

Summary: On July 28 (Wednesday), 2010, a Cessna TU206G operated by Company A took off from Niigata Airport at 08:49 local time for a ferry flight to Sapporo Airfield, but it did not arrive there even after the estimated arrival time of 12:49 and went missing.

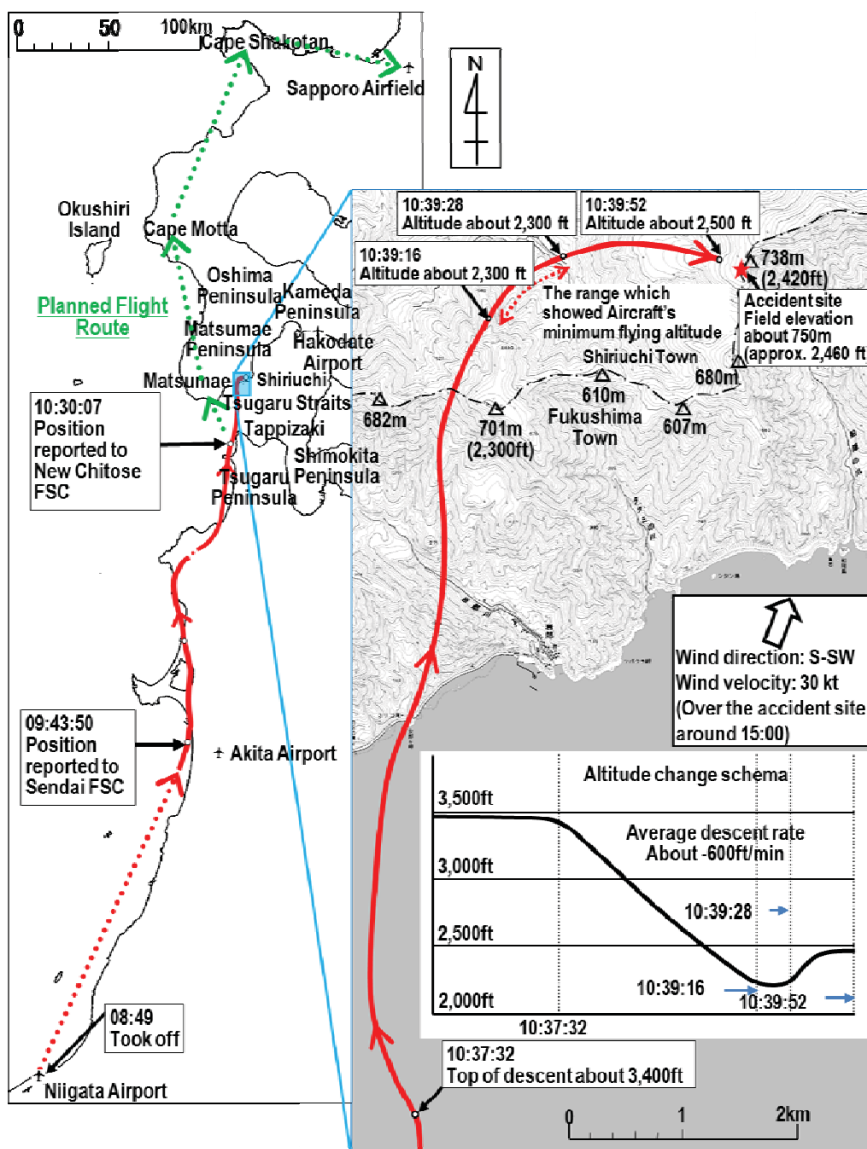
Estimated Flight Route

It is highly probable that the aircraft was flying almost in line with its planned flight route from Niigata Airport to an area over Tappizaki at an altitude of about 3,500 ft.

The aircraft continued to fly northward over the Tsugaru Straits at an altitude of about 3,500 ft and started a descent just in front of Hokkaido.

After changing its course to north-northeast the aircraft descended to about 2,300 ft, subsequently climbed to about 2,500 ft in a right turn and headed for east-southeast.

The aircraft disappeared from the ATC radar at an altitude of about 2,500 ft while flying east-southeastward over the mountains which border Shiriuchi-town, Kamiiso-gun and Fukushima-town, Matsumae-gun, Hokkaido Prefecture.

The aircraft was flying over the Tsugaru Strait and then, it was flying at a low altitude for a period of 2 minutes 20 second from its start of descent to the time when its target disappeared from the ATC radar display. It is probable that the PIC, without changing flight rules from VFR to IFR by climbing, continued to fly VFR at low altitude and without requesting for a radar vector by an ATC facility and the aircraft consequently crashed into the tree top near the ridge.

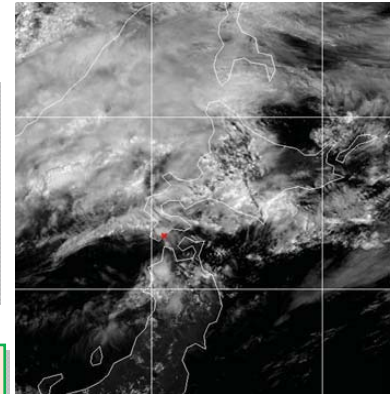
Meteorological Satellite Japan Area  
Visible Imagery (at 10:30 on July 28)

It is possible that the PIC probably judged before departure that weather in the Hokkaido region would worsen as time goes by.

It is possible that judging from the meteorological conditions on the day of the accident, the PIC should not have decided to have a VFR flight for Sapporo Airfield.

- A pilot needs to confirm meteorological information before the flight in cooperation with an operation dispatcher and they should discuss for common understanding about the weather.
