Case 3

After completing the unloading of chloroform, a crew member inhaled chloroform gas and lost consciousness in a ballast pump room

The Vessel (bulk carrier for liquid chemicals)

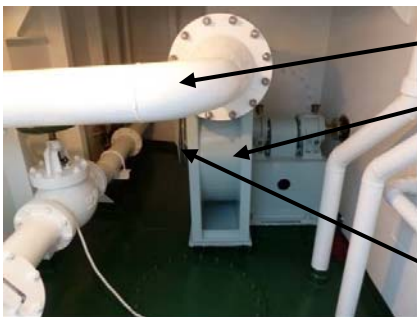
Inflow Route of Chloroform Gas

The area between the cargo piping of No.4 cargo tank on both sides and the suction port of the air blowing fan in the ballast pump room became ventilatable through the air sending piping. Then, chloroform gas in the cargo piping was absorbed by the exhaust fan in the room, and came into the room through the suction port of the air blowing fan. Due to the nature of being heavier than air, chloroform gas resulted in stagnating at the bottom of the room.

It is considered probable that due to being heavier than air and inclined to stagnate at a lower place, chloroform gas which came into the ballast pump room stagnated at the bottom of the room.

Air sending piping
Air blowing fan
Exhaust fan
Suction port of the air blowing fan

It is considered probable that chloroform gas in the cargo piping was absorbed by the exhaust fan and came into the room through the suction port of the air blowing fan.

With respect to vessels transporting dangerous goods, it is necessary to establish operation procedures for handling such cargoes and instruct the crew to fully observe the procedures so that cleaning and ventilation of a cargo tank as well as valve opening and closing should be properly implemented. It is also necessary to ensure that measurement of oxygen concentration and detection of toxic gases should be implemented without fail when entering a place where facilities like a ballast pump are installed and a toxic gas is likely to flow in.

- (1) Instruct the crew to ensure that measurement of oxygen concentration and detection of toxic gases should be implemented without fail when entering a ballast pump room, as in the case of entering a cargo tank or a cargo pump room where a toxic gas may exist.
- (2) Be aware of the details of such onboard work as may endanger the crew, establish safety check procedures during work as well as working procedures, and give them instructions on these procedures and ensure observance by them.

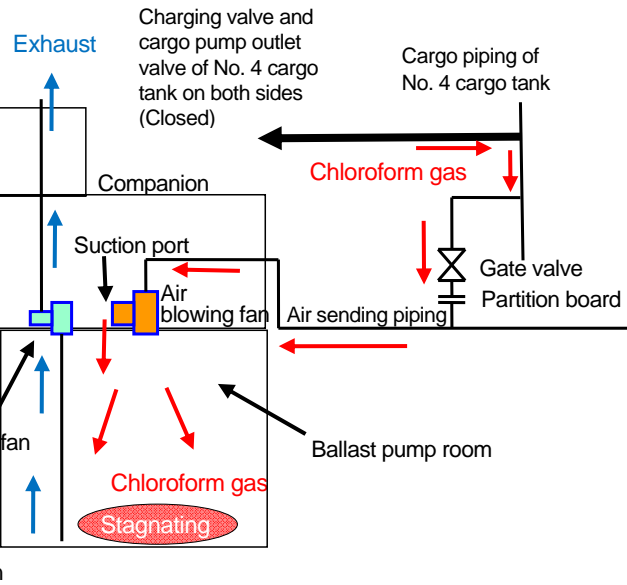
How the Area between the Cargo Piping and the Air Sending Piping Became Ventilatable

When the Vessel was pumping water into the ballast tank to adjust the draft, both the partition board and the gate valve which were separating the cargo piping and the air sending piping in No. 4 cargo tank on both sides were opened.

After operating the ballast pump in order to pump water into the ballast tank, 1/E opened the partition board and the gate valve which were separating the cargo piping and the air sending piping in No.4 cargo tank on both sides.

Concerning whether the charging valve and cargo pump outlet valve of the cargo piping were opened or closed when the accident occurred, they were normally closed when cargo handling was not going on.
