**AIRCRAFT SERIOUS INCIDENT  
INVESTIGATION REPORT**

## RUNWAY INCURSION

F-2A, 93-8550

EMBRAER ERJ 170-100STD, JA216J

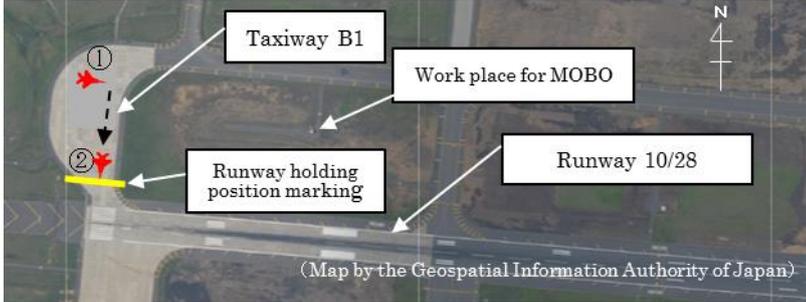
<p>Figure 1: Moving route of Aircraft A</p> <p>Around 12:43, though the PIC of Aircraft A reported the completion of departure preparation to Misawa Tower for expecting take-off clearance just after arrival of the two F-15 formation aircraft that were entering the traffic pattern to land, he was instructed by Misawa Tower to hold short of</p>

The PIC of Aircraft A moved his aircraft closer to the runway holding position marking\*<sup>4</sup> (shown in Figure 1 ②) before the runway and stopped the aircraft in accordance with the holding instruction from Misawa Tower. At this point, it became obvious that the take-off of Aircraft A would be behind scheduled time (12:45) and therefore the training plan should be revised.

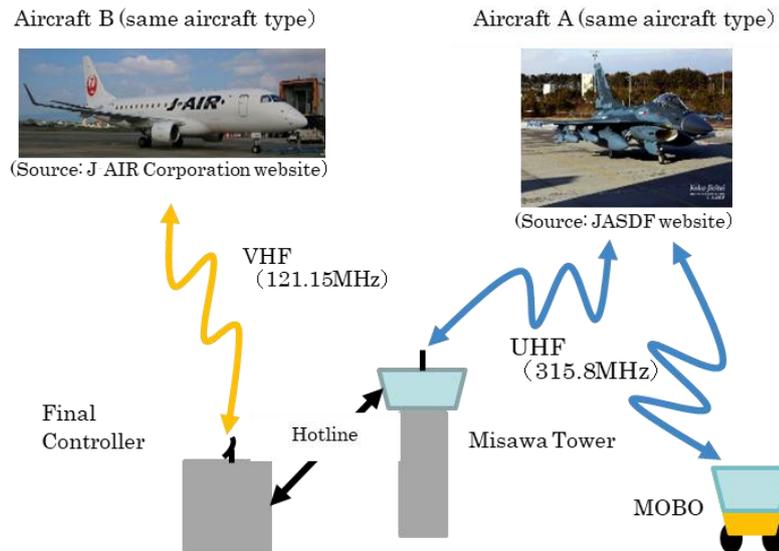
Figure 2: Circumstances of communications among Aircraft A, Aircraft B and air traffic facilities

On the other hand, as shown in Figure 2\*<sup>5</sup>, around 12:44, after Aircraft B got a clearance for ILS approach to Runway 10 from Misawa Terminal Radar (121.15 MHz), the control of Aircraft B was transferred to Final Controller at the same frequency in order to continue radar monitoring.

At 12:46:58, Misawa Tower issued a landing clearance to Aircraft B on the final approach via Final Controller; however, this landing clearance was transmitted via different frequency (121.15 MHz) from the one (315.8 MHz) to which the PIC of Aircraft A was listening. Therefore, the PIC of Aircraft A had no information about the existence of Aircraft B that was cleared for landing.

Besides, in this serious incident, Aircraft B communicated with Final Controller and received a landing clearance from Misawa Tower via Final Controller (see Figure 2). At Misawa Airbase, controllers routinely perform this kind of control operations for those aircraft making an ILS approach in order to reduce the workload of tower controllers.

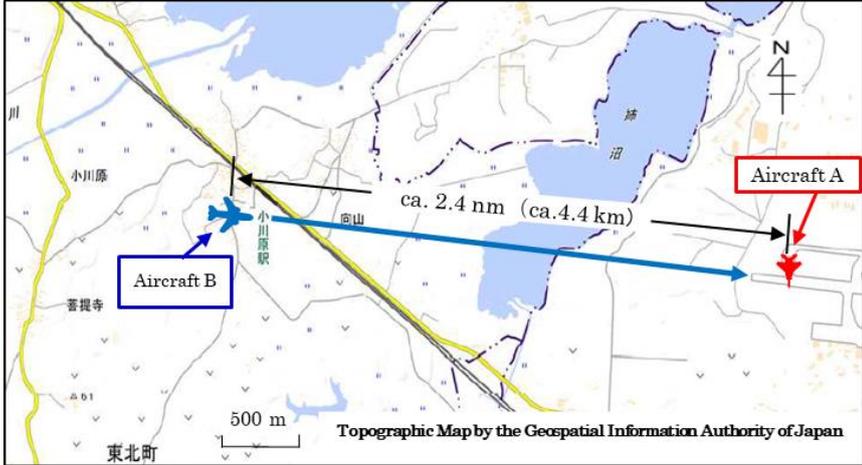
2.7 Additional Information	<p>(1) Position and distance of aircraft concerned</p> <p>According to Records of Aircraft B's Flight Data Recorder, the position of Aircraft B at the time of occurrence of the runway incursion by Aircraft A is shown in Figure 3, and the distance between Aircraft A and Aircraft B was approximately 2.4 nm (about 4.4 km).</p>

<p>Figure 3: The position of Aircraft B when Aircraft A enter the runway (Blue arrow indicates the flight route of Aircraft B after the occurrence of the serious incident)</p> <p>(2) Aerodrome control at Misawa Airbase</p> <p>The control operations for the aerodrome and approach control area</p>

It is highly probable that the distance between Aircraft A and B, when Aircraft A entered runway, was approximately 2.4 nm (4.4 km).
