**AIRCRAFT ACCIDENT  
INVESTIGATION REPORT**

**AIR CHINA LIMITED  
B 2 9 0 6**

# **AIRCRAFT ACCIDENT INVESTIGATION REPORT**

**AIR CHINA LIMITED  
BOEING 737-300, B2906 (China)  
ABOVE MATSUE CITY, SHIMANE PREFECTURE, JAPAN  
AT ABOUT 19:19 JST, FEBRUARY 10, 2008**

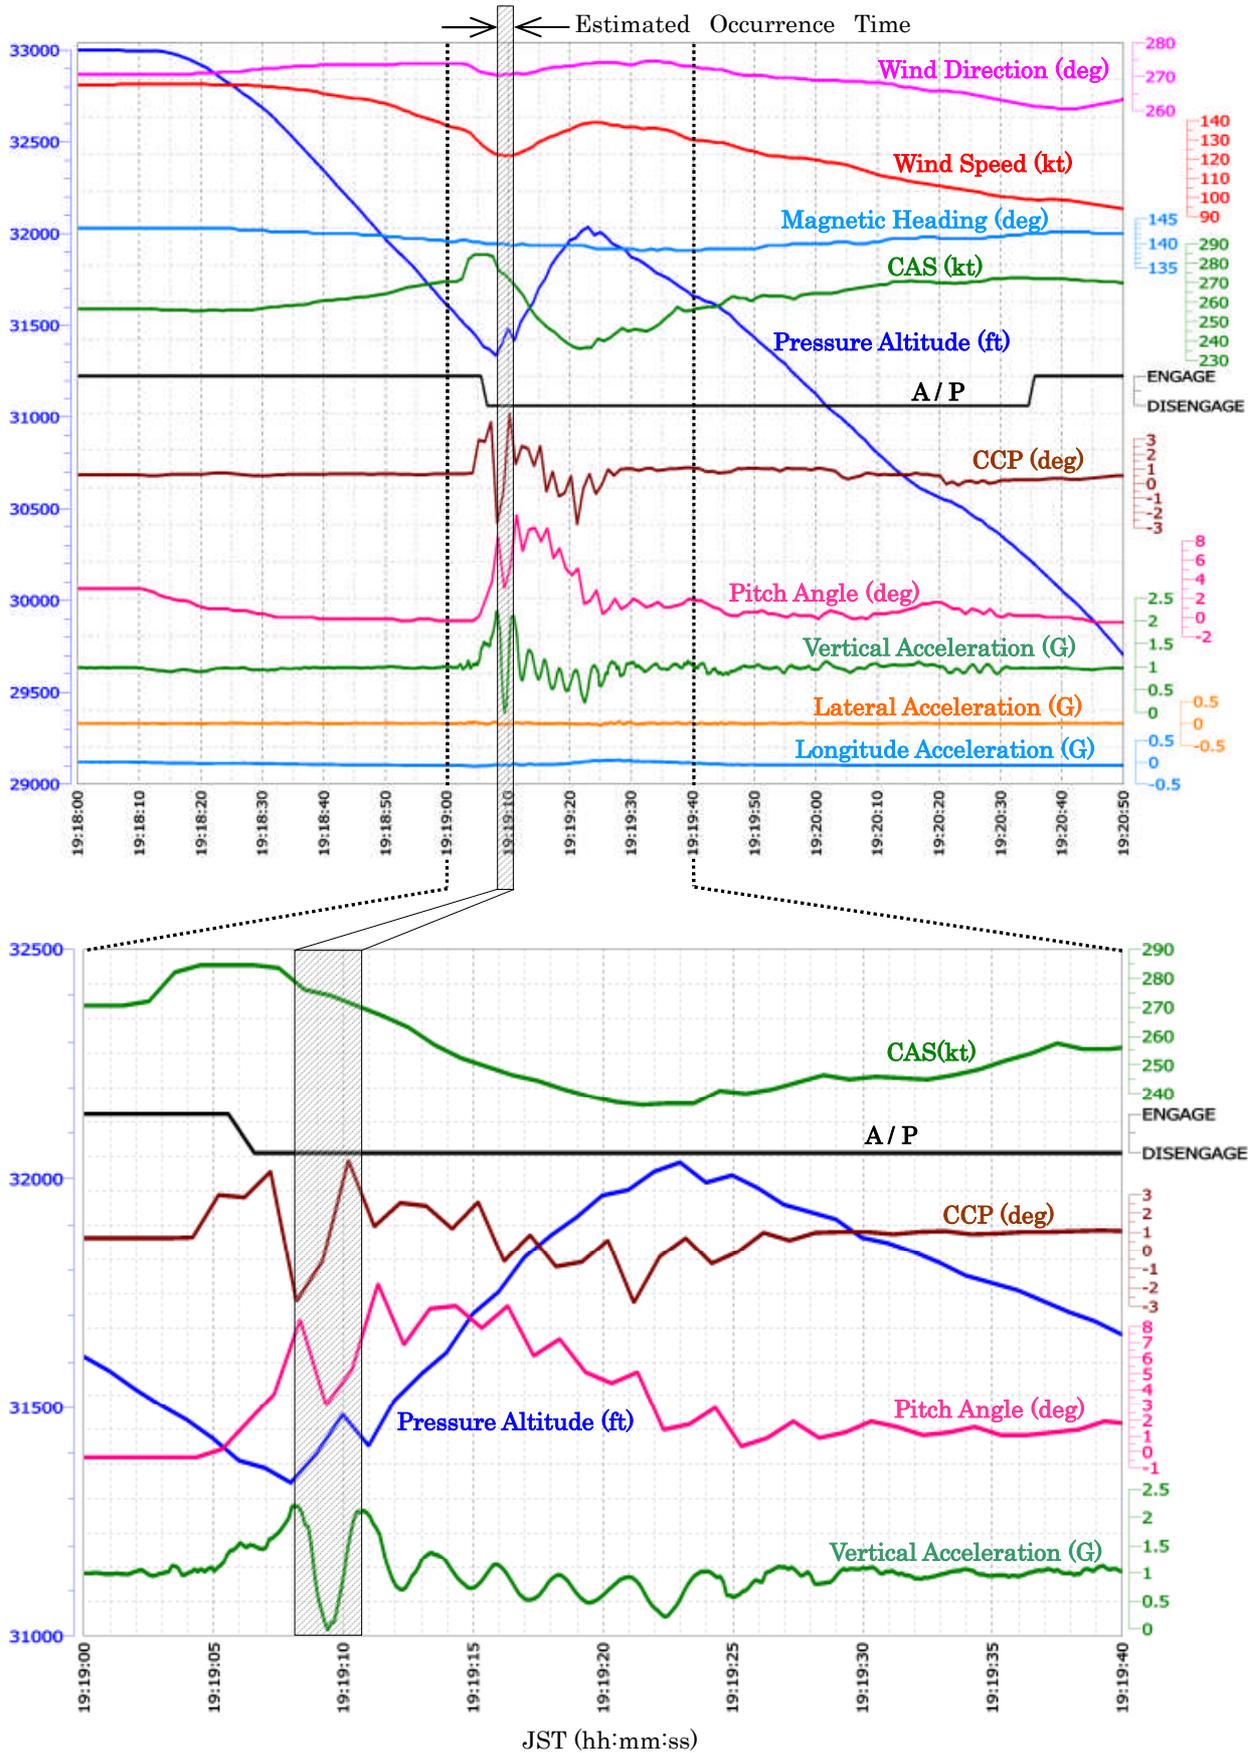
# Figure 3 DFDR Records

While the Aircraft was descending at a rate of about 2,000 ft/min, the wind velocity began to drop at a steeper rate, the CAS\*<sup>3</sup> increased rapidly and the control column position (CCP)\*<sup>4</sup> moved towards the pitch-up direction at about 19:19:03, when the Aircraft was at a pressure altitude of about 31,500ft, and the A/P disengaged at about 19:19:06. Subsequently, the CCP changed back and forth. During the period from 19:19:08 to 19:19:11, the vertical acceleration showed remarkable change, dropping from about 2.2G to about 0.0G and then reaching again to about 2.0G. Until about 19:19:27, the pitch angle\*<sup>5</sup> had changed upward and downward following the changes in CCP, and the changes in the vertical acceleration accompanied by the changes in the pitch angle were recorded.

(1) The Aircraft began descending from a cruising altitude of FL330 at about 19:18:13 with the A/P engaged. At about 19:19:04, when the Aircraft was at a pressure altitude of about 31,500 ft, the CAS increase rapidly from about 270 kt to 285 kt, in response to which the A/P moved the control column to pull up the nose as an automatic control action against this quick change in CAS. At about 19:19:06, i.e., when the Aircraft began to pitch upwards, the A/P disengaged. There was no factual information in the data from the Aircraft's DFDR to indicate what caused the disengagement of the A/P.

(2) After disengagement of the A/P while the Aircraft's pitch-up attitude had begun to increase, the Second PIC executed manual control to continue bringing the nose up in order to decrease the CAS. When the CAS stopped increasing, the Second PIC moved the control column forward by a fairly large amount to bring the nose down, and

immediately after this, he moved the column aft, also by a large amount. Following these control column movements, the Aircraft's pitch angle changed upward, then significantly downward, and again upward. The vertical acceleration thus showed these large changes during the period from 19:19:08 to 19:19:11, i.e., having changed positively to about 2.2G, the maximum value during the flight, then changing negatively to about 0.0G, the minimum value during the flight, and again changing positively to about 2.0G.

This wide fluctuation in vertical acceleration took place 55 seconds after the Aircraft began descending. Since there were no significantly large fluctuations in vertical, lateral or longitudinal acceleration in the DFDR data for any other time from takeoff to landing, it is considered highly probable that the injured passenger lost one's balance due to this distinctively large fluctuation in vertical acceleration.

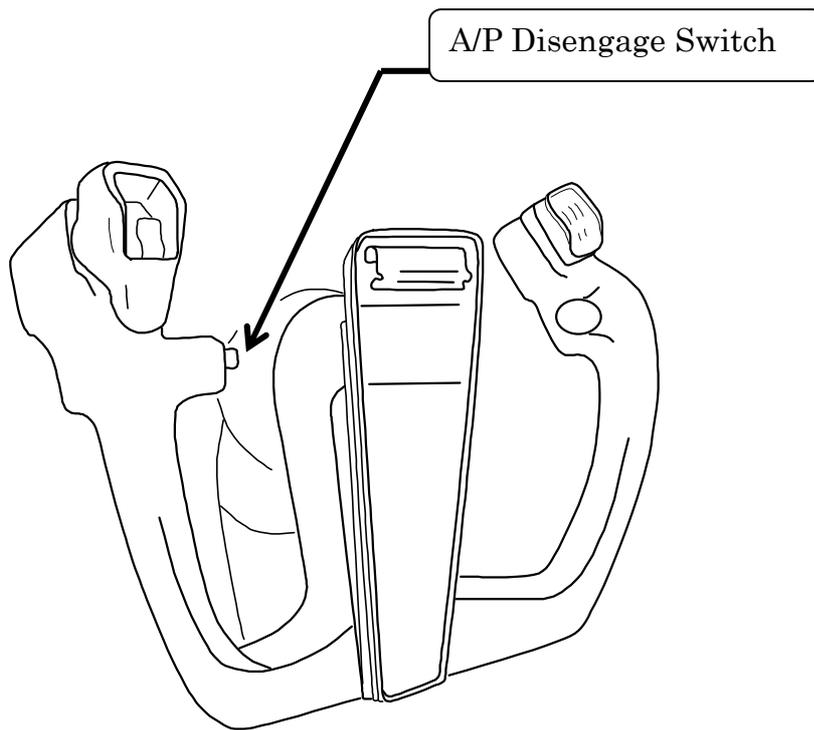
Figure 4 A / P Disengage Switch

The cause of A/P disengagement, therefore, could not be determined, although it is considered possible that a loss of valid signals or intermittent contact on switches or relays might have occurred as suggested in the response from the adviser of the United States of America, the State of Design and Manufacture of the Aircraft, as described in 2.10, or the Second PIC might have unconsciously pushed the A/P disengage switch on the control wheel.

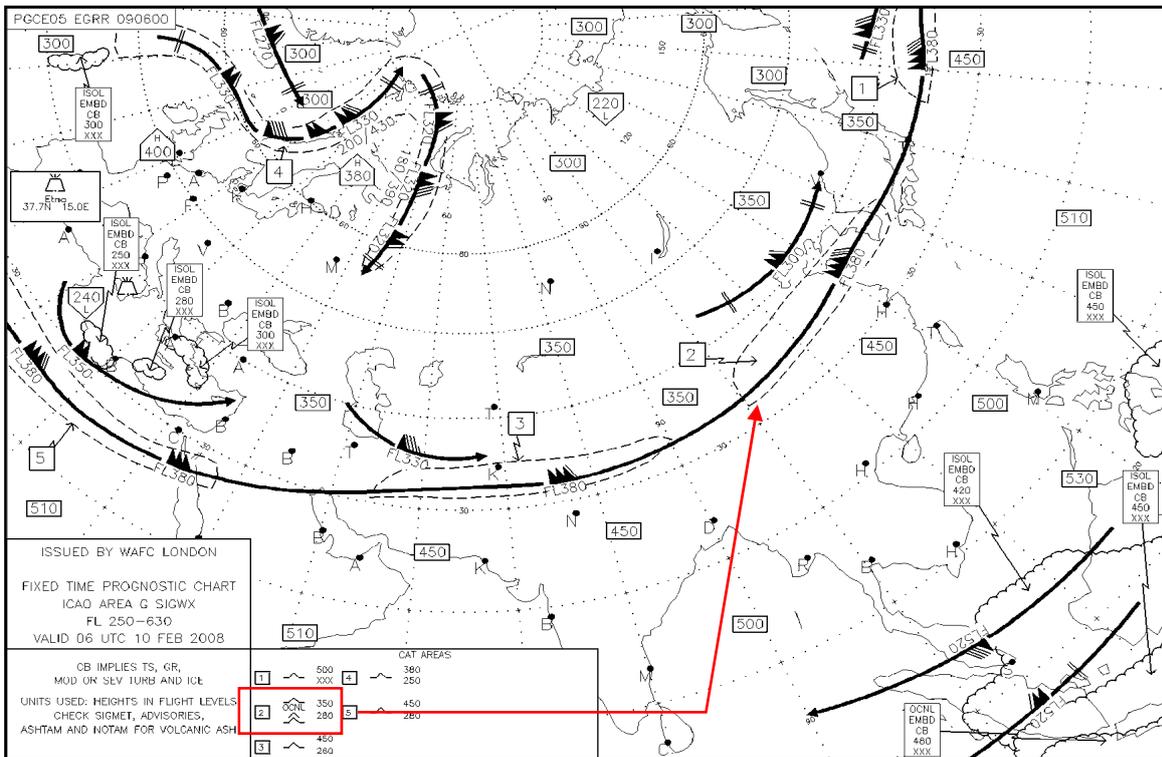
Figure 6 Significant Weather Prognostic Chart  
at 15:00 on Feb. 10, 2008

The Significant Weather Prognostic Chart valid at 15:00 on the day of the accident, which the PIC and other flight crewmembers received prior to the flight, showed a 180 knots jet stream zone at FL380, which stretched from China to Japan along the parallel of latitude that runs approximately 37 degrees north. It also showed a forecast zone of moderate or locally intensified CAT (Clear Air Turbulence) at FL280 – 350, which extended from 35 to 38 degrees north, a zone straddling the jet stream zone, and stretched from the 100 degrees east longitude line in China to South Korea including the Yellow Sea.

As supported by the CAT zone forecast on the Significant Weather Prognostic Chart checked by the PIC and the Second PIC prior to the flight and by the Significant Weather Analysis Charts valid at 15:00 and 18:00 on the day of the accident, as described in 2.6.2 and 2.6.3, it is considered highly probable that a CAT zone was moving eastward while widening in latitudinal direction, and the point of occurrence of the accident was in the area of the CAT zone at the time of the accident.

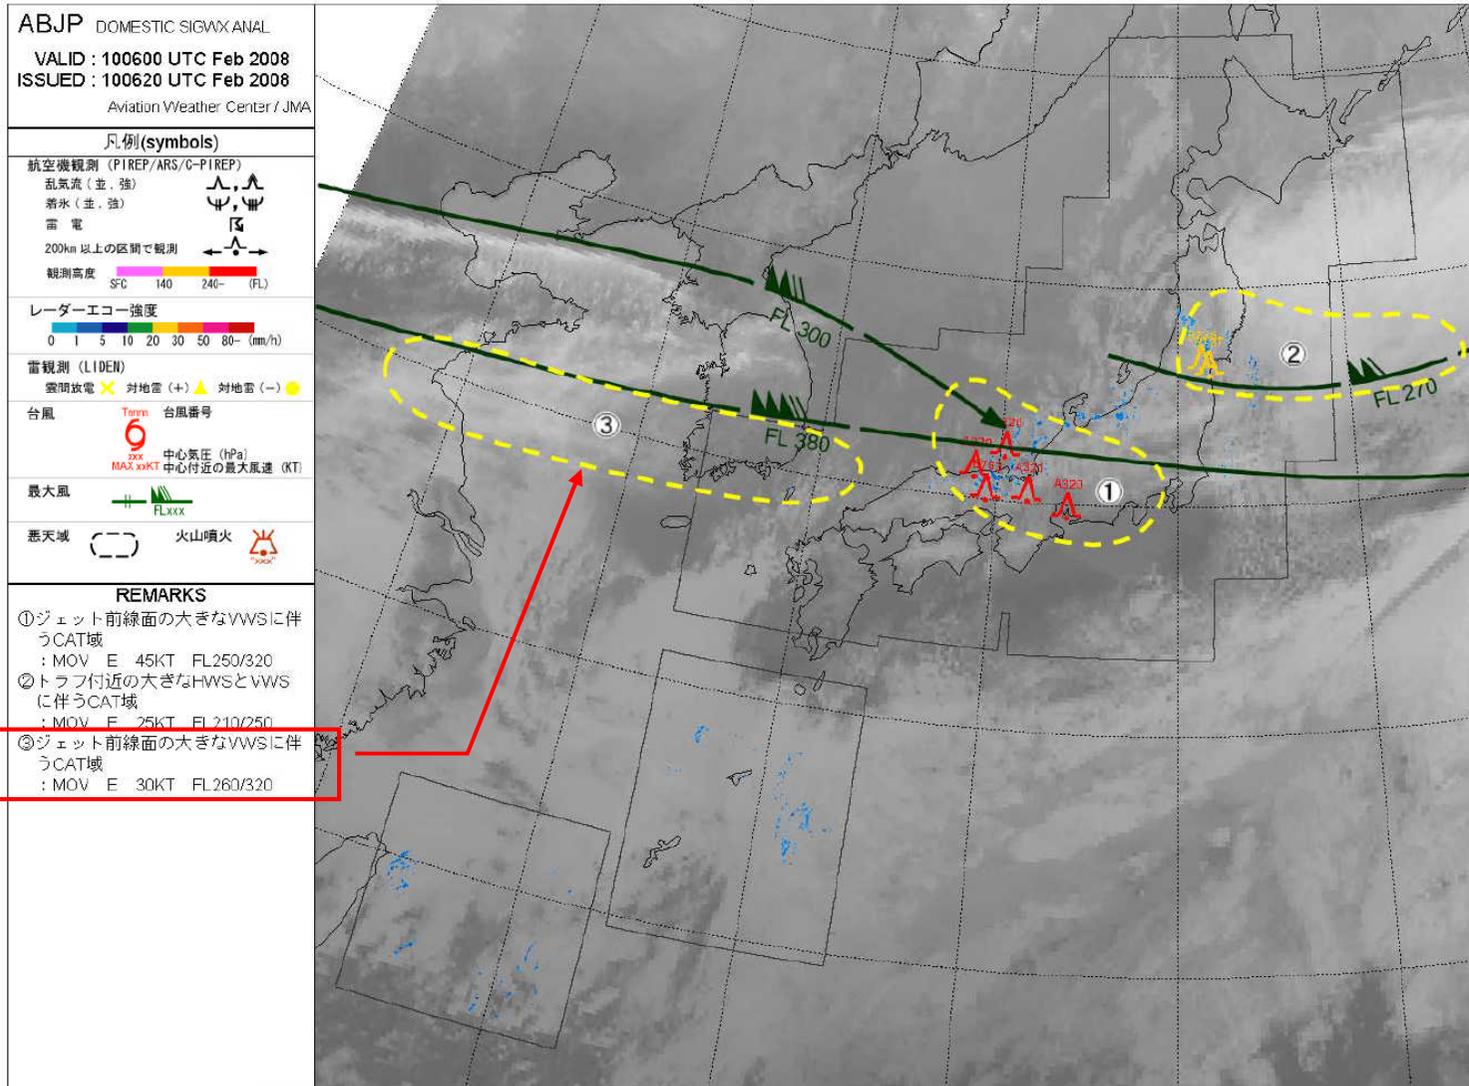
Figure 7-1 Significant Weather Analysis Chart at 15:00 on Feb.10, 2008

The Significant Weather Analysis Chart for users in Japan valid at 15:00 on the day of the accident showed a CAT zone at FL260 – 320 resulting from the great VWS (Vertical Wind Shear<sup>\*6</sup>) accompanied by a jet stream front, which extended widthwise from 34 to 36 degrees north and stretched from the Yellow Sea to the Sea of Japan off Yamaguchi Prefecture via the southern part of South Korea. The analysis thereof expected the CAT zone to move eastward at 30 kt.

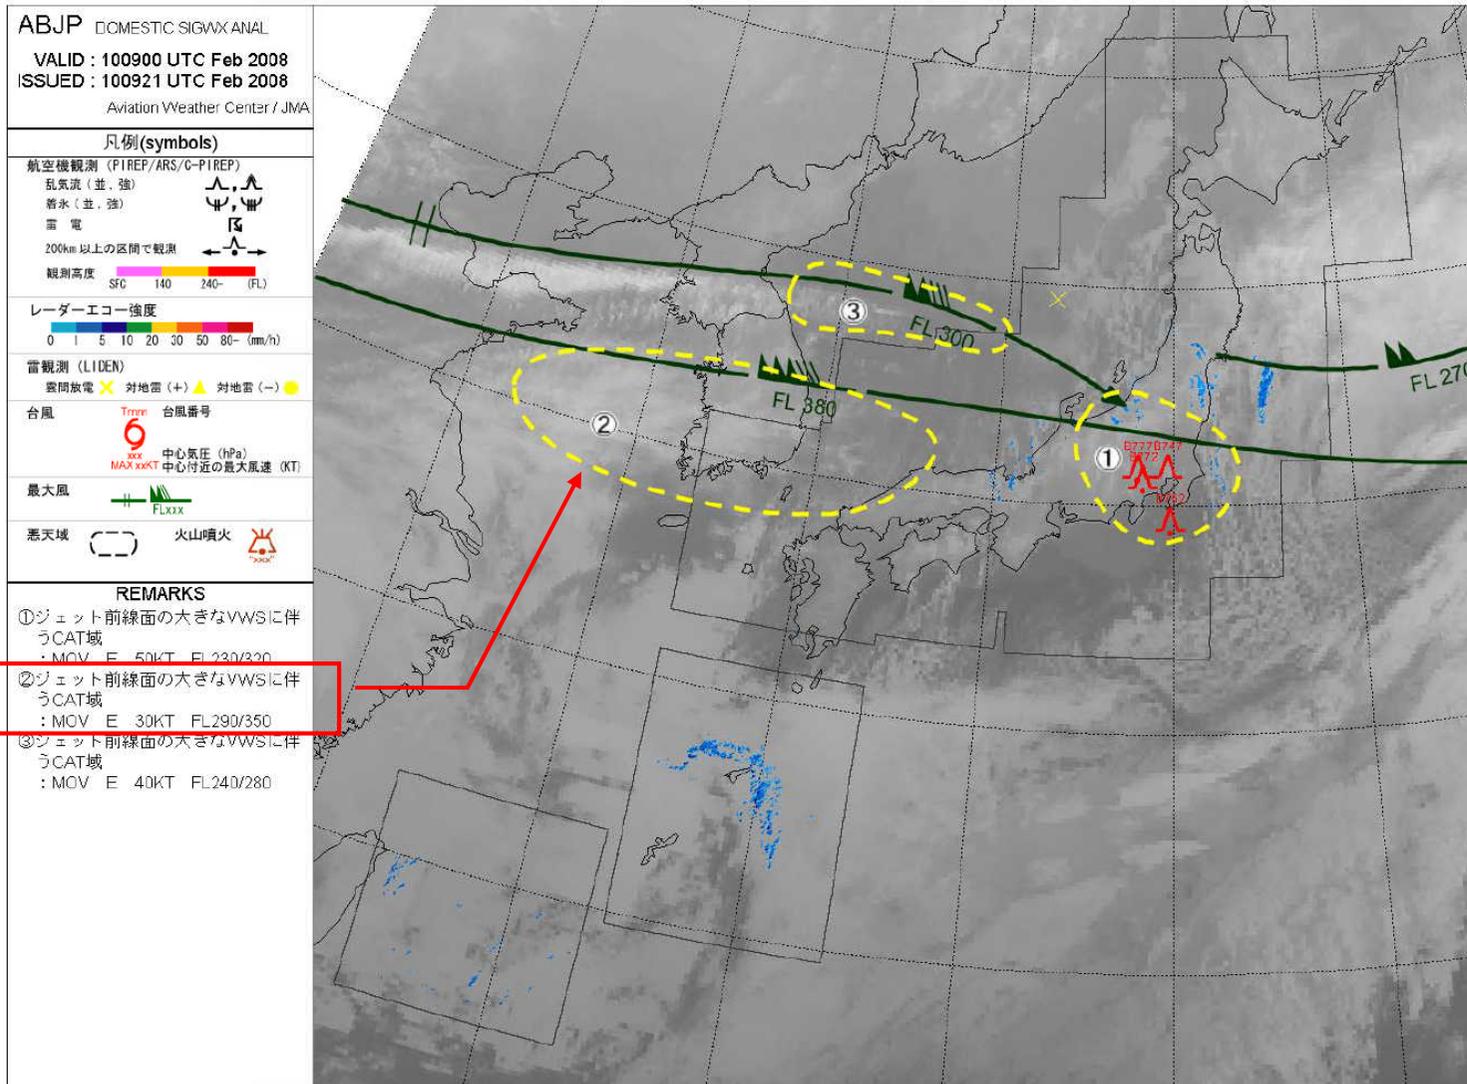
Figure 7-2 Significant Weather Analysis Chart at 18:00 on Feb.10, 2008

The Significant Weather Analysis Chart valid at 18:00 on the day of the accident showed a CAT zone at FL290 – 350 resulting from the great VWS accompanied by a jet stream front, which extended widthwise from 34 to 38 degrees parallel north and stretched from the Yellow Sea to the Sea of Japan off Shimane Prefecture via South Korea. The analysis thereof expected the CAT zone to

move eastward at 30 kt.

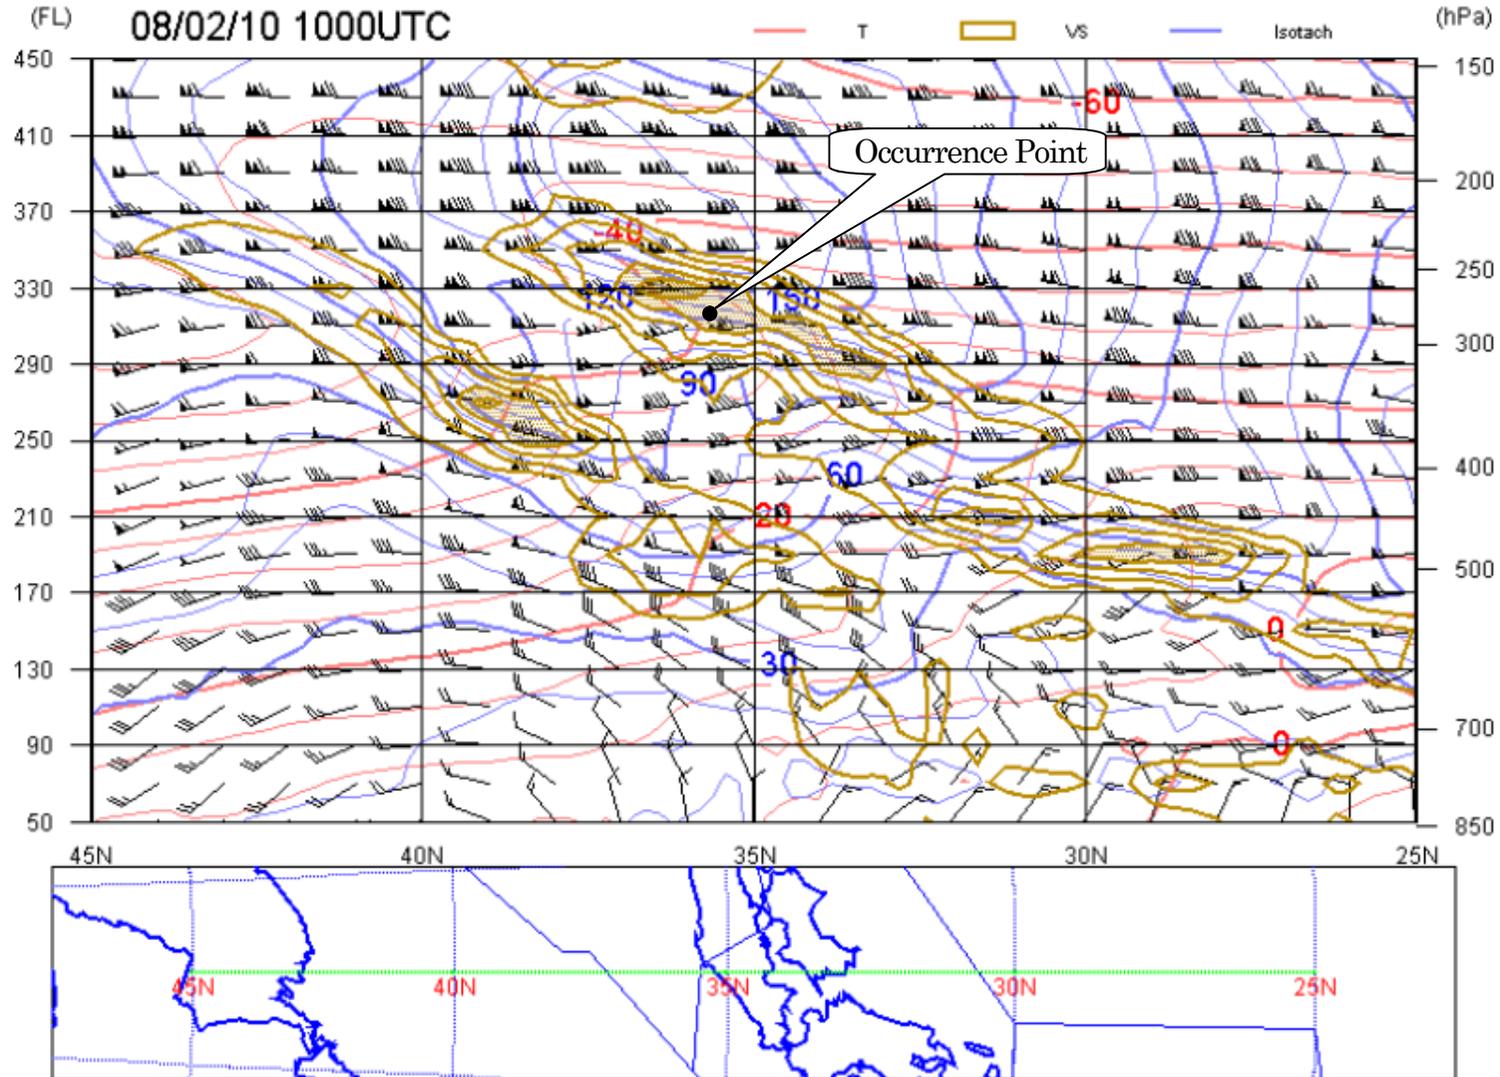
# Figure 8-1 Vertical Wind Shear Analysis Chart

The vertical wind shear analysis chart representing a vertical section along the 132.5 degrees east longitude line valid at 19:00 on the day of the accident, the vertical wind shear in the area where the accident occurred included a jet stream of 170 kt or faster in the air at FL380 – 350 and latitude near 35 degrees 30 minutes north, the point where the Aircraft encountered strong shaking, whereas the jet stream's velocity at FL310 was much lower, i.e., at 120 kt. That is, the vertical wind shear across FL330 – 310 was 12 – 15 kt/1,000 ft. The temperature at FL340 was about –35°C, whereas the isothermal curve for FL310 indicates a –40°C line extending from the north, showing that an inversion layer.

The vertical wind shear analysis charts described in 2.6.4 show a jet stream in the area above the point where the accident occurred; a strong wind of 180 kt was prevailing at FL380 and there was significant variation in wind velocity as represented by closely spaced isotachs in the area down to FL310, in addition to narrowly spaced isothermal lines extending along the strong wind line, which was bordered by a jet stream front extending from west to east. It is considered probable that vertical wind shear of 12 kt/1,000 ft or greater existed in the area of occurrence of the accident as well as an inversion layer as expected by the analytical data included in the charts.

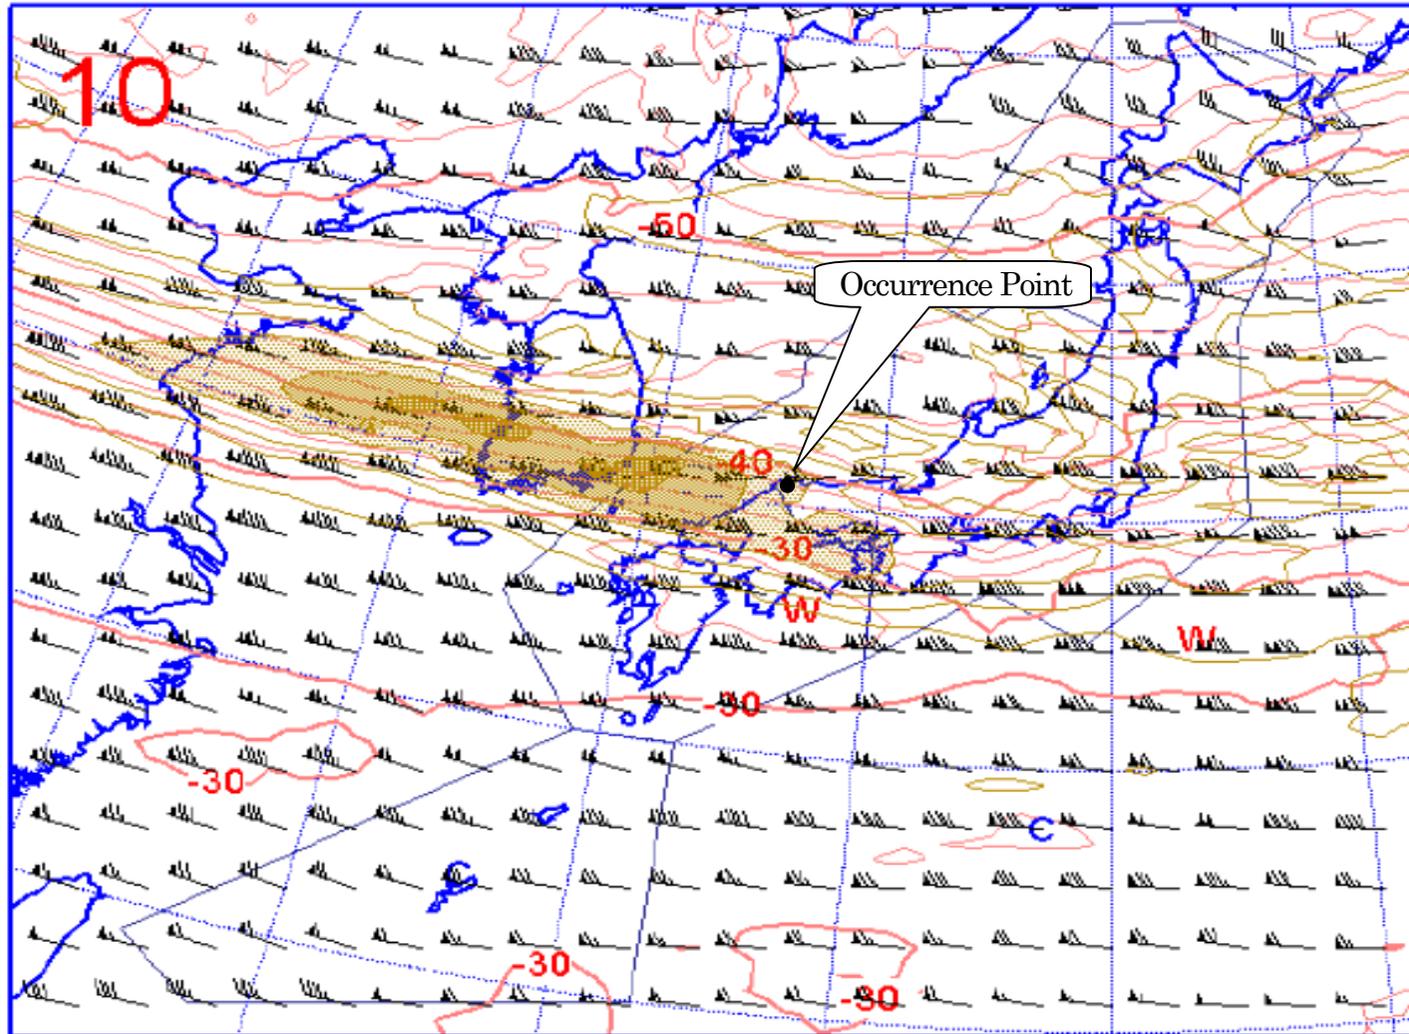
# Figure 8-2 Vertical Wind Shear Analysis Chart

The vertical wind shear analysis chart representing a horizontal section at FL310 valid at 19:00 on the day of the accident shows isothermal lines extending at close intervals along the strong wind line, depicting the vertical wind shear was 12 kt/1,000 ft or greater extending eastward from the central part of China, covering the southern part of South Korea and reaching the Setouchi region of Japan.

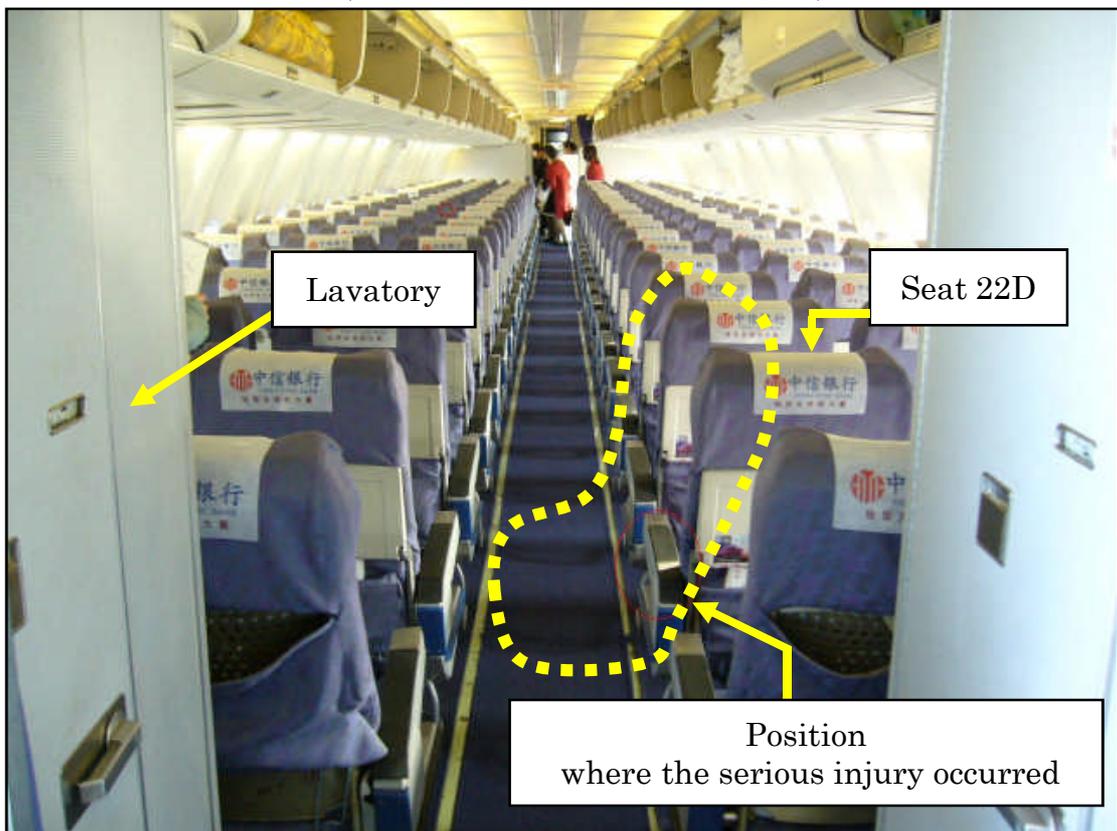
Photo 2 The Aisle of the Aircraft  
(Viewed from aft to forward)

It is considered highly probable that the latter passenger who was walking in the aisle from the lavatory back to her seat lost her balance due to the shaking, hitting her abdomen hard against a part of a nearby seat and thus sustaining serious injury.
