**AIRCRAFT SERIOUS INCIDENT
INVESTIGATION REPORT**

**JUNEYAO AIR CO., LTD.
B 8 2 3 6**

**JAPAN COAST GUARD
J A 8 5 7 0**

TAKE-OFF FROM A RUNWAY BEING USED BY OTHER AIRCRAFT
ON RUNWAY 18 AT NAHA AIRPORT
AT AROUND 18:42 JST, MARCH 18, 2018

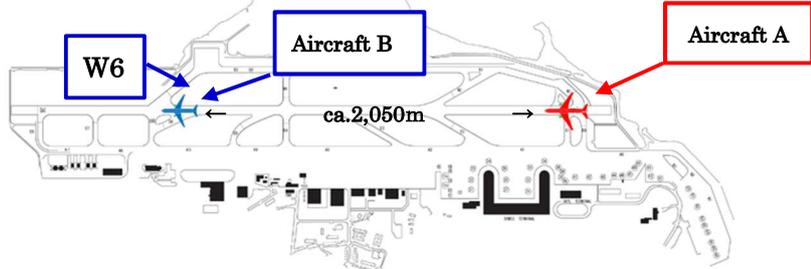
<p style="text-align: center;">Figure 2: The position of the Aircraft B when the Aircraft A commenced a take-off roll</p>

While approaching the runway, the PIC of the Aircraft A thought that the Aircraft B, which had landed earlier, would have already vacated the runway; therefore, he did not visually recognize the Aircraft B on the runway in front of it when he commenced a take-off roll.

It is highly probable that this serious incident occurred as follows: Without receiving a take-off clearance from the Tower, the Aircraft A commenced a take-off roll on the runway where the Aircraft B, which had landed earlier, was still present on the runway; furthermore, although the Aircraft A had failed to hear the Tower’s instructions to stop immediately, it continued take-off roll.

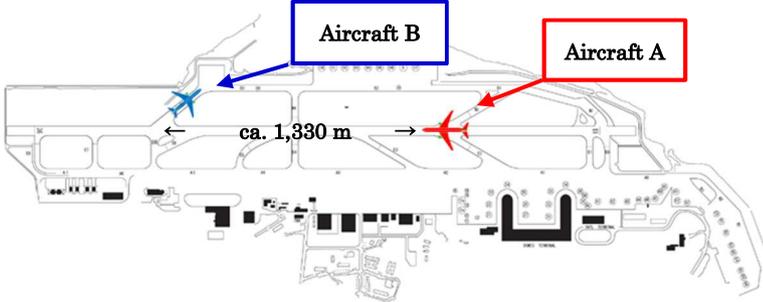
As shown in Figure 3, the estimated separation between the Aircraft A and the Aircraft B was 1,330 m.

According to ICAO “Manual on the Prevention of Runway Incursions,” it is certain that the severity of risk for this serious incident falls in the “Category C (an incident characterized by ample time and/or distance to avoid a collision). (See Attachment 2: Classification of the Severity of Runway Incursions)
