**AIRCRAFT ACCIDENT  
INVESTIGATION REPORT**

**PRIVATELY OWNED  
G - B Y L P**

AIRCRAFT DAMAGE DURING FORCED LANDING  
YANO TOWN, AIOI CITY, HYOGO PREFECTURE, JAPAN  
AT AROUND 15:52 JST, JULY 11, 2017

PRIVATELY OWNED, HALES CS RAND KR-2  
(AMATEUR-BUILT AIRCRAFT, TWO-SEATS)  
G-BYLP (BRITISH REGISTRY)

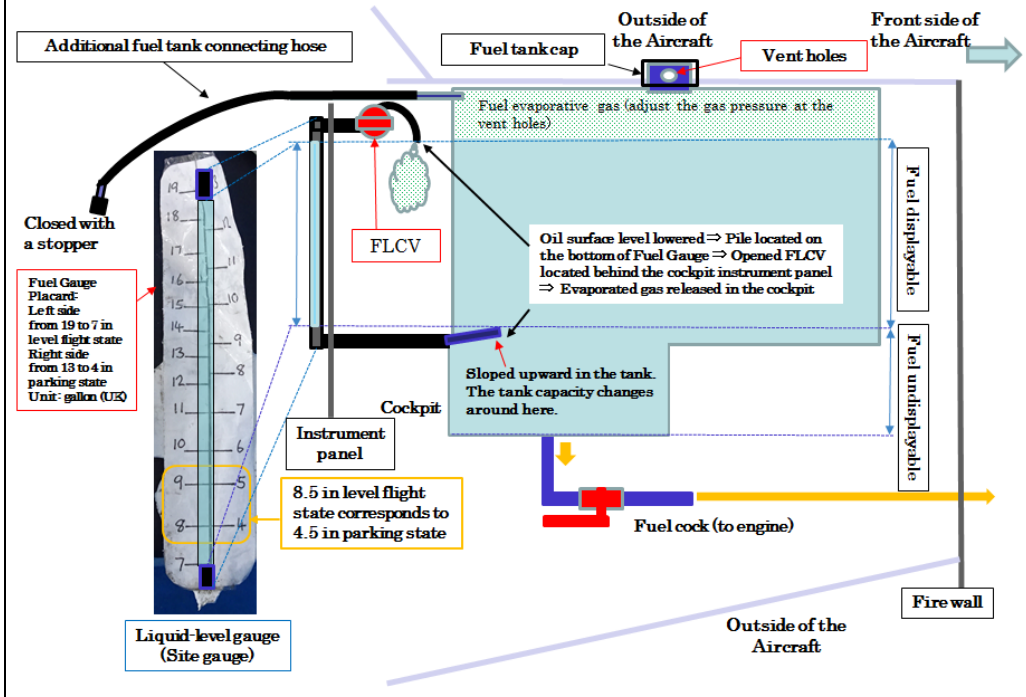
Figure 3: Fuel tank and the Fuel Gauge diagram

The fuel tank of the Aircraft is equipped between the fire wall in the aft part of engine compartment and the cockpit instrument panel. The fuel tank is an integrated aluminum box with no internal partition and the capacity of its bottom part is smaller than that of the upper part.

The Fuel Gauge is a liquid-level gauge that reads the fuel level position directly on a translucent vertical pipe. As the capacity of its bottom part is smaller than that of the upper part, the scale of the Fuel Gauge is unevenly spaced. Because the Aircraft is a tailwheel type airplane, the Fuel Gauge indication varies depending on the inclination of the tank, thus its indication is different between in a level flight state and in parking on the ground. From the maximum load capacity of 19 gal (UK) to the minimum indicated value of 7 gal (UK) are indicated by the scale for the level flight state, but the remaining fuel quantity will not be indicated, if the Fuel Gauge reads less than 7 gal (UK). From the maximum indicated value of 13 gal (UK) to the minimum indicated value of 4 gal (UK) are indicated by the scale for the parking state (pitch angle: about 20 degrees), but the remaining fuel quantity will not be indicated, if the Fuel Gauge reads more than the maximum indicated value of 13 gal (UK).

The Fuel Gauge was detached, but as water was poured into the vacant tank placed horizontally, and when the fuel level reached from the minimum indicated value of 7 gal (UK) (about 32 ℓ) to further to approximately 5 gal (UK) (about 24 ℓ), water came out from the broken pipe at the bottom part of the damaged Fuel Gauge. From this fact, it was confirmed that the pipe was tilted upward in the tank at the bottom of the Fuel Gauge. (See Figure 3.)

3.1 Involvement of Weather	None
3.2 Involvement of Pilot	Yes
3.3 Involvement of Aircraft	Yes
3.4 Analysis of Findings	<p>(1) Fuel tank and the Fuel Gauge</p> <p>It is highly probable that the Pilot did not realize that the remaining fuel was exhausted rapidly after it was less than 7 gal (UK) because the Fuel Gauge stops indicating the remaining fuel quantity when it reads less than the minimum indicated value of 7 gal (UK) during flight, in addition, the Aircraft was not equipped with the fuel gauge capable of indicating the reduced amount of fuel up to the fuel exhaustion.</p> <p>It is probable that the fuel tank had such a structure as to cause an error between the fuel level in the tank and the indication of the Fuel Gauge when the fuel quantity was reduced close to 7 gal (UK), because the fuel tank is an integrated aluminum box with no internal partition and the pipe at the bottom of the Fuel Gauge was tilted upward in the tank.</p> <p>(2) Fuel consumption rate</p> <p>It is highly probable that during the flight plan, the Pilot judged that the fuel consumption rate was around 4 gal (UK)/h (18.18 ℓ/h) to 20 ℓ/h based on the average fuel consumption rate estimated from his past flight experience.</p> <p>It is probable that the fuel consumption rate during the first half flight was approximately 20 ℓ/h, because the Pilot was checking the remaining fuel quantity with the Fuel Gauge.</p> <p>According to the statement of the Pilot and the records of a portable GPS receiver, the Aircraft was repeatedly climbing and descending at an average ground speed of about 100 kt in strong headwind after climbing; and from the analysis of Pilot's smartphone video images, the number of engine revolutions per minute in both of climbing and descending was almost constant at a speed of 3,150 rpm, and the Aircraft continued flying in a higher power status than the target values (2,850 to 2,950 rpm at cruising and 2,950 to 3,050 rpm at descending) that the Pilot used; and therefore, it is somewhat likely that the fuel consumption rate during the latter half flight was higher than what the Pilot was thinking.</p> <p>(3) Rapid decrease in fuel during the latter half flight</p> <p>Judging from the fact that there was no remaining fuel in the fuel tank, no trace of fuel leakage nor a smell of gasoline fumes, when the Aircraft made a forced landing and was destroyed, it is probable that the amount of fuel equivalent to 20 ℓ was rapidly reduced during the five minutes from around 15:45 when gasoline fumes were smelled to the timing when the engine stopped, or during the latter half flight; and it is somewhat likely that this might be caused by a significant fuel leakage. However, as described in 2.8 (3), it was impossible to identify the location and cause of the fuel leakage, since</p>

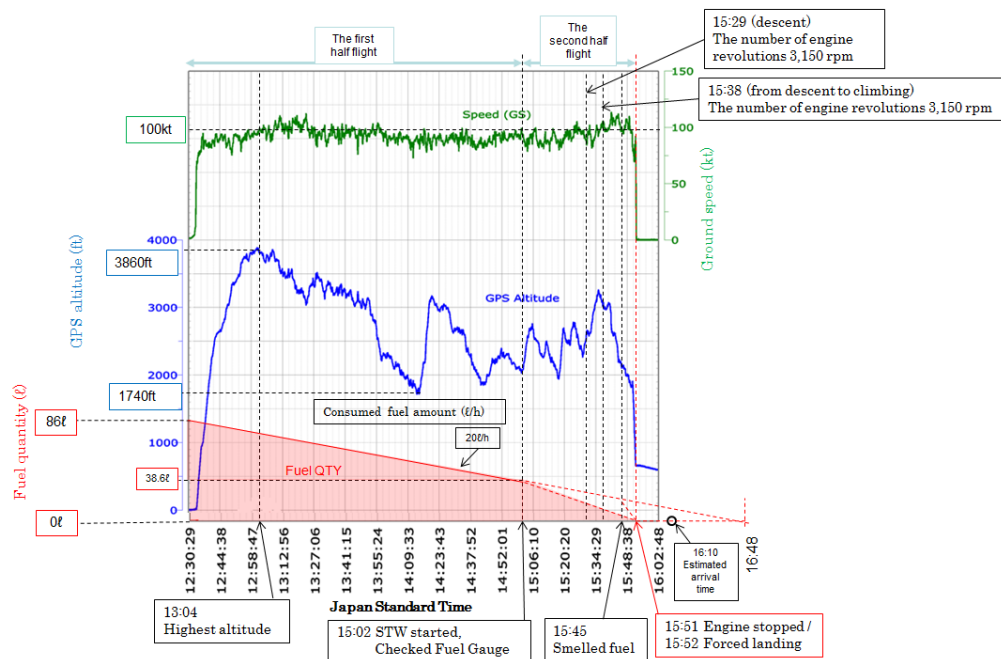
Figure 4: Estimated fuel quantity, ground speed and GPS altitude

According to the Pilot, the fuel consumption rate of the Aircraft was approximately 20 l/h during the first half flight. At 15:02, the Pilot confirmed the remaining fuel quantity to be 8.5 gal (UK); when converting the remaining fuel quantity of 8.5 gal (UK) into approximately 38.6 l and considering that the engine stopped after about 50 minutes and the remaining fuel quantity was 0 l, the simple mean average of the fuel consumption rate during the latter half flight was calculated to be 46.5 l/h,

Figure 4 shows the estimated fuel quantity, the ground speed and the GPS altitude based on the records of a portable GPS receiver.
