**AIRCRAFT SERIOUS INCIDENT
INVESTIGATION REPORT**

KOREAN AIR LINES CO.,LTD.(REPUBLIC OF KOREA)

BOEING 737-900

AKITA AIRPORT, JAPAN

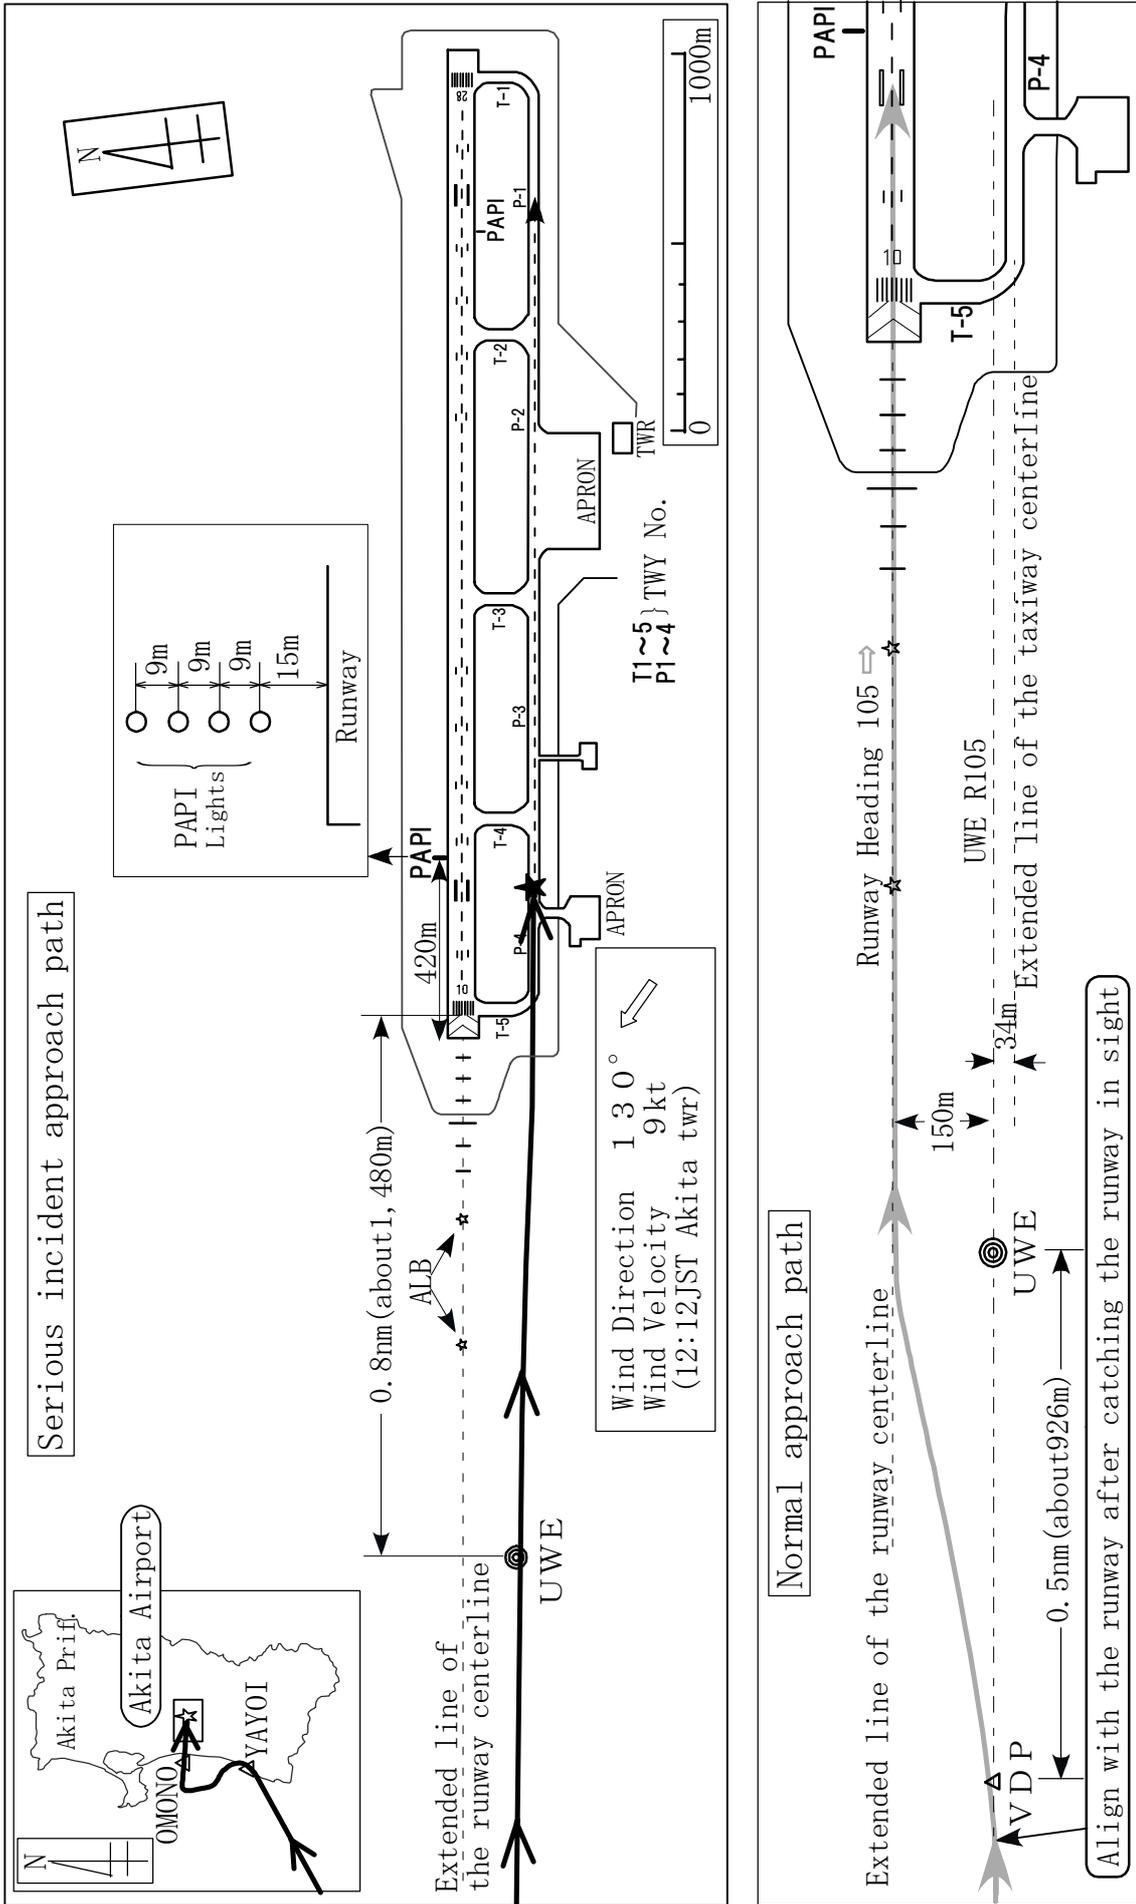
Figure 1 Estimated Flight Path

It is estimated that this serious incident was caused by that the captain and the first officer made a landing by misidentifying the parallel taxiway for the runway.

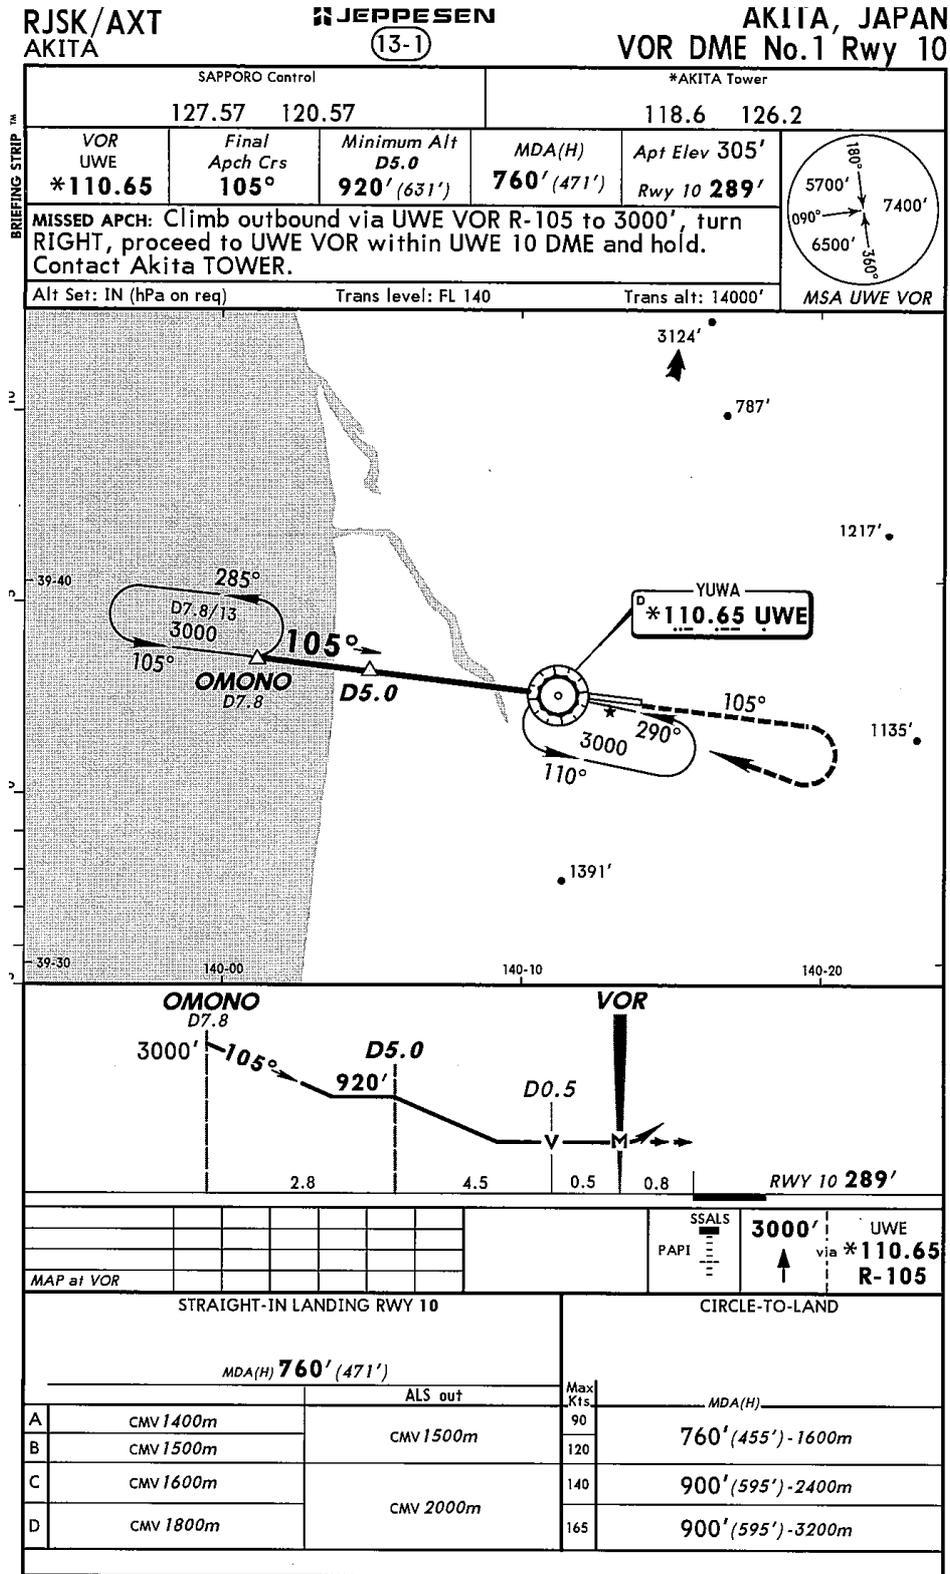
Figure 2 VOR/DME No.1 Rwy 10 Approach Chart

UWE used in VOR No.1 approach is located 0.8nm west of Runway 10 threshold, and offset to the south of the extended centerline of the runway. Therefore, approaching aircraft make a sidestep into the runway when they come close to UWE, or they fly towards the runway from early stage, and which way to choose depends on each pilot.

to be published as “a straight in approach” under the condition that the relative position between the final approach course and the extended runway center line meets certain ICAO standard, and that the approach procedure under the other condition to be published as “a circling approach”. There are no definitions in ICAO standard to require the description on the relative position between the final approach course and the extended runway center line for the publication on both of “straight-in approach” and “circling approach”. “The Design Criteria for flight procedure” of JCAB was established based on the same ICAO standard and the description on the relative position between the extended line of the final approach course and the extended runway center line was not added to the publication on VOR No.1 Approach.

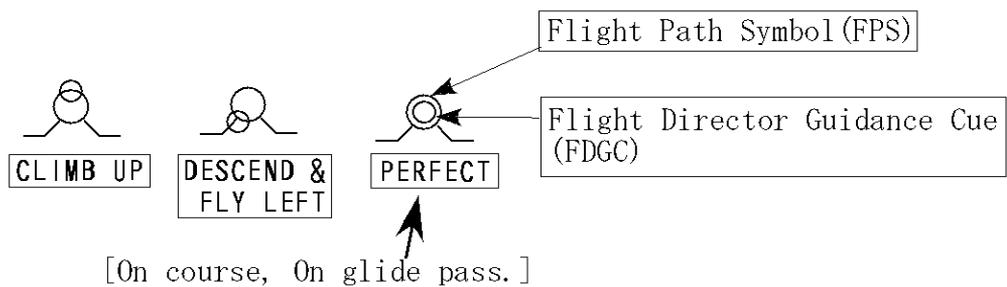
3 Flight Path Symbol & Flight Director Guidance Cue

Lateral movement of FPS is limited on the display. In such case, FPS is displayed in ghost that is, indication is changed from solid line to broken line. Under such conditions, the FPS does not mean the actual flight vector. In PRI mode, the FPS is displayed in ghost when it is more than about 7.3° apart laterally from the heading.

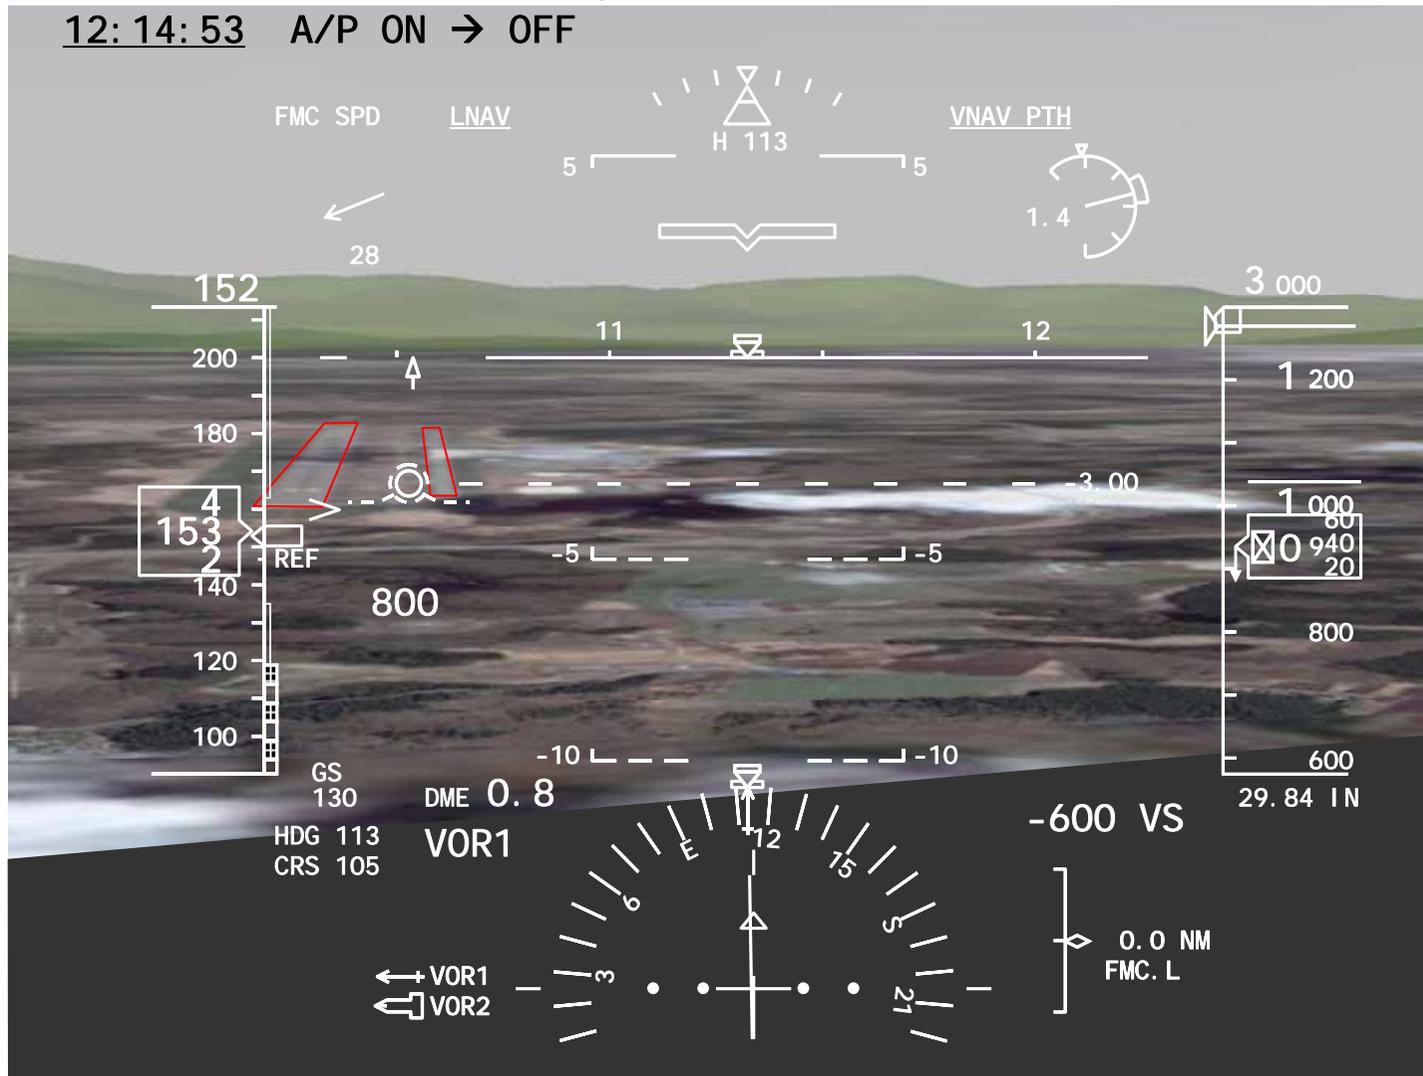
Attachment 3 Runway View and HUD Indication Example

It is considered that the captain entered touchdown maneuver, focusing his attention to align the FPS on the centerline of the taxiway, and it is considered that he failed to recognize that the centerline of the taxiway is a fine continuous line, that there were no touchdown zone markings, and so on, thereby he was unable to reach judgment that it was not a runway.

12:14:53 A/P ON → OFF

Drift Angle : -7.6deg, Heading : 113.2deg
