**AIRCRAFT ACCIDENT
INVESTIGATION REPORT**

**KOREAN AIR LINES CO., LTD.
H L 7 7 2 5**

DAMAGE ON LOWER AFT FUSELAGE
DUE TO TAIL STRIKE DURING GO-AROUND
KOREAN AIR LINES CO., LTD.
BOEING 737-900, HL7725
ON RUNWAY 06L AT KANSAI INTERNATIONAL AIRPORT
AT AROUND 21:33 JST, APRIL 09, 2018

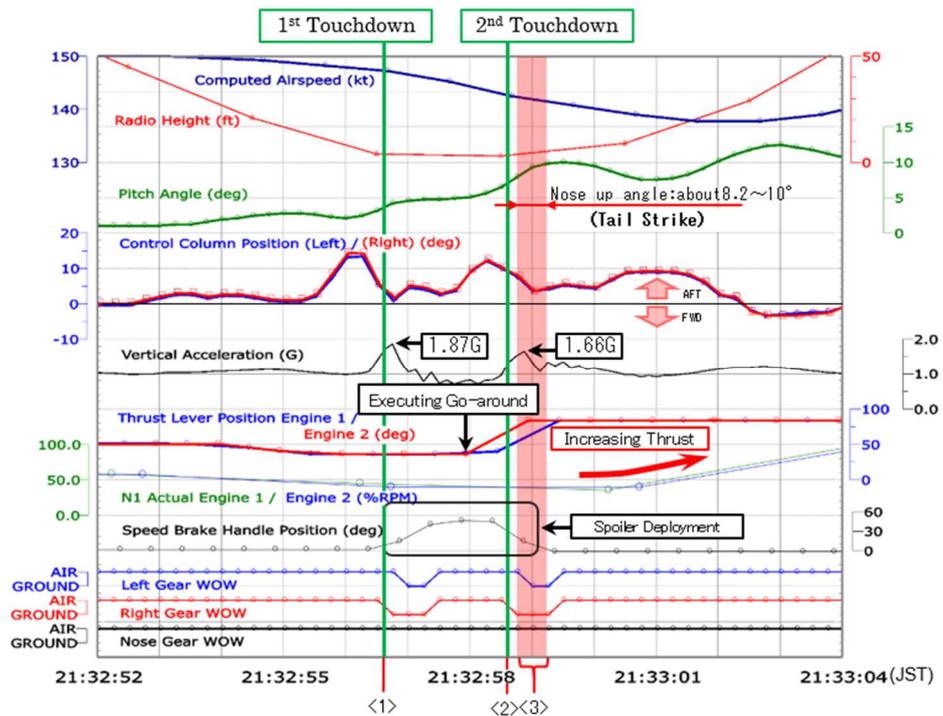
Figure 2 ; FDR Data

At around 21:32:57, the right main landing gear of the aircraft touched down at pitch angle of about 3.5 ° (Fig. 2 <1>), and all spoilers began to deploy when the auto speed brake was activated. Subsequently, after the left main landing gear had touched down, the aircraft bounced. The maximum vertical acceleration recorded in the FDR during this period was 1.87 G.

Both the POM and the FCTM prescribe that the lower aft fuselage contacts the ground at a pitch angle of 8.2 ° or greater at the moment of the touchdown. The FDR records indicate that the pitch angle varied from approximately 7° to approximately 10° during the time from a second touchdown of the right main gear after initiating the go-around to the lifting off. During this period, it is highly probable that the lower aft fuselage of the Aircraft was damaged with contacting the runway because its pitch angle became too high exceeding 8.2 °.

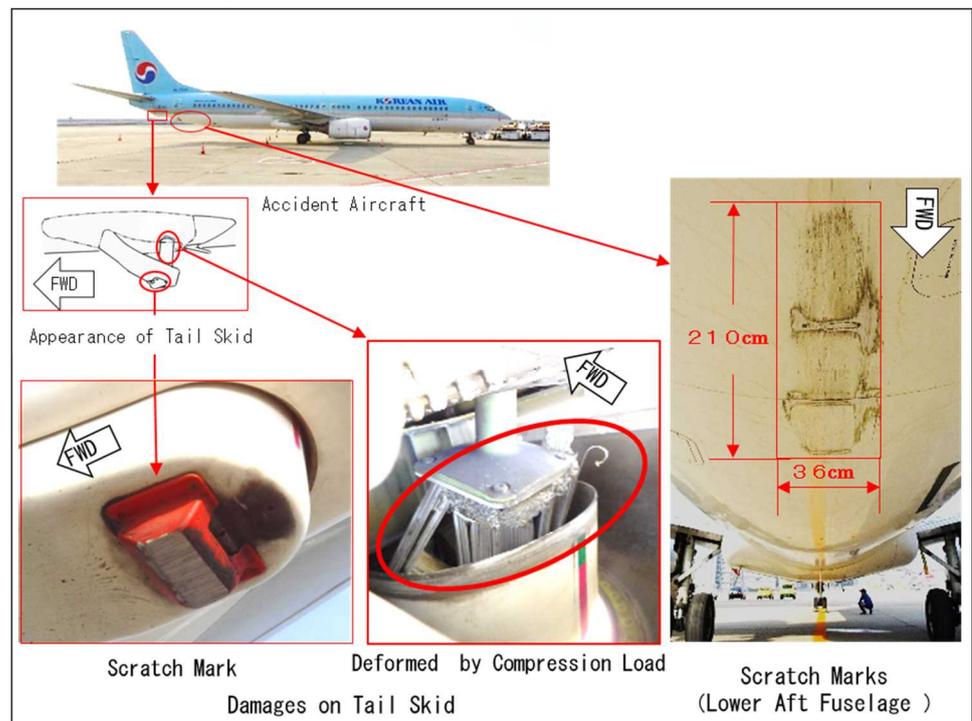
Figure 3 ; Damages on the Aircraft

<p>2.2 Damage to the Aircraft</p>	<p>Substantial damage (1) Lower aft fuselage: Scratch marks (2) Tail Skid*2: Damaged (see Figure3)</p>
<p>2.3 Personnel Information</p>	<p>(1) PIC Male, Age 45 Airline transport pilot certificate(Airplane) January 26, 2011</p>

Scratch marks approximately 210 cm in length and approximately 36 cm in the maximum width were found on the skin of the lower aft fuselage including cracks.

In addition, the tail skid was broken.

In this accident, it is highly probable that the lower aft fuselage of the aircraft was damaged with contacting the runway because its pitch angle became too high during the go-around following the bounce at the time of the landing.

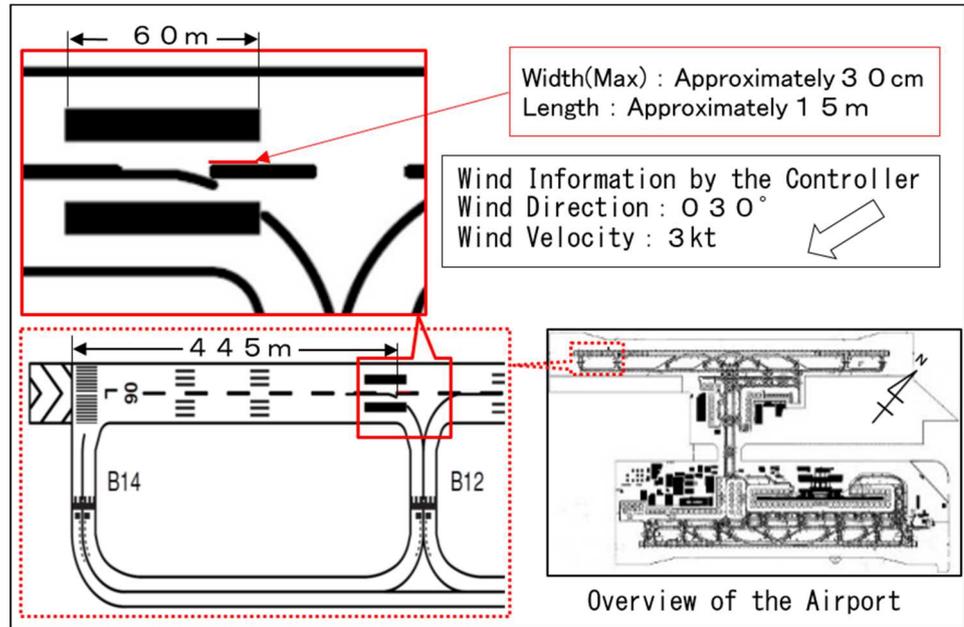
Figure 4 ; Accident Site

On-site investigation found the scratch marks approximately 15 m in length and approximately 30 cm in the maximum width on a location about 445 m beyond the threshold of runway 06L.

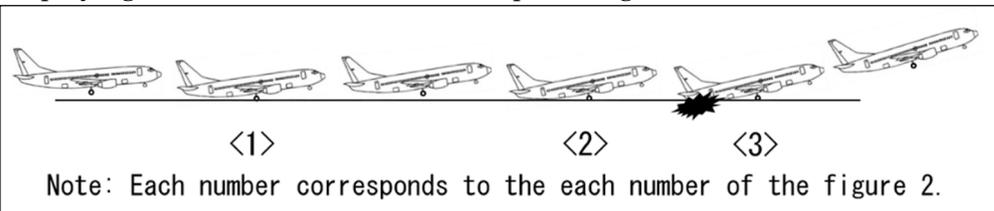
Figure 6 ; Image of Tail Strike

Moreover, it is somewhat likely that the fact that the go-around was initiated when the attitude of the Aircraft was changing by the nose up maneuver immediately before the touchdown and the spoilers were deploying contributed to the excessive pitch angle.
