**AIRCRAFT SERIOUS INCIDENT  
INVESTIGATION REPORT**

**EASTAR JET CO., LTD.  
H L 8 0 5 2**

ATTEMPT OF LANDING ON A RUNWAY  
WHERE A VEHICLE EXISTS  
EASTAR JET CO., LTD.  
BOEING 737-800, HL8052  
ABOUT 0.2 NM SOUTHWEST FROM THE SOUTH END OF  
RUNWAY 03R  
AT HYAKURI AIRFIELD, IBARAKI PREFECTURE, JAPAN  
AROUND 16:17 JST, AUGUST 22, 2019

March 5, 2021

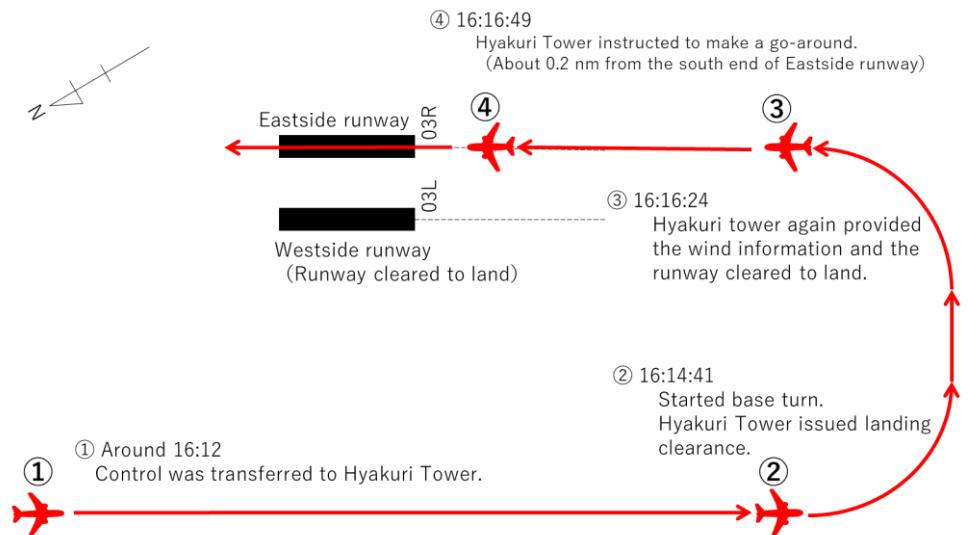
Figure 1: Flight status after control was transferred to Hyakuri Tower

The Aircraft started to descend from cruising flight. After entering the Hyakuri approach control area, the Aircraft was informed that a visual approach<sup>\*5</sup> for runway 03L would be expected at Hyakuri Airfield, and flew while receiving radar vectoring from Hyakuri Approach. Both of the Captain and the FO visually confirmed the Airfield and the two runways at the position of about 5 nm (about 9.3 km) north-northwest of the Airfield, and reported it to Hyakuri Approach accordingly. Upon receiving this report, Hyakuri Approach issued clearance to the Aircraft for a visual approach to the Westside runway, and instructed the Aircraft to change to the Hyakuri Tower frequency around 16:12 (position ① in Figure 1).

After the Aircraft was transferred to Hyakuri Tower, the flight crew reconfirmed visual approach procedure, and entered the downwind leg on the west side of the Airfield. At 16:14:41, when the Aircraft started a turn to the base leg (hereinafter referred to as “Base turn”), it was cleared to land on the Westside runway (position ② in Figure 1). During the Base turn, the aircraft was set its flaps to landing position in order to prepare to descend for the final approach, and after making pre-landing checks according to the landing check list, the Aircraft started a turn onto the final approach course (hereinafter referred to as “Final turn”).

When completing the Final turn (at an altitude of about 700 ft), the Captain thought the white runway (Eastside runway) in front of him was the runway cleared to land, then he disconnected autopilot (HDG SEL mode<sup>\*6</sup> and V/S mode<sup>\*7</sup>) and manually controlled the aircraft, and focused on stabilizing the Aircraft’s attitude, the flight speed and the descent rate in order to maintain a stabilized approach<sup>\*8</sup> while continuing to approach the white runway. During this time, the FO was concentrating on

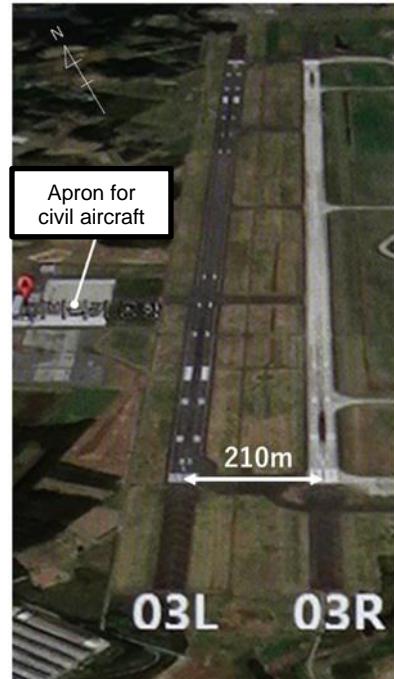
Figure 2: Hyakuri Airfield Runways  
(Source: Eastar Jet Co., Ltd.)

<p>There were no conditions, such as flight experience and others, attached to the PIC*<sup>9</sup> flying to Hyakuri Airfield.</p> <p>(3) Hyakuri Airfield runways</p> <p>The two runways at Hyakuri Airfield are paved with different materials, the runway paved with concrete is the white colored Eastside runway which is for the self-defense force aircraft.</p> <p>On the other hand, the other runway paved with asphalt is the charcoal colored Westside runway which is for civil aircraft (See Figure 2).</p> <p>(4) Cases of Misidentification of runways occurred at Hyakuri Airfield</p> <p>As the cases where the pilots of civil aircraft misidentified the runways at Hyakuri Airfield, the case was occurred on April 22, 2012, in which a scheduled flight landed on the runway different from the one instructed by air traffic controller. The other was a serious incident occurred on September 20, 2014, in which a pilot of a small aircraft conducting a sightseeing flight misidentified the Eastside runway as a permitted runway and attempted a landing.</p>
