AA2021-3

**AIRCRAFT ACCIDENT
INVESTIGATION REPORT**

**JIN AIR CO., LTD.
HL 8243**

**CABIN CREW MEMBER INJURY
BY THE SHAKING OF THE AIRCRAFT
JIN AIR CO., LTD.
BOEING 737-800, HL8243
AT FL 250 ABOUT 30 KM NORTHWEST OF
FUKUOKA AIRPORT, JAPAN
AROUND 13:17 JST, JANUARY 12, 2020**

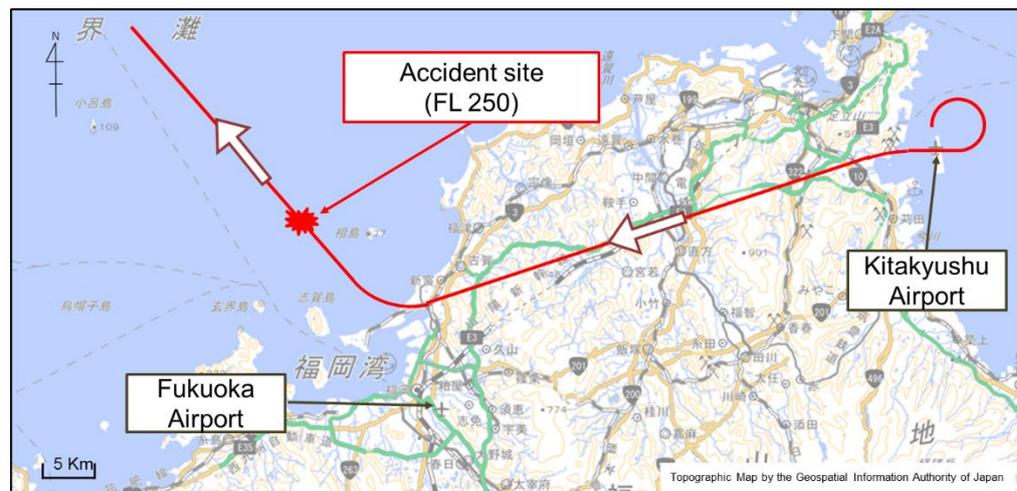
Figure 1: Estimated flight route

This accident occurred on January 12, 2020 around 13:17, at FL 250 about 30 km northwest of Fukuoka Airport (33° 48' 08" N, 130° 16' 21" E).

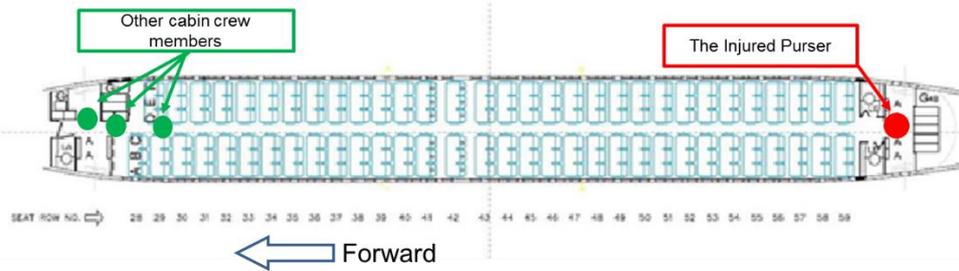
Figure 2: Layout of cabin crew members' positions immediately before the accident
(Added to the figure provided by Aviation and Railway Accident Investigation Board, Republic of Korea)

When this shaking occurred, the Purser in the center of the aft galley was standing facing forward of the cabin, but fell down to the right not being able to support herself. Afterward, being seated in her seat located near the aft galley, the Purser confirmed that she had pain in her right ankle and suffered abrasions. Following the initial shaking, smaller shakings continued. The Aircraft ceased to be shaken after reaching FL 270, and it reported to Fukuoka Air Traffic Control that they encountered turbulence. Besides, the Aircraft was using the autopilot system from the initial climb after taking off from Kitakyushu Airport until it encountered a shaking and it subsided. Furthermore, when the Aircraft encountered turbulence, the auto pilot system remained engaged.

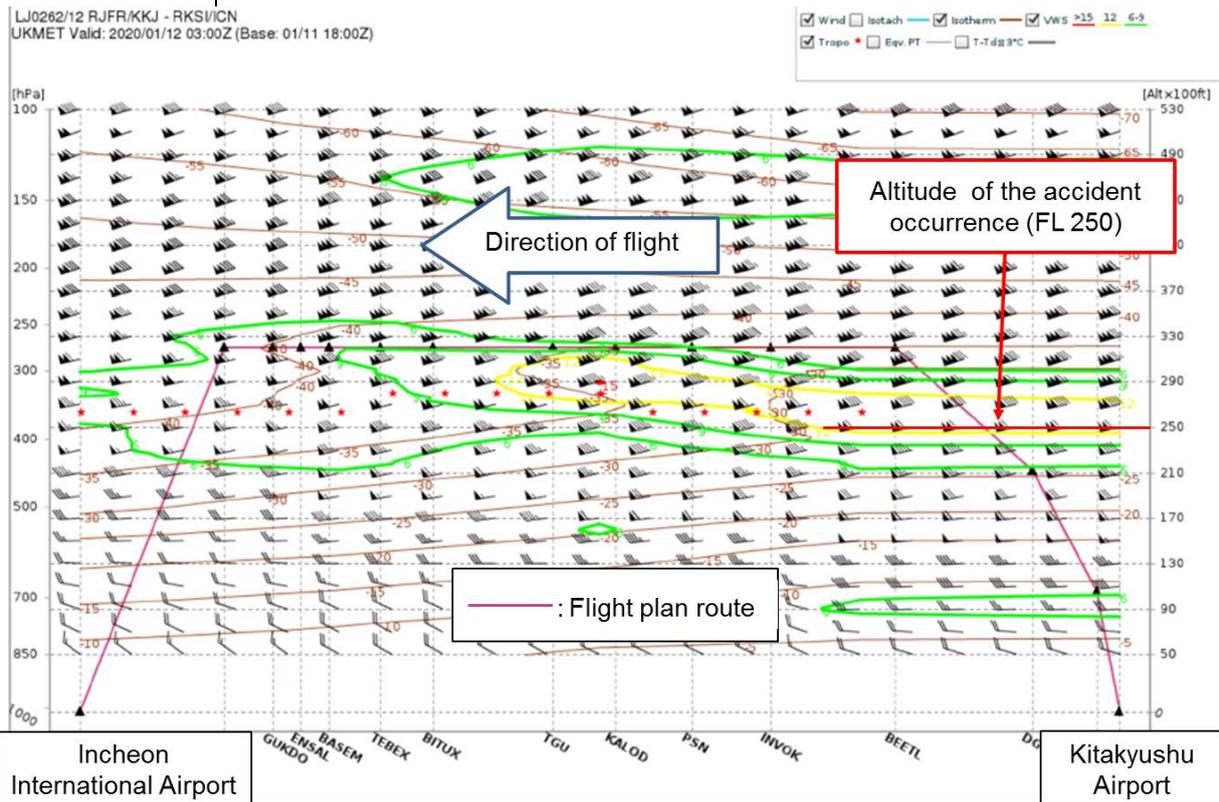
Figure 3: Upper layer wind forecast chart checked prior to the departure from Kitakyushu Airport
(Added to the chart provided by Jin Air)

In the upper layer wind forecast chart (the forecast at 12:00 on the accident day based on the data at 03:00 on January 12, 2020) which the flight crew members checked prior to the departure from Kitakyushu Airport (See Figure 3), the area enclosed with the green solid line indicate the airspace of Vertical Wind Shear*⁴ (VWS) of 6 to 12 kt/1,000 ft, and the other area enclosed with the yellow solid line indicate the airspace of VWS of 12 to 15 kt/1,000 ft. Generally, VWS in excess of 10 kt/1,000 ft can cause moderate turbulence and VWS in excess of 15 kt/1,000 ft can cause severe turbulence in the aircraft.

Upper layer wind forecast chart indicated that VWS was 12 to 15 kt/1,000 ft at between FL 240 and FL 270 during the climb on the flight plan route of the accident day.

It is desirable for flight crew members to make decisions on the operation of seat belt sign from a safer side, by the information obtained from pre-flight meteorological data.

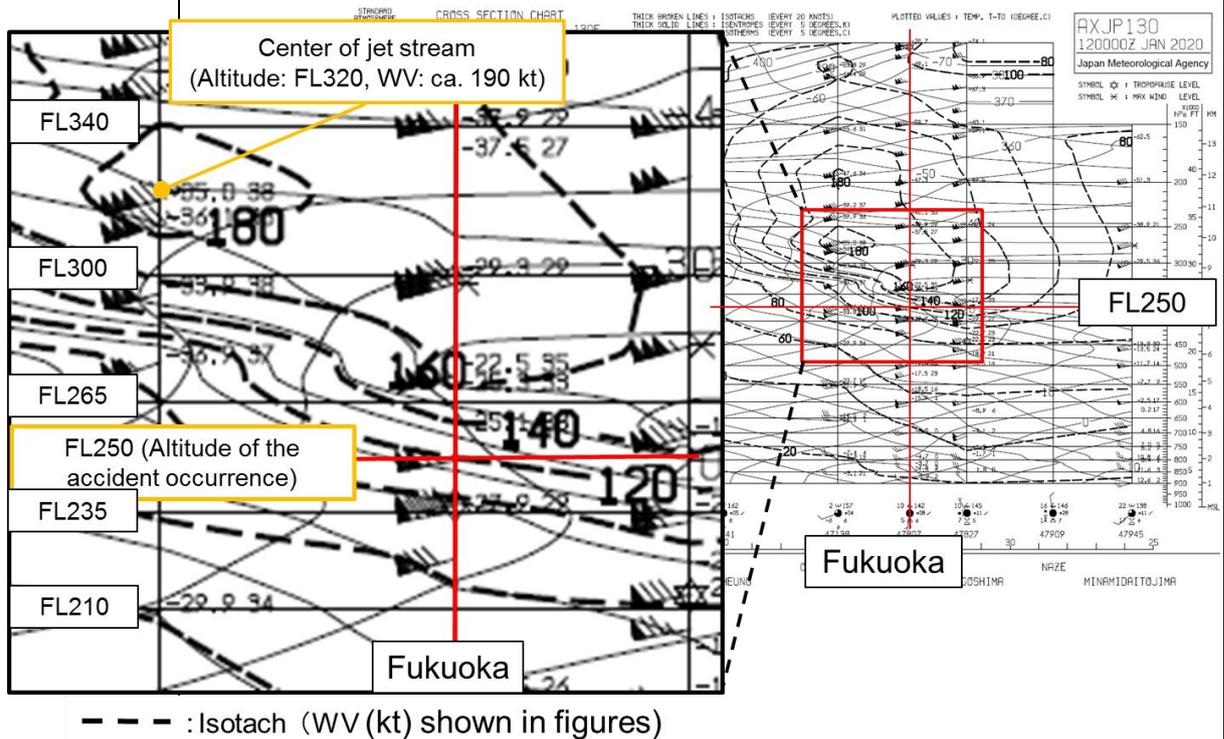
Figure 4: Cross section chart (AXJP130)
 (at 09:00 on January 12, 2020)

According to cross section chart (AXJP130) (Figure 4) at 09:00 on January 12, 2020, it was analyzed that there was the center of jet stream near FL 320 north of Fukuoka, and that at an altitude higher than FL 240 over Fukuoka, there was fluctuation such that the wind velocity increased 20 kt for every 1,000 ft rise in altitude.

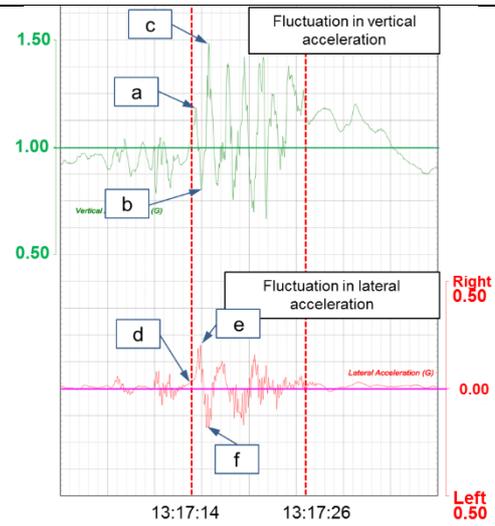
Figure 5: Fluctuation in acceleration

After the vertical acceleration (calm wind conditions in level flight: 1 G) decreased from 1.19 G (a in Figure) to 0.8 G (b in Figure) between 13:17:14 and 13:17:15, it increased up to 1.49 G (c in Figure) between 13:17:15 and 13:17:16. After that, until 13:17:26, it repeated fluctuating little by little.

In addition, after the lateral acceleration (calm wind conditions in level flight: 0 G) fluctuated from right 0.02 G (d in Figure) to right 0.2 G (e in Figure) between 13:17:14 and 13:17:15, it fluctuated to left 0.18 G (f in Figure) between 13:17:15 and 13:17:16, and it gradually stopped to

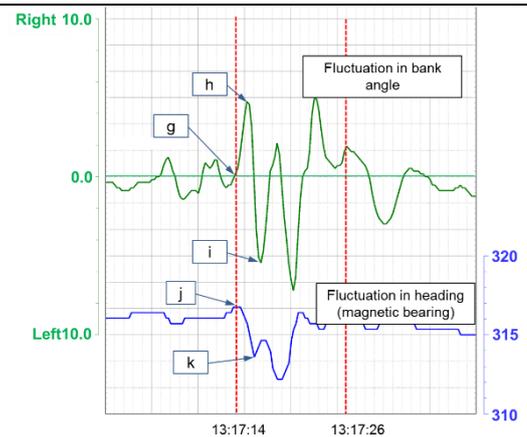
Figure 6: Fluctuation in flight attitude

After the bank angle fluctuated from around 0 degree (level) (g in Figure) to right 4.7° (h in Figure) between 13:17:14 and 13:17:15, it fluctuated to left 5.5 ° (i in Figure) between 13:17:15 and 13:17:17.

The heading of the Aircraft (magnetic bearing) fluctuated from 317 ° (j in Figure) to 314° (k in Figure) between 13:17:15 and 13:17:16.

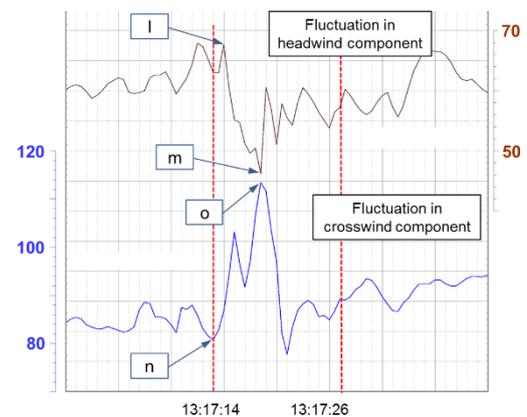
Figure 7: Wind fluctuation

The headwind component decreased from 68 kt (l in Figure) to 44 kt (m in Figure), and the crosswind component from the left direction increased from 82 kt (n in Figure) to 114 kt (o in Figure) between 13:17:14 and 13:17:18.

During the above period, the wind velocity increased from 120 kt to 140 kt.
