**AIRCRAFT SERIOUS INCIDENT
INVESTIGATION REPORT**

**ASIANA AIRLINES INC.
H L 8 2 5 6**

**JAPAN TRANSOCEAN AIR CO., LTD.
J A 0 1 R K**

RUNWAY INCURSION 1. ASIANA AIRLINES INC. AIRBUS A321-231, HL8256 2. JAPAN TRANSOCEAN AIR CO., LTD. BOEING 737-800, JA01RK ON RUNWAY 18 AT NAHA AIRPORT AROUND 13:14 JST, JULY 21, 2019

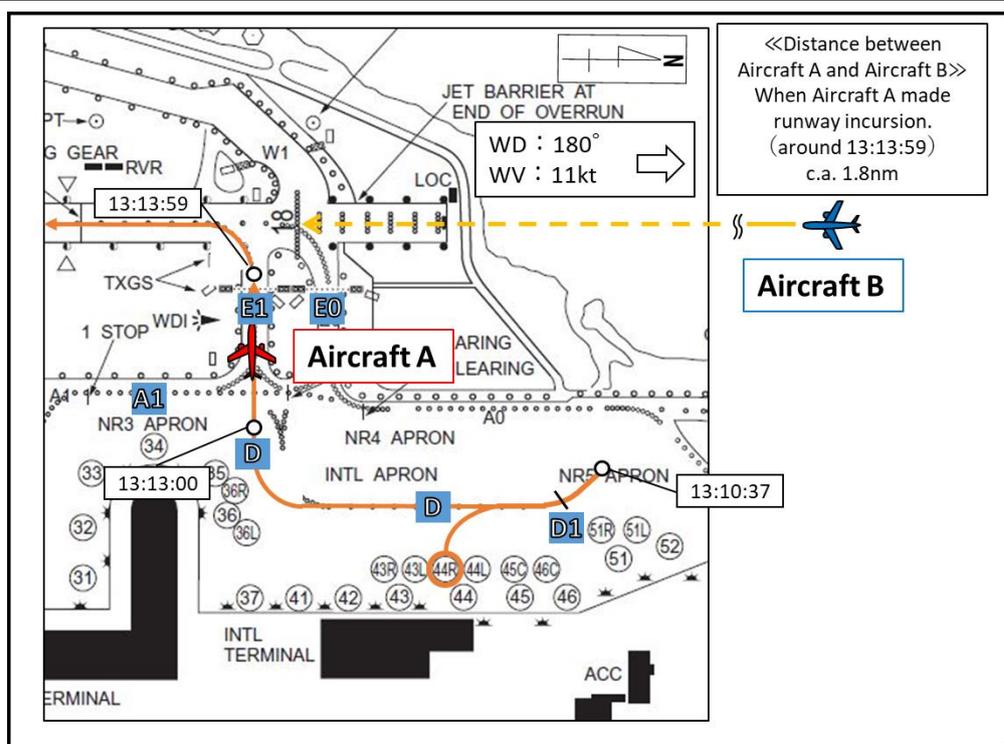
Figure 3: Estimated taxiing route

Aircraft A made incursion into Runway 18 from E1 without receiving ATC instruction (around 13:13:59)

At this time, the position of the Aircraft B was about 1.8 nm from the threshold of Runway 18 and at an altitude of about 600 ft.

The PIC A saw the final approach course when entering the runway, but was not able to find the Aircraft B. The FO A did not monitor the location of the aircraft and external environment as he was changing the setting of the FMS.

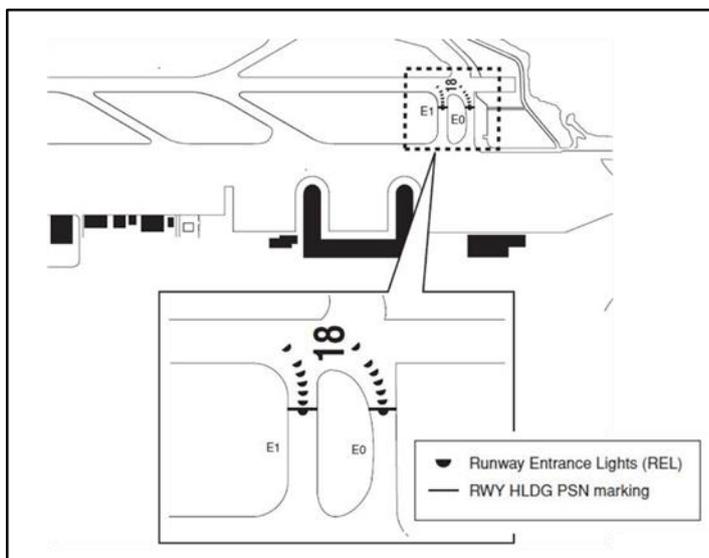
Figure 4: Runway Entrance Lights (REL)

At this time, the Runway Entrance Lights (REL) (see 2.7 (4)) turned on.

The Runway Entrance Lights (REL) are installed on the side of Runway 18 in the Airport in order to avoid runway incursions and warn an aircraft approaching the runway from the taxiway when the runway is occupied by other aircraft taking off or landing. However, Aircraft B on the final approach had not yet entered the area where RELs function, therefore, the RELs in the proximity did not turn on when Aircraft A started entering the runway.
