**AIRCRAFT ACCIDENT  
INVESTIGATION REPORT**

## AIRFRAME DAMAGE FROM LIGHTNING STRIKE

GULFSTREAM AEROSPACE G-IV, JA001G

AT ABOUT 14:35 JST, MARCH 13, 2015

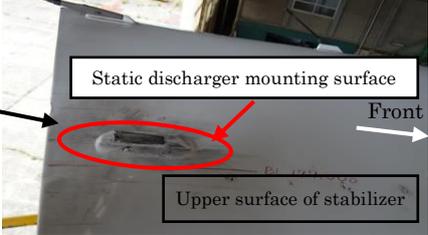
<p>or burnt (about 20 locations) No.1 DME antenna of front lower fuselage partially damaged</p> <ul style="list-style-type: none"> <li>• Tail Section: Tip of static discharger on left horizontal stabilizer lost trailing edge and end of left horizontal stabilizer damaged</li> </ul> <p>Outer skins around static discharger mounting surface of left horizontal stabilizer discolored and damaged</p> <div style="display: flex; justify-content: space-around;"> <div style="text-align: center;">

<p>Photo 2 Damage to left horizontal stabilizer</p> </div> </div> <div style="display: flex; justify-content: space-around; margin-top: 20px;"> <div style="text-align: center;">

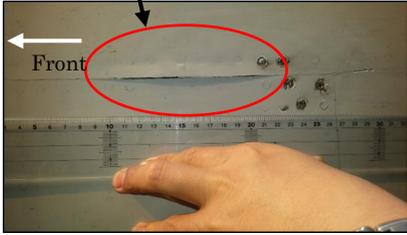
<p>Photo 3 Location of damage to outer skin of left front lower fuselage</p> </div> <div style="text-align: center;">

It is probable that this accident occurred because the aircraft sustained damage to the outer skins of its left front lower fuselage as a result of being struck by lightning to the airframe in flight.

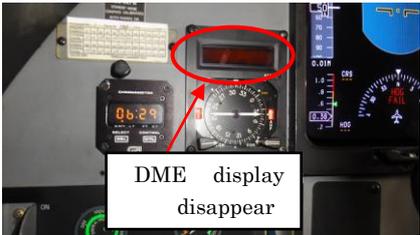
<p>Photo 4 Defect of captain's side display(airborne DME)</p> </div> </div>

the cockpit instrument display was affected by the fact that locations impacted by the lightning strike were close to the cockpit.
--	--
