AA2012-5

**AIRCRAFT ACCIDENT
INVESTIGATION REPORT**

**PRIVATELY OWNED
ROBINSON R22 BETA (ROTORCRAFT), JA007J
ROLL-OVER UPON LANDING
SABAEKOIZUMI TEMPORARY HELIPAD, KOIZUMI,
SABAE CITY, FUKUI PREFECTURE, JAPAN
AROUND 18 : 15 JST, JULY 14, 2011**

May 25, 2012

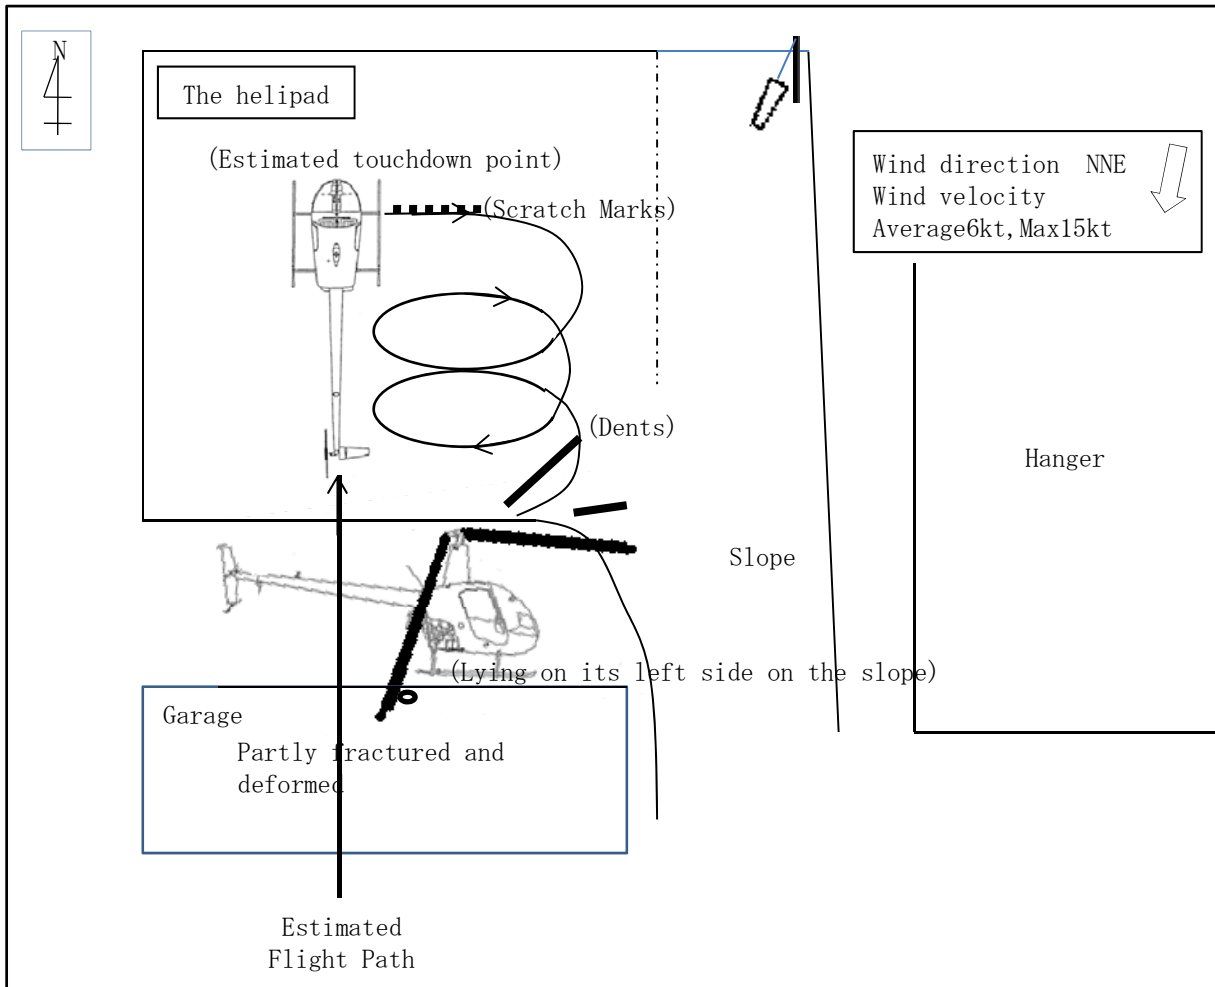
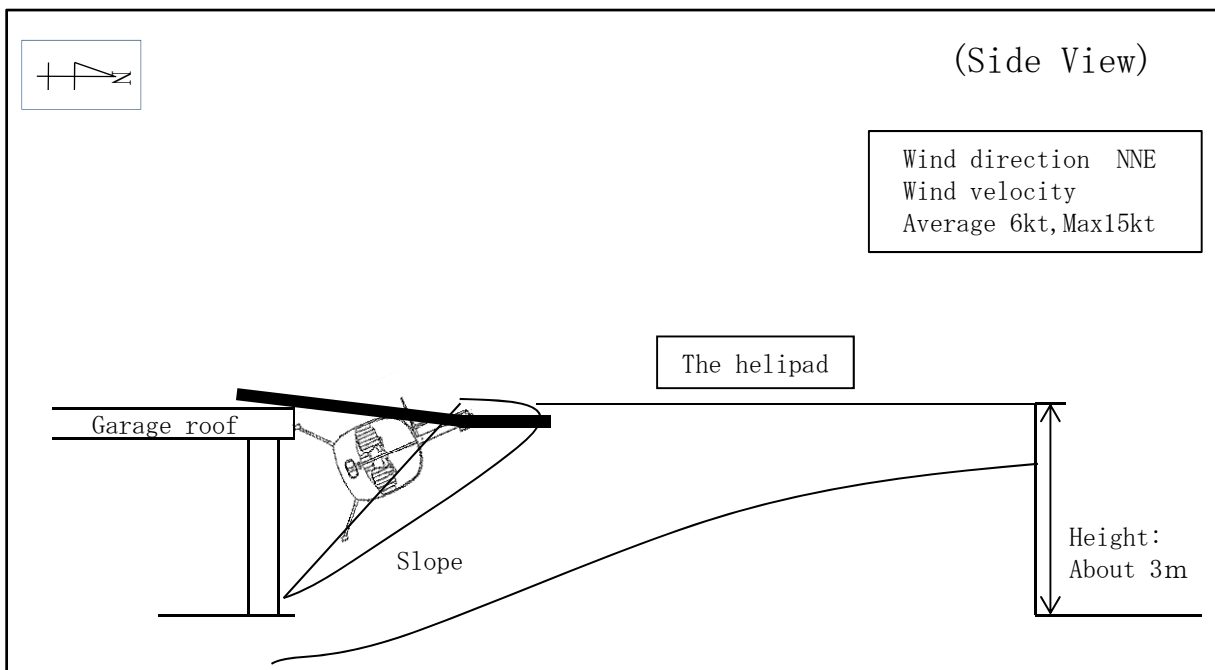
Figure 2 Accident Site

The aircraft was lying on its left side on the south slope of the helipad with its nose orienting to the east.

On the surface of the helipad were scratch marks, about 2.3 m long to the east-west direction, and three dents (almost parallel to the rotor blades). On the roof of the garage, which is about 30 cm lower than the helipad, had also traces of the accident including a fracture, depression and distortion.

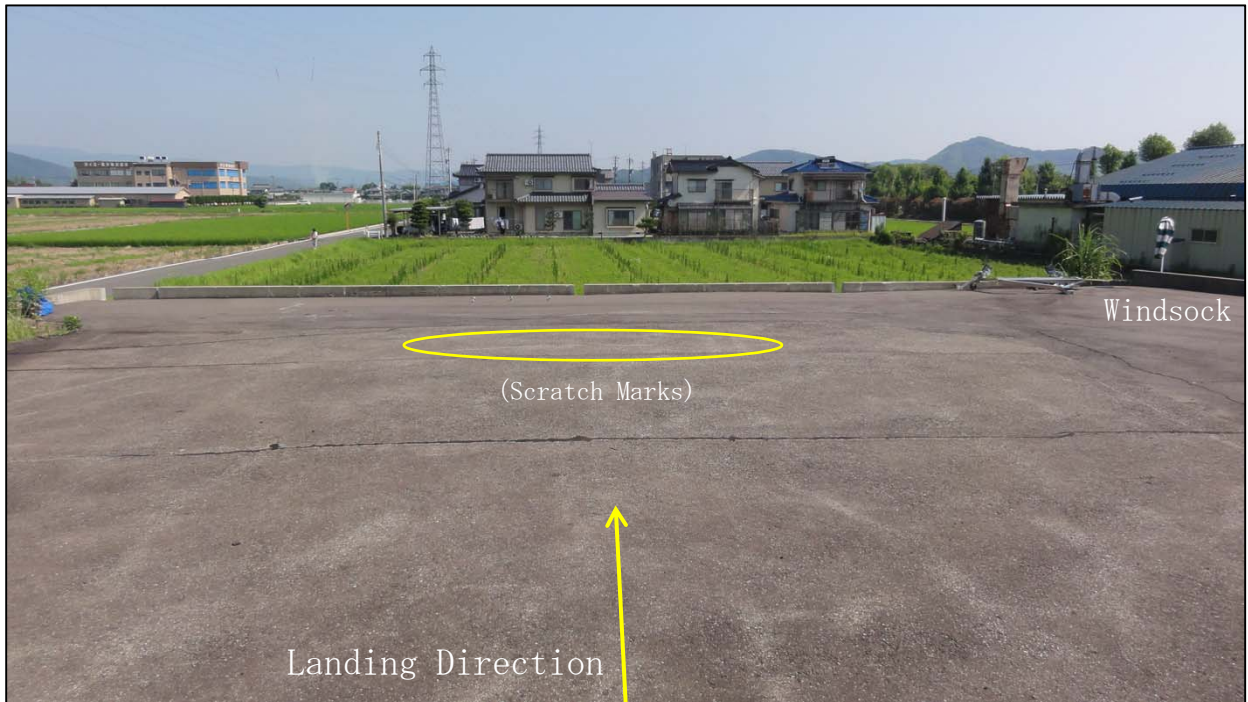
Photo 1 Accident site

(The helipad (Northward))

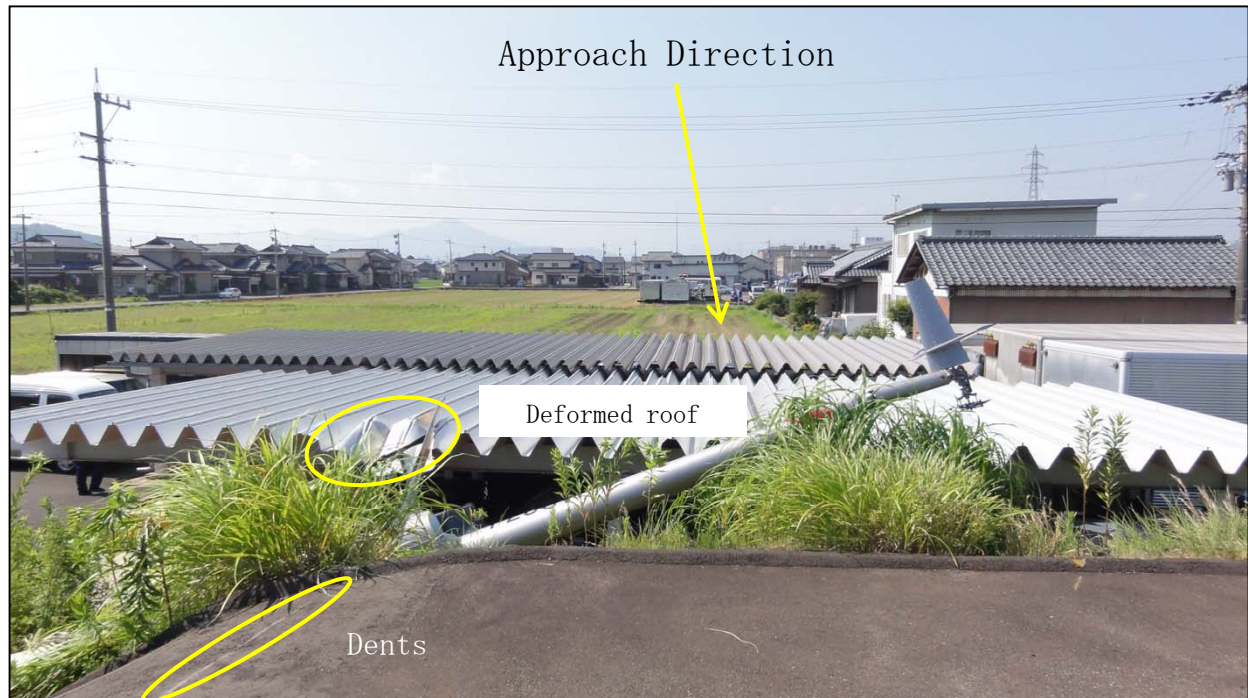
A windsock was installed on the helipad; however, it had become hardened lacking flexibility. It drooped and it was not fit to indicate accurate wind velocities.

As described in 2.7.1, the windsock installed at the helipad had become hardened and was in inadequate condition to indicate an accurate wind velocity. Therefore, it is highly probable that it was difficult to know the accurate state of the airflow at the helipad.

(The helipad (Southward))

- (2) It is imperative to know the accurate state of winds before making an approach when flying a small helicopter, which is easily affected by winds while landing. Therefore, a pilot should fly over once to check the wind condition by looking at a windsock before making a final approach to a helipad, where wind information is unavailable with radio. If the windsock, which is important for this purpose, becomes unfunctional as described in 2.7.1, it must be repaired/replaced for accurate wind indication.

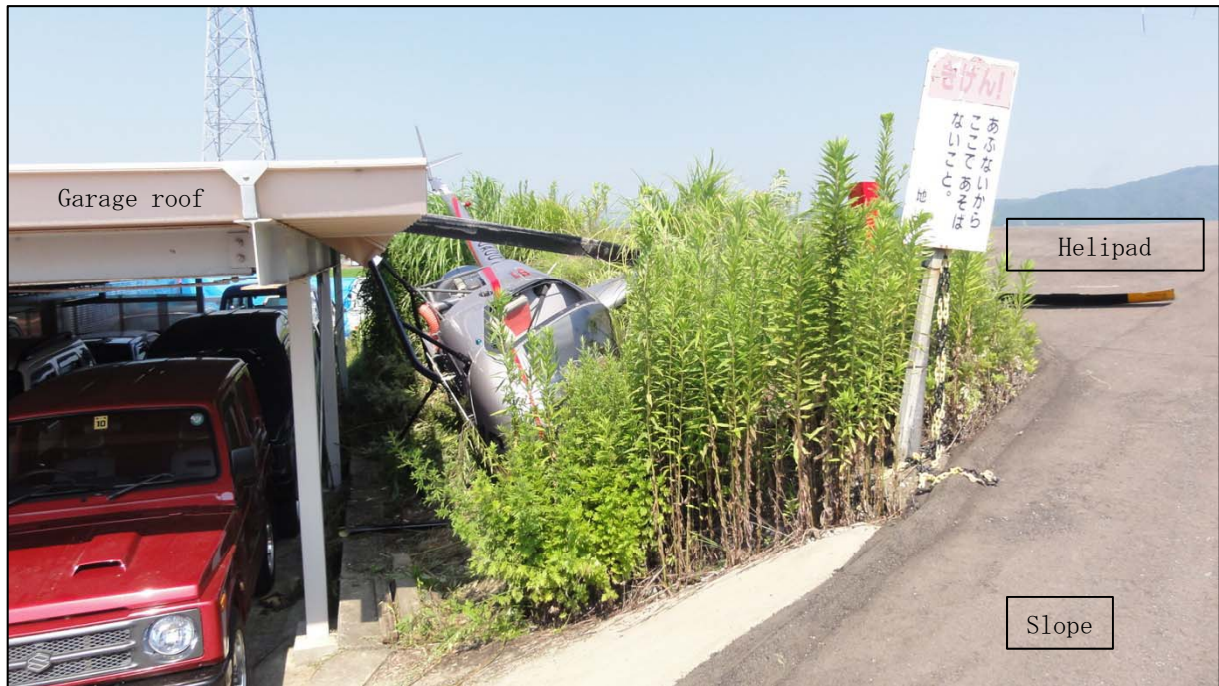
Photo 2 Accident Aircraft

- (1) Fuselage : the left side canopy and left door were broken
- (2) Landing Gears : the left skid was fractured, the right skid was cracked, and the cross tube was deformed
- (3) Rotors : the main rotor was deformed and damaged, the main rotor mast was deformed, and the tail rotor was fractured

(The Aircraft on the slope)

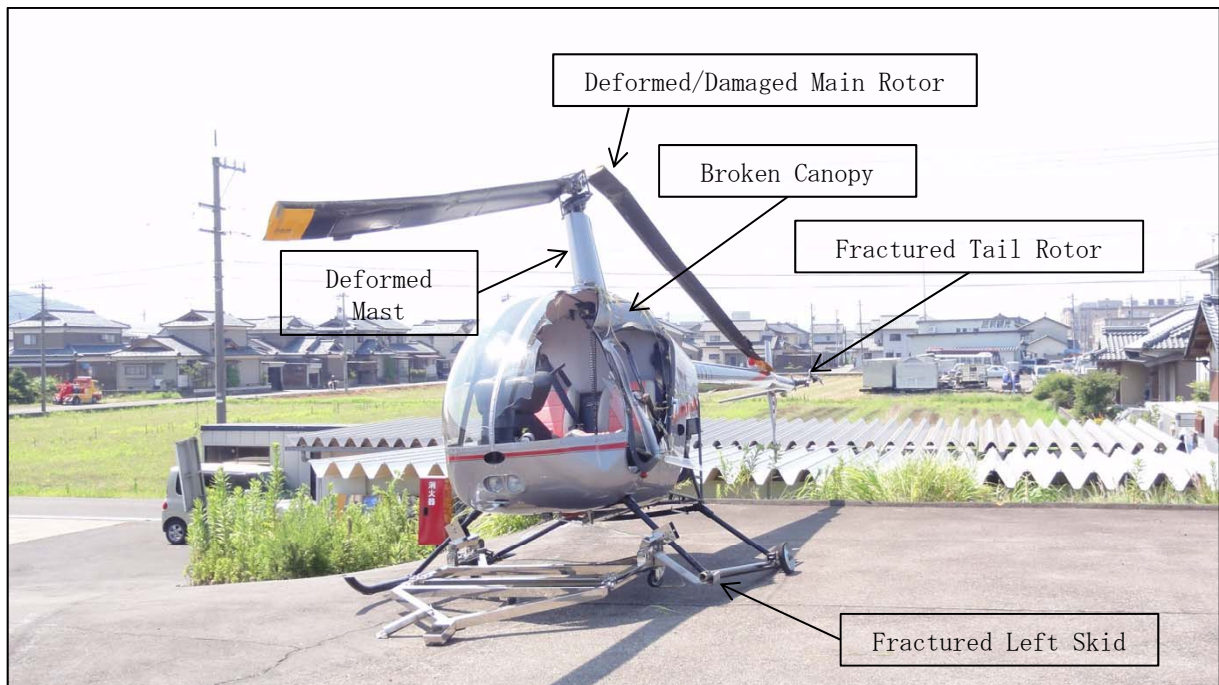
The flight control system was connected in a normal manner, but operation of the swash plate was partly restricted due to the deformed mast.

The Aircraft damage described in 2.3.2, it is highly probable that all of the damage was caused by the external force in the accident. Additionally, it is highly probable that there had been no abnormalities with the aircraft prior to the Accident judging from the PIC's statements as described in 2.1(1).

(The Aircraft placed upright on the helipad)
