**AIRCRAFT SERIOUS INCIDENT
INVESTIGATION REPORT**

NIPPON CARGO AIRLINES CO., LTD.

Japan Transport Safety Board

**NIPPON CARGO AIRLINES CO., LTD.
BOEING 747-400F, JA01KZ
ABOUT 140 FEET OVER RUNWAY A OF
NARITA INTERNATIONAL AIRPORT, JAPAN
AT ABOUT 21:54 JST, JUNE 11, 2010**

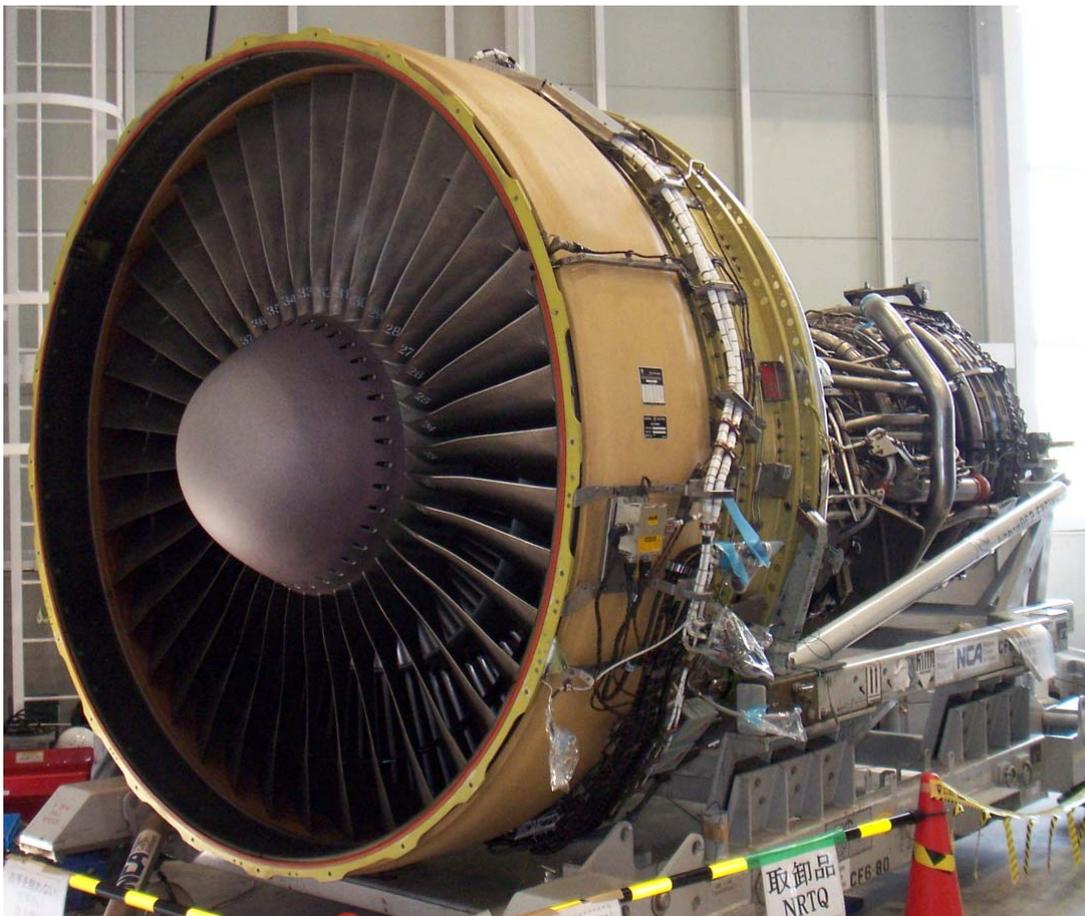
Photo 2 Dismounted No.1 Engine

The inside of No.1 engine was substantially damaged, but there was no other damage to the Aircraft.

A visual inspection and a borescope inspection (hereinafter referred to as “BSI”) revealed that damaged condition of No.1 engine was as follows:

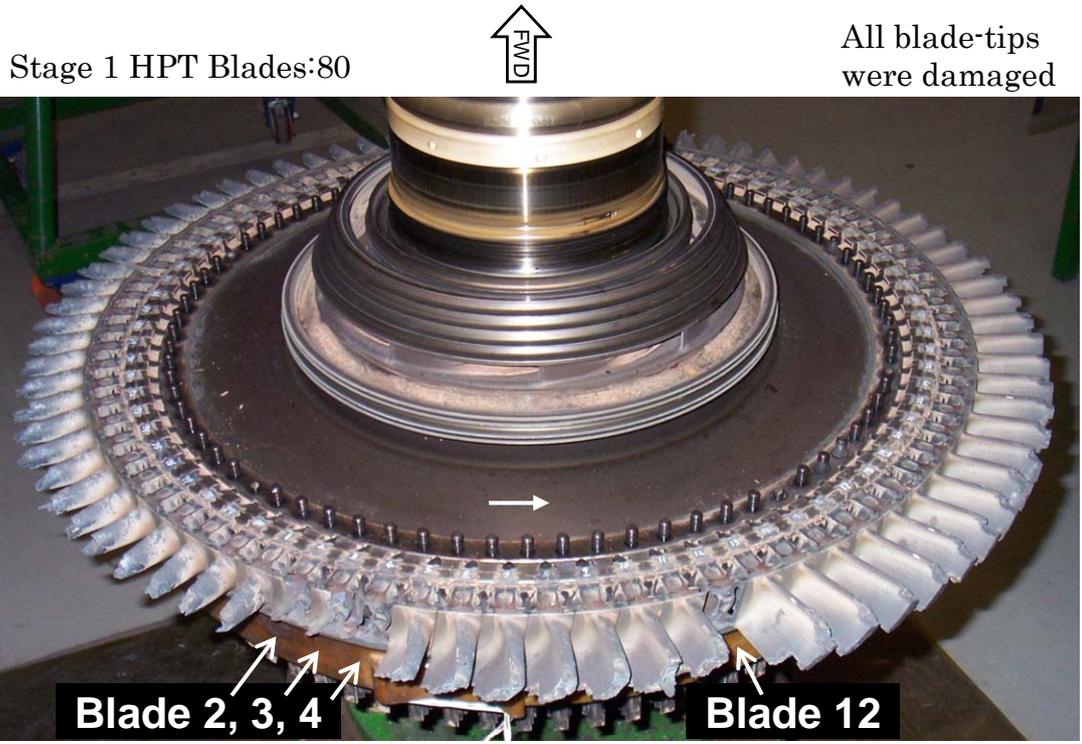
Photo 3 Stage 1 HPT Rotor

- (4) Four of the 80 stage 1 HPT blades (Blades numbered 2 to 4 and 12) had been fractured in the shank area below the platform. Other blades were damaged with the airfoils broken or lost. Three blades (numbered 5, 8 and 77), were found cracked in the shank area in the same place as the four fractured blades.

(See Photo 3 Stage 1 HPT Rotor, Photo 4 Damaged Stage 1 HPT Blades, Photo 7 Stage 1 HPT Blades with Cracks Found)

- (5) The stage 1 HPT shroud had been substantially damaged with holes made in some areas.
 (6) The stage 2 HPT vanes had been damaged and all the vane leading edges were damaged.
 (7) All of the 74 stage 2 HPT blades had been damaged with their tips lost.
 (8) In the LPT with five stages in total, the airfoils of the stage 1 to stage 3 blades had been fractured around the whole circumference at various heights. The stage 4 and stage 5 blades and the stage 1 to stage 5 vanes had been all damaged and part of them had been lost.

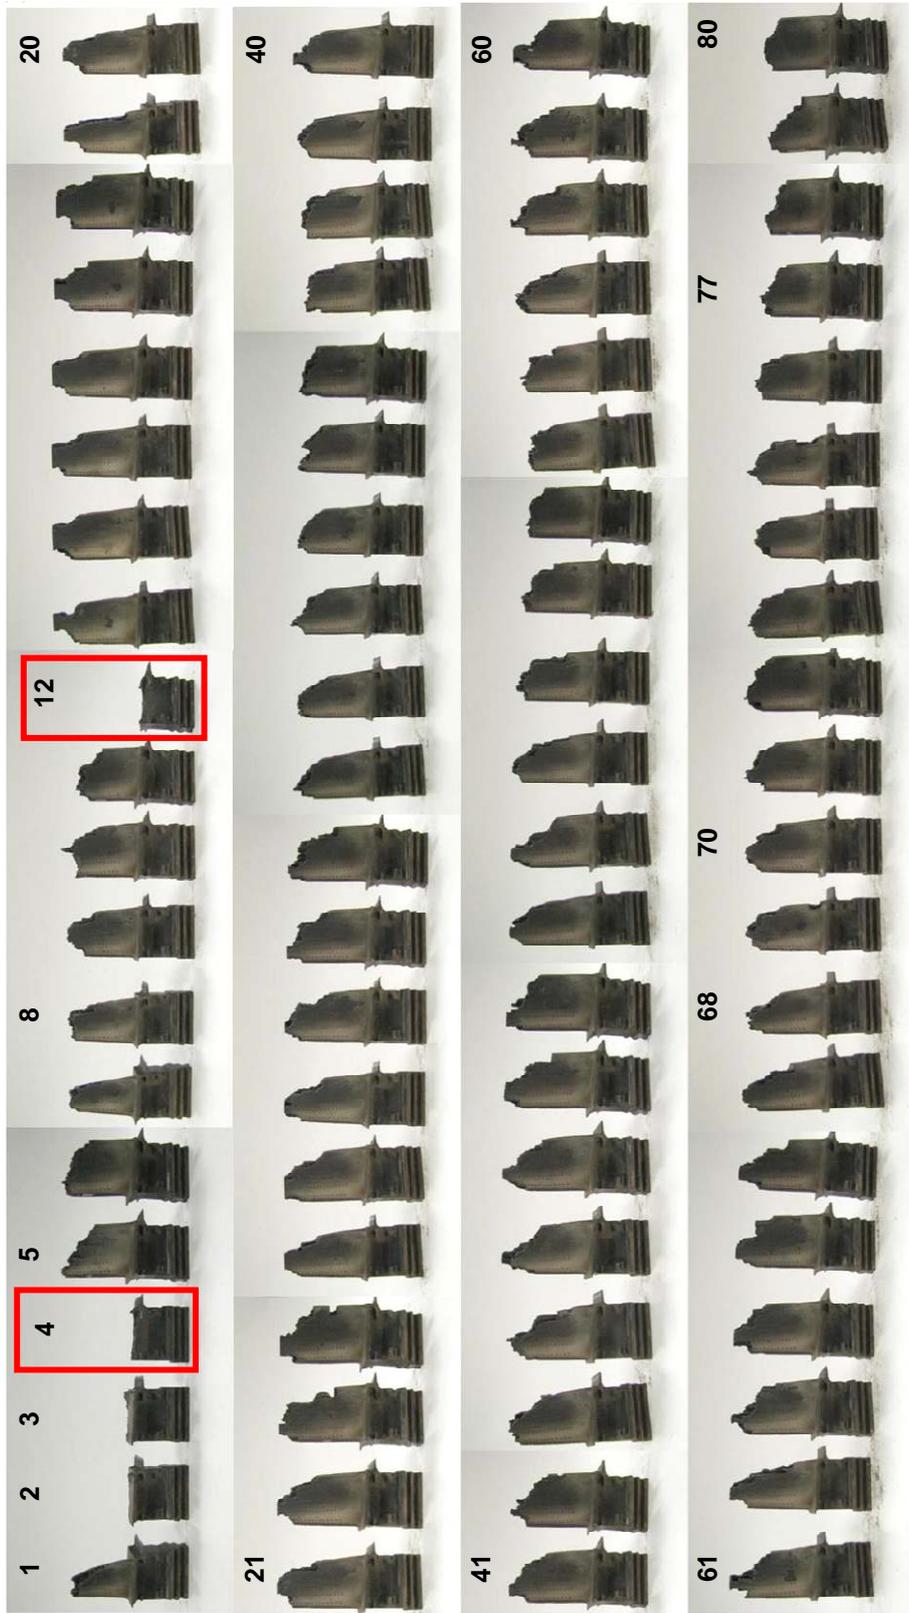
Photo 4 Damaged Stage 1 HPT Blades

Blade	Serial Number	Condition
Blade 2	PCMDHBG9	Broken
Blade 3	PCMDGUD2	Broken
Blade 4	PCMDGUB4	Broken
Blade 5	PCMDGUD7	Cracked
Blade 8	PCMDHCT0	Cracked
Blade 12	PCMDGUB3	Broken
Blade 77	PCMDGSN8	Cracked

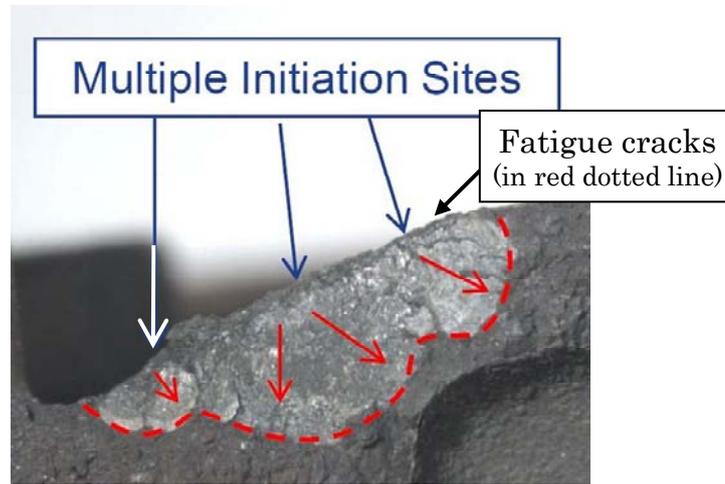
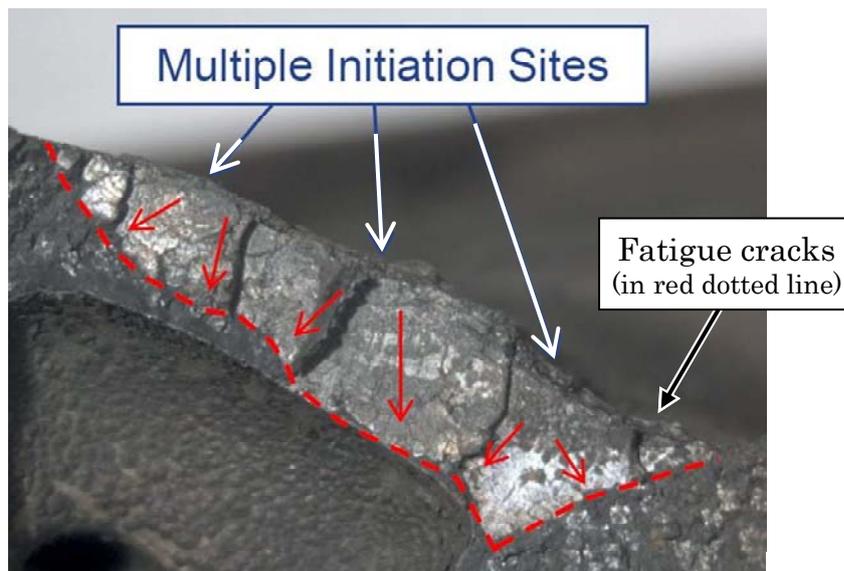
Photo 5 Fractured Portion of Blade 2 of Stage 1 HPT

- (1) Pitting (very small holes created by corrosion) was found on the convex and concave side surfaces of the shank area of all blades. Debris accumulated to the shank area included sodium, potassium and sulfates.
 (2) Fatigue cracks with multiple initiation sites were found on the convex side surface of the shank area for the four blades which had been fractured below their platforms (blade 2 to 4 and 12). The size of each crack was as follows:

Areas in these four blades with no fatigue cracks had been fractured due to tensile rupture.

(See Photo 5 Fractured Portion of Blade 2 of Stage 1 HPT, Photo 6 Fractured Blades

(4) All four fractured stage 1 HPT blades had widened fatigue cracks with multiple initiation sites. As a result, fracture occurred at the platform area due to overload. Type II hot corrosion (to be described later in 2.13.3) was found in the under platform area for all blades.

Judging from this, it is considered highly probable that pitting had been caused by type II hot corrosion occurred in the shank area below the platform of the stage 1 HPT blades and cracks occurred from there and then, fatigue cracks widened with cycle stress applied on the blades following the engine's operation, leading to the fractures of the blades.

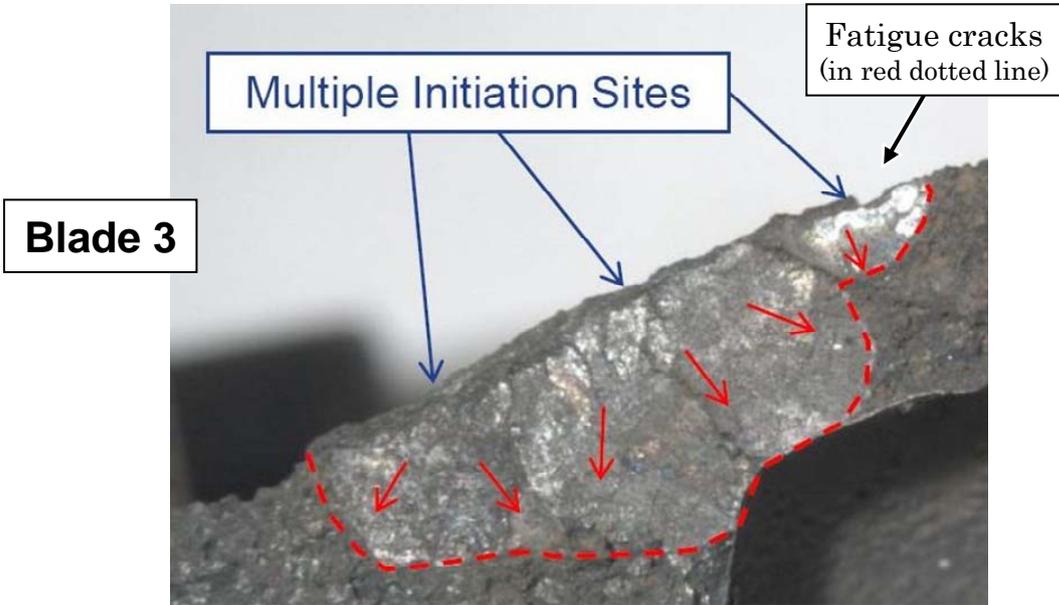
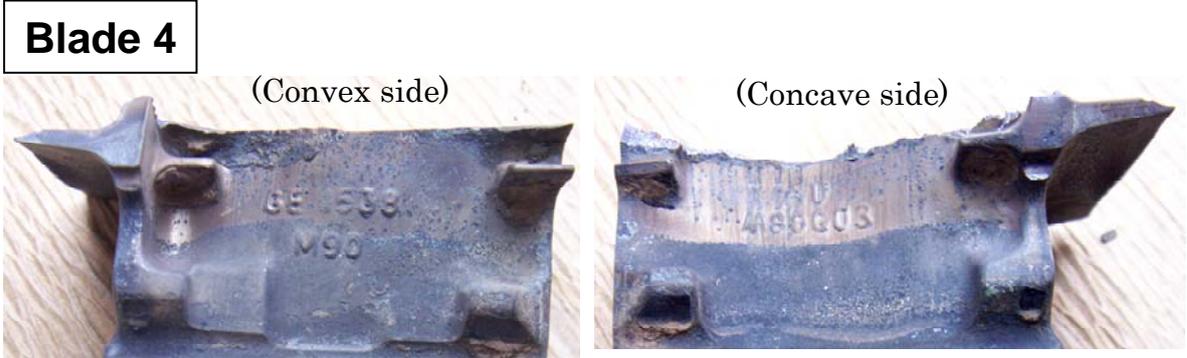
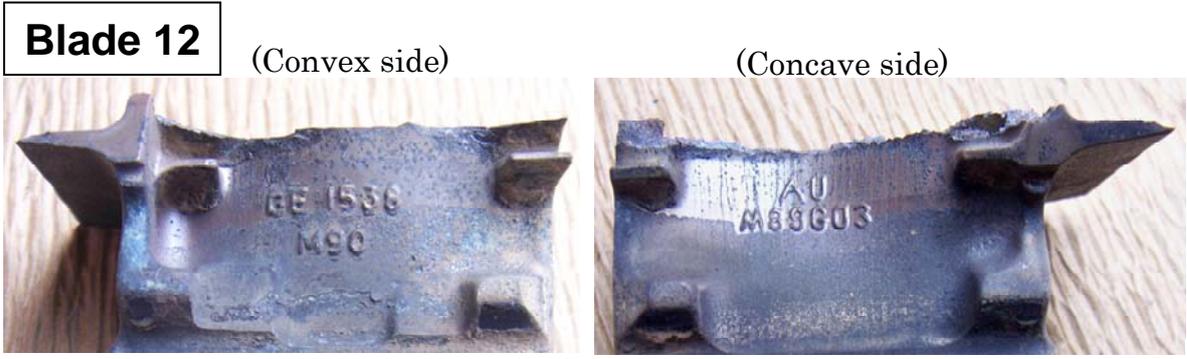
Photo 6 Fractured Blades 3, 4 and 12 of Stage 1 HPT

As described in 2.12.2 (2), the fatigue cracks in blades 4 and 12 were seen widely in the fractured areas as a whole. Therefore, it is considered highly probable that initial fractures occurred in blades 4 or 12.

Traces of fatigue cracks were also seen in the fractured surfaces of blades 2 and 3, though less widely than in blades 4 or 12. Therefore, it is considered highly probable that following the fracture of blade 4, the neighboring blades 3 and 2, already weakened by existing fatigue cracks, fractured completely due to impact from blade 4.

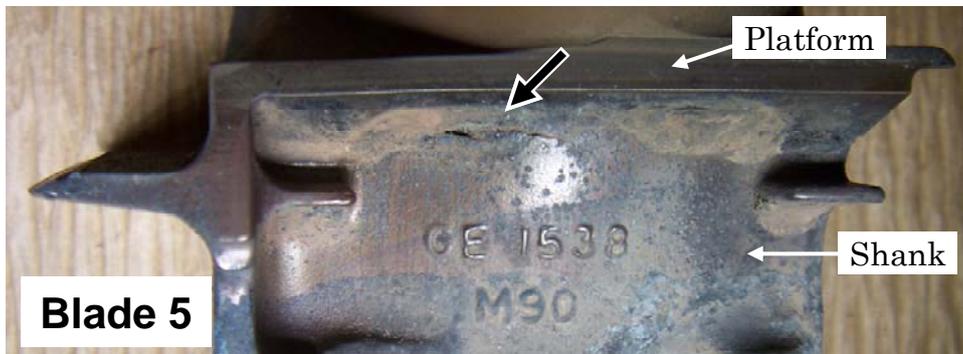
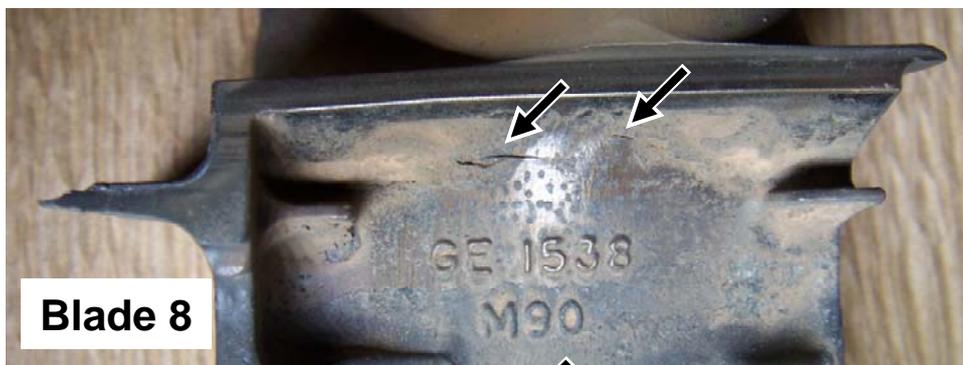
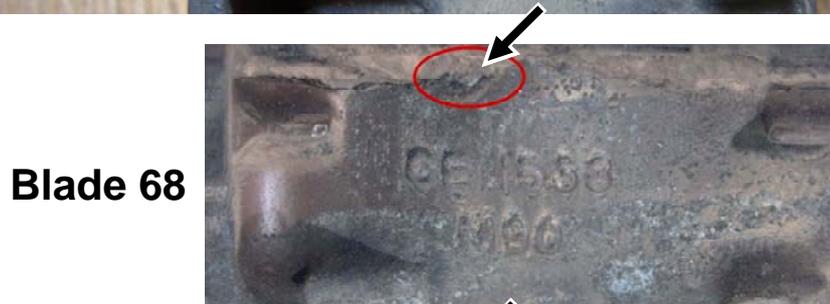
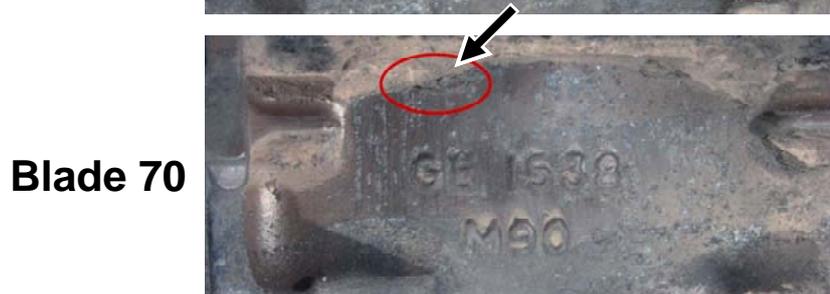
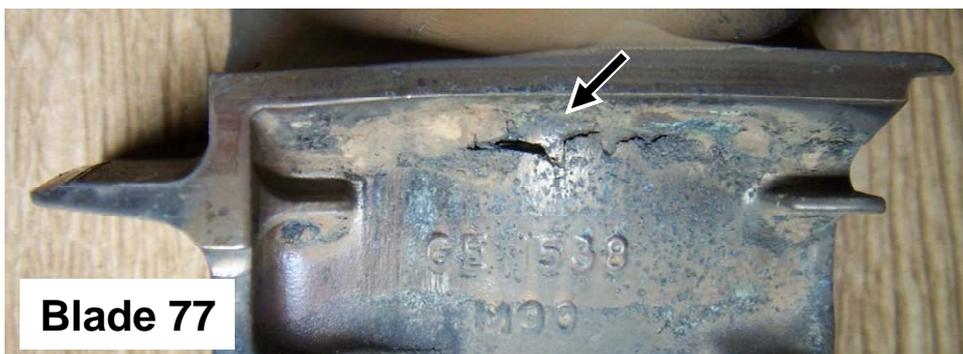
Photo 7 Stage 1 HPT Blades with Cracks Found

(3) Cracks were found on the convex of the shank area of the following five blades:

Blade	Serial Number	Size of Crack
Blade 5	PCMDGUD7	About 8 mm
Blade 8	PCMDHCT0	About 5 mm and 3 mm
Blade 68	PCMDDHL3	About 0.5 mm
Blade 70	PCMDGSM9	About 0.5 mm
Blade 77	PCMDGSN8	About 17 mm

(See Photo 7 Stage 1 HPT Blades with Cracks Found)

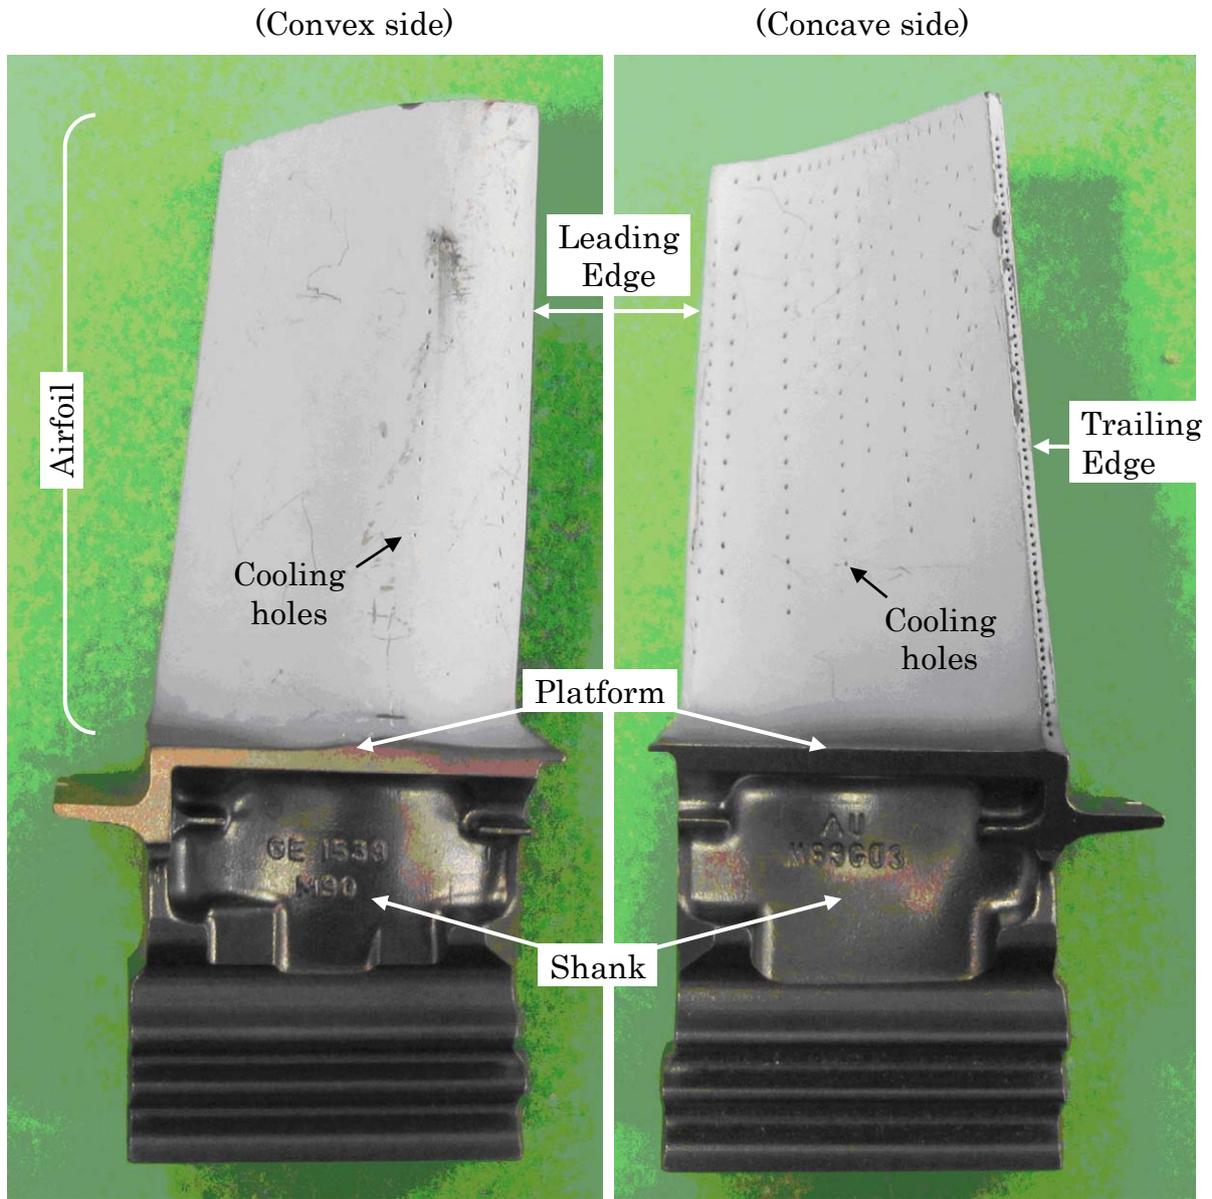
Photo 8 Stage 1 HPT Blade (Unused)

The S/B concerned added protective coating against type II hot corrosion (to be described later in 2.13.3) on the shank area (See Photo 8) below the platform of the stage 1 HPT

This Service Bulletin provides rework instructions to add a corrosion protective coating to the shank area of the blade below the platform as a field rework.
