**AIRCRAFT ACCIDENT
INVESTIGATION REPORT**

**PRIVATELY OWNED
J A 0 2 1 R**

June 30, 2016

DAMAGE TO AIRCRAFT DUE TO OVERRUNNING PRIVATELY OWNED CESSNA 525A, JA021R KOHANAN AIRFIELD, OKAYAMA PREFECTURE, JAPAN AROUND 15:46 JST, JUNE 10, 2015

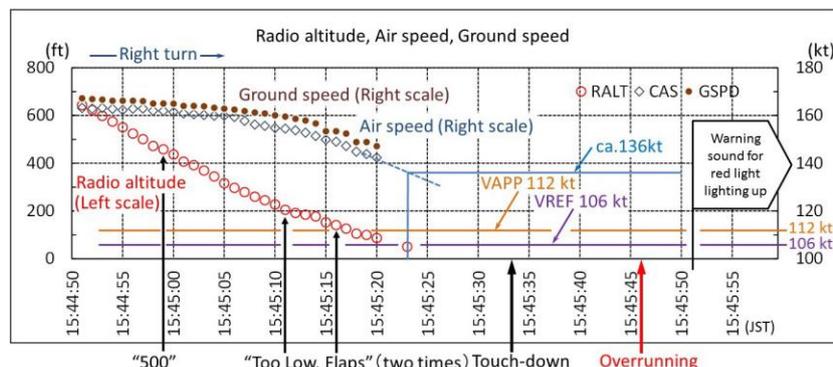
Figure 3: Records of EGPWS and CVR

The captain remembered that he selected land flaps at 155 kt before entering final approach course, performed pre-landing checks while on the final approach, and completed the checks by 500 feet AGL. However, according to the CVR and EGPWS records, when an automatic voice message "Five Hundred" was recorded, the aircraft was almost on its final approach course at 458 feet AGL, with an airspeed 162 kt and a ground speed 165 kt. In addition, the first warning of "Too Low, Flaps" issued at 205 feet AGL, when airspeed was 155 kt and ground speed was 160 kt. From this finding, it is highly probable that the captain did not complete the pre-landing checks until 205 ft AGL, and selected the land flaps after that.

If the deceleration rate of airspeed is extrapolated as shown in Figure 3, it is highly probable that the airspeed of the aircraft at 50 feet AGL was about 136 kt. Therefore, it is highly probable that the aircraft exceeded about 30 kt from the V_{REF} derived from the performance table of the flight manual described in 2.7(5), and actual landing distance exceeded the landing distance obtained in it by a substantial distance.

It is necessary to recognize that actual landing distance is longer than that derived from the performance table when actual speed exceeds V_{REF} ; in case of the landing on a short runway, it is necessary to maintain the required approach speed, and make a judgment a go-around when speed maintaining is difficult.

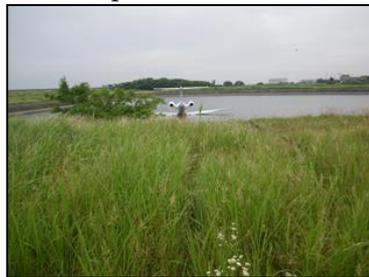
Photo 3: Trace of the nose landing gear

In the grass area, the trace of nose landing gear was almost wheel width detruing, blowing down the grass, ran down straight towards the pond from the stopway. There were traces of the both main landing gears which cut the ground to the width of the wheel and ran down straight towards the pond.

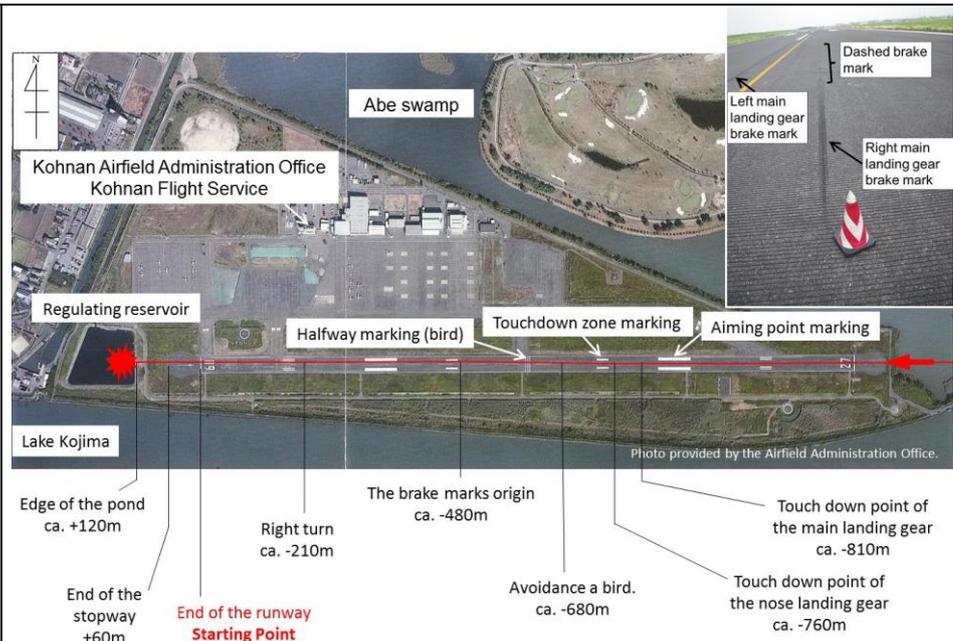
Figure 4: Estimated landing path and brake marks

According to the statement of the captain, the main landing gear of the aircraft touched down at about 30 m forward of the aiming point marking (about – 810 m from the end of the runway), and the nose wheel touched down at about 10 m short of the forward touchdown zone marking (about – 760 m from the end of the runway). He turned right to avoid a bird at about 80 m before the halfway marking (about – 680 m from the end of the runway).

Brake marks of both main landing gears were found on the runway at about – 480 m from the end of the runway. The brake marks started as short dashed lines, indicating the antiskid system was in operation. The brake marks turned slightly to the right at – 210 m from the end of the runway, and passed into the end of the stopway.

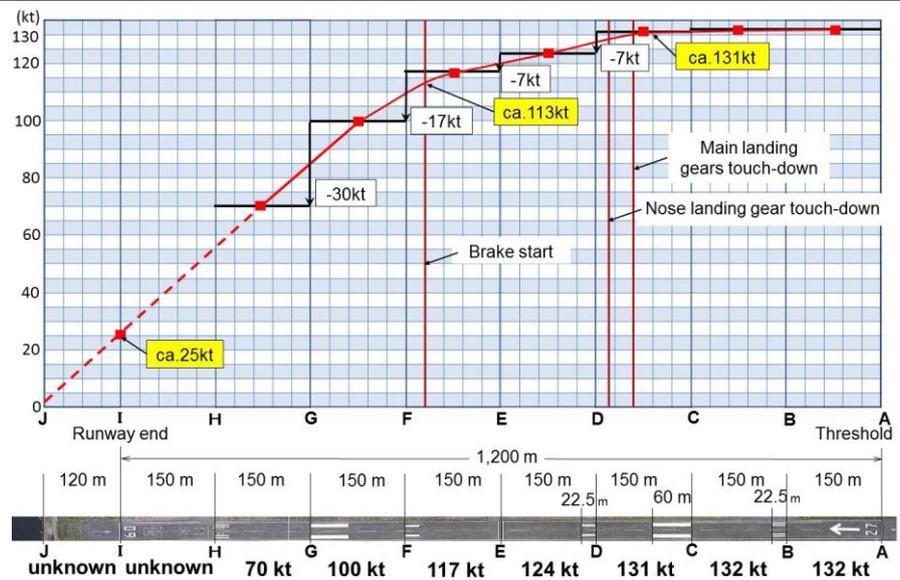
Figure 5: The ground speed of the aircraft

Figure 5 shows the ground speed of the aircraft, estimated based on images captured by four surveillance cameras at the airfield during its landing.

It is probable that the aircraft touched down at about 131 kt as shown in Figure 5. The NORMAL PROCEDURES in the flight manual provides to first apply the brakes after the nose wheel touches down, and then set the ground flaps. It is highly probable that although the captain set the ground flaps after the nose wheel touched down, he noticed a bird and was forced to its correspondence; accordingly, he started to apply the brakes after about 280 m landing roll after the nose wheel touched down. At that time, it is probable that the distance to the runway end was about 480 m and the speed was about 113 kt. It is probable that the deceleration rate were to be about 7 kt per 150 m after touching down to starting the brakes and about 30 kt after applying the brakes. It is somewhat likely that the speed of the aircraft is to be about 25kt when it passed the end of the runway. As described in (2), the aircraft had substantially exceeded V_{REF} at 50 feet AGL, it is somewhat likely that the aircraft would overrun at this point; besides, it is highly probable that the delay in applying the
