**AIRCRAFT SERIOUS INCIDENT
INVESTIGATION REPORT**

HOKKAIDO AIR SYSTEM CO., LTD.

**HOKKAIDO AIR SYSTEM CO., LTD.
SAAB 340B, JA03HC
EMERGENCY OPERATION TO AVOID
COLLISION WITH THE TERRAIN
ABOVE OKUSHIRI AIRPORT
AROUND 11:38 JST, JUNE 4, 2011**

November 7, 2014

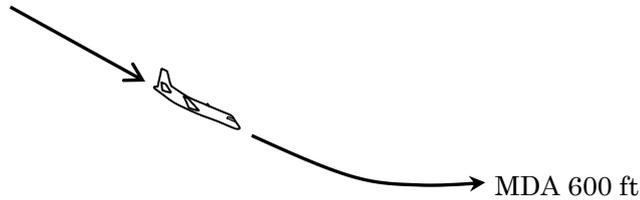
Figure A MDA captured

- 11:34:34 The AP/FD system captured final approach course of 322°.
- 11:34:39 Okushiri Remote gave the flight crew the advice of “Obstruction not reported on the runway” and they read back it.
- 11:35:39 When the Aircraft was passing an altitude of about 750 ft, the vertical mode of the AP/FD system captured a minimum descent altitude (hereinafter referred to as “MDA”) of 600 ft, and the mode changed from VS for flying with the descent rate maintained to ALTS for flying at the selected altitude.

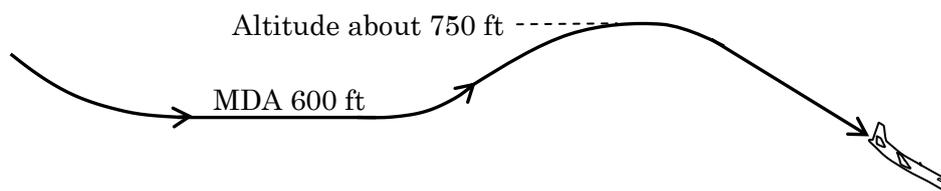
Figure D TAWS activated

- 11:37:52 The Aircraft continued to descend. The autopilot ON was recorded at about 650 ft. At this time, the lateral mode remained HDG and the vertical mode was ALTS for maintaining the MDA of 600 ft.
- 11:37:54 The vertical mode of ALTS was disappeared. The Aircraft further continued to descend. The altitude was about 560 ft and the radio altitude was about 330 ft.
- Around 11:37:55 At about an airspeed 190 kt, the vertical mode turned to H CLM (CLM SPD HIGH) for climbing at a high speed, but shortly after that, the vertical mode changed to VS for flying with the descent rate maintained. The radio altitude was about 320 ft.
- 11:37:57 At an airspeed of about 200 kt, the power lever was retarded. TAWS called out “SINK RATE” as a caution against an excessive descent rate, and the engine torque momentarily decreased to about 50 %. The radio altitude was about 270 ft.

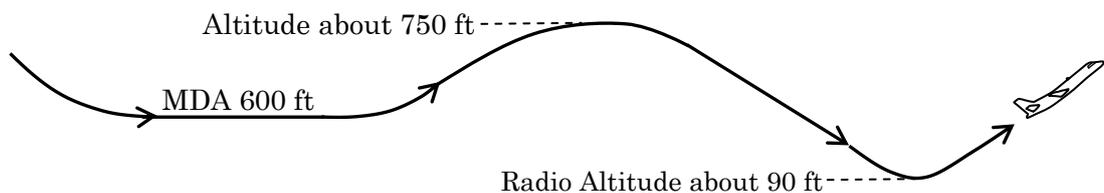
Figure E Recovery maneuver

- 11:37:59 The vertical mode turned to M CLM for climbing at a medium speed. The radio altitude was about 160 ft.
- 11:38:00 The power lever was advanced to the maximum power setting position.
- 11:38:01 TAWS called out “TOO LOW TERRAIN” as a caution against a proximity with the ground.
- 11:38:02 The DFDR recorded a radio altitude of 92 ft (87.8 ft in terms of the TAWS radio altitude), showing a minimum value in this approach, and at the same time, the engine torque turned to 118 % (the maximum value which can be recorded on the DFDR) for 4 seconds. At this time, the airspeed was recorded of the maximum value of 213 kt.

- 11:38:03 The pitch angle increased to 9.5° in a second and the vertical acceleration increased to the maximum value of about 4.1 G. The bank angle recorded the maximum value of -28.5° (a negative figure shows left bank) and TAWS called out “BANK ANGLE” as a caution against an excessive bank angle.
- 11:38:06 The autopilot was disengaged.
- 11:39:05 The Aircraft reported having executed a go-around to Okushiri Remote.

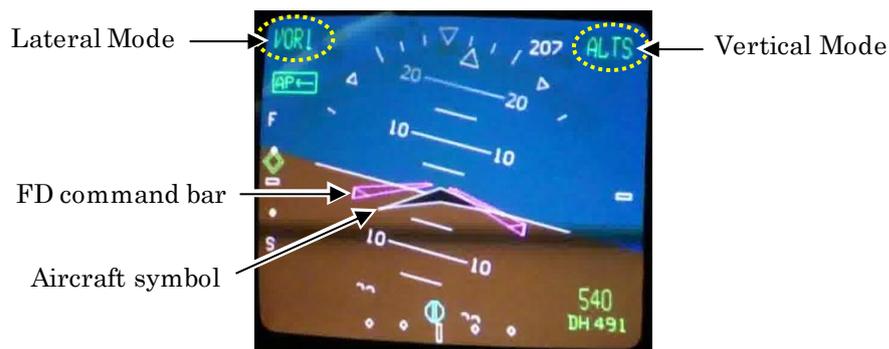
Figure J EADI Display

- (1) While the aircraft was descending on the VS mode with autopilot engaged, the MDA of 600 ft was set to APA, and then it leveled off at and maintained the altitude of 600 ft. The vertical mode switched to the ALTS Track Mode (ALTS) was indicated on the EADI.

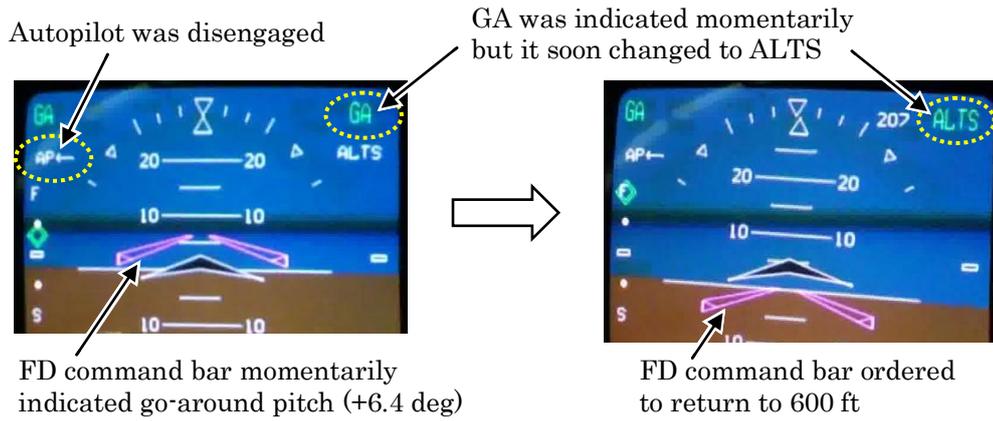
Figure K EADI Display During Go-around Was Performed

- (2) In the situation described above, the go-around button was pressed with the altitude of 600 ft kept on APA, the engine power was increased with the power levers and CTOT was activated. Then autopilot was disengaged, and the vertical mode on EADI changed to GA from ALTS at once, but it immediately returned to ALTS. The FD command bar also momentarily indicated +6.4° as the go-around pitch, but it soon returned to the previous position.

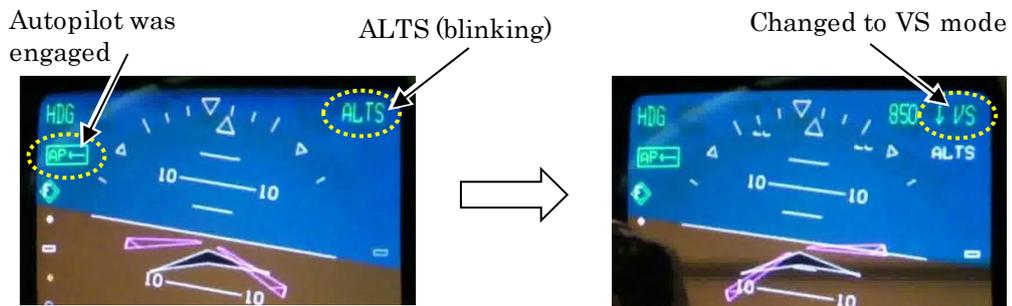
Figure L Autopilot engaged and APA mode changed

- (3) In the situation described above, when the aircraft was manually controlled to climb, the FD command bar indicated a pitch down to return to 600 ft. Upon operating the aircraft to follow the command, the aircraft began to descend.
- (4) In the situation described above, when autopilot was engaged during a descent to 600 ft, after the vertical mode on EADI changed to ALT from ALTS, it immediately captured 600 ft. Following the mode change, ALTS was blinking.
- (5) While ALTS was blinking, when an altitude higher than the current altitude (for example, 4,000 ft) was set to APA, the vertical mode on EADI changed to the VS mode. Autopilot continued descending, keeping the rate of descent at the time.
