**AIRCRAFT SERIOUS INCIDENT
INVESTIGATION REPORT**

RUNWAY INCURSION

1. AERO ASAHI CORPORATION
BELL 430 (ROTORCRAFT), JA06NR
2. ALL NIPPON AIRWAYS CO., LTD.
BOEING 767-300, JA605A

ON RUNWAY 06R AT KANSAI INTERNATIONAL AIRPORT
AROUND 08:32 JST, SEPTEMBER 10, 2013

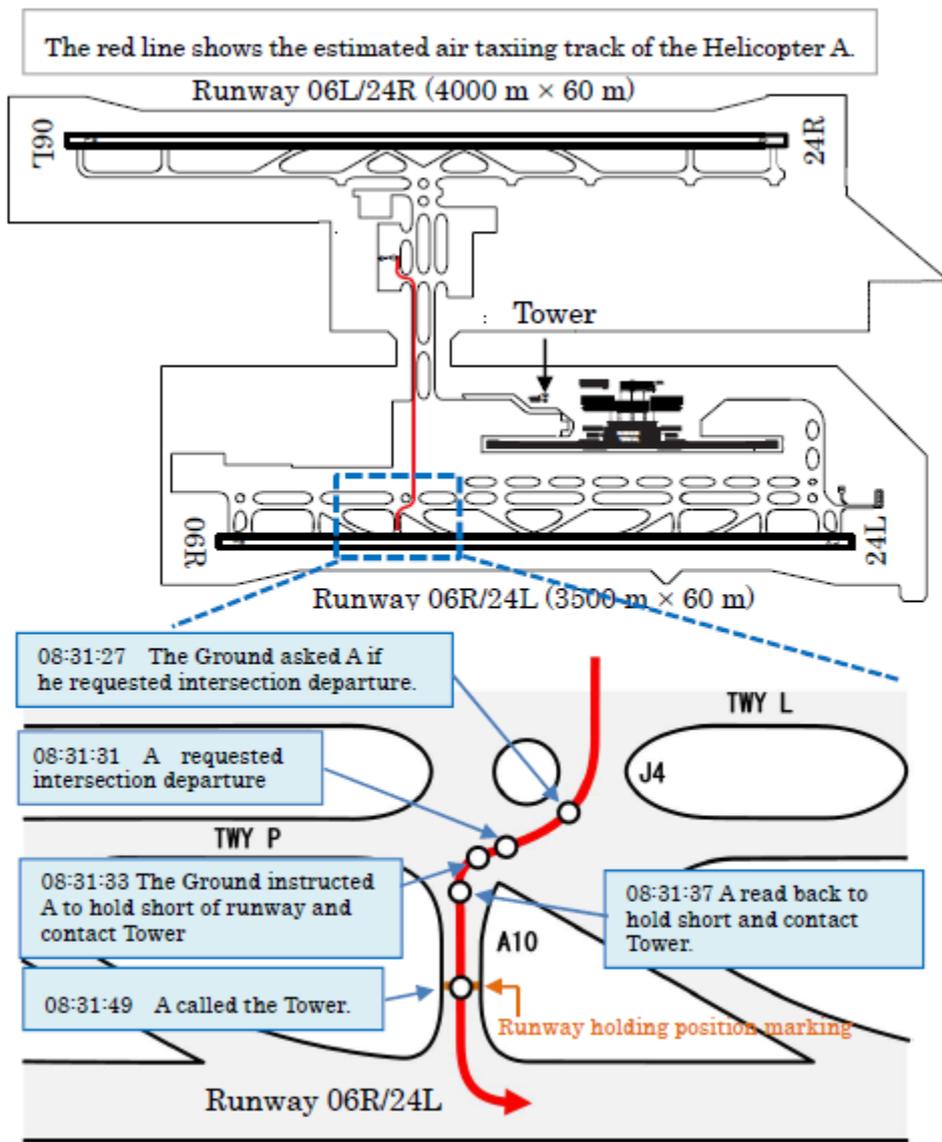
The Ground asked the PIC of the Helicopter A if he requests intersection departure from taxiway A10 because it looked like heading towards the taxiway though he had not requested that in advance. In response to the PIC's answer in affirmative to this, the Ground instructed him to hold short of the runway and to contact Tower controller (hereinafter referred to as "the Tower"), which the captain read back. The PIC changed the frequency to the Tower. Being distracted by the engine instruments, however, he entered the runway before establishing communication with the Tower. He allegedly realized that the Helicopter A crossed the runway holding position marking when it nearly reached just over the marking. He called the Tower almost concurrently when the Helicopter A was crossing the marking. Although the Tower began replying to it, mid-transmission, he stopped it in order to give the instruction of a go-around to the Aircraft B which was on the final for the runway. The PIC of the Helicopter A vaguely assumed that he had received permission of entering the runway. However, he realized he had not when he heard the instruction of a go-around given to the Aircraft B. The Helicopter A continued air taxiing after crossing the runway holding position marking, and then halted on the runway centerline marking.

In the meanwhile, the Aircraft B, which was on final approach with landing clearance, was instructed to execute a go-around. It was at around one mile on final, with an altitude of around 300 ft when the Aircraft B commenced climbing.
