**AIRCRAFT ACCIDENT
INVESTIGATION REPORT**

**PRIVATELY OWNED
J A 0 7 K D**

CRASH DURING LAUNCHING

SCHEMPP-HIRTH DUO DISCUS

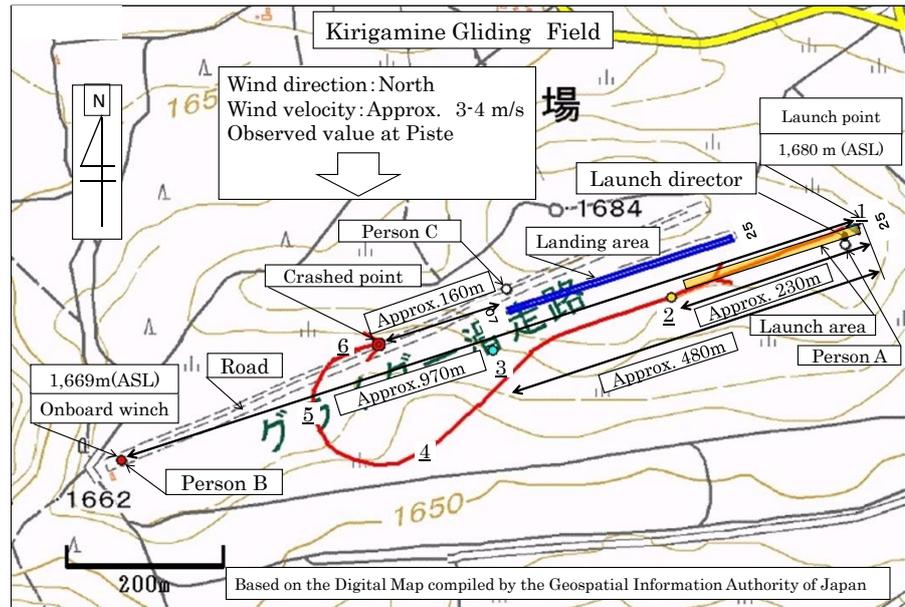
Figure: The Estimated Flight Route

- 1 Launched position 2 Fuse broken position 3 Fuse fell position
- 4 Starting right turn position 5 Bank angle increased position
- 6 Contact marks of right wing tip
