AIRCRAFT ACCIDENT INVESTIGATION REPORT

ALL NIPPON AIRWAYS FLIGHT 391
AIRBUS A321 - 131, JA104A
HAKODATE AIRPORT, HOKKAIDO, JAPAN
JANUARY 21, 2002

September 26, 2003

Aircraft and Railway Accidents Investigation Commission
Ministry of Land, Infrastructure and Transport

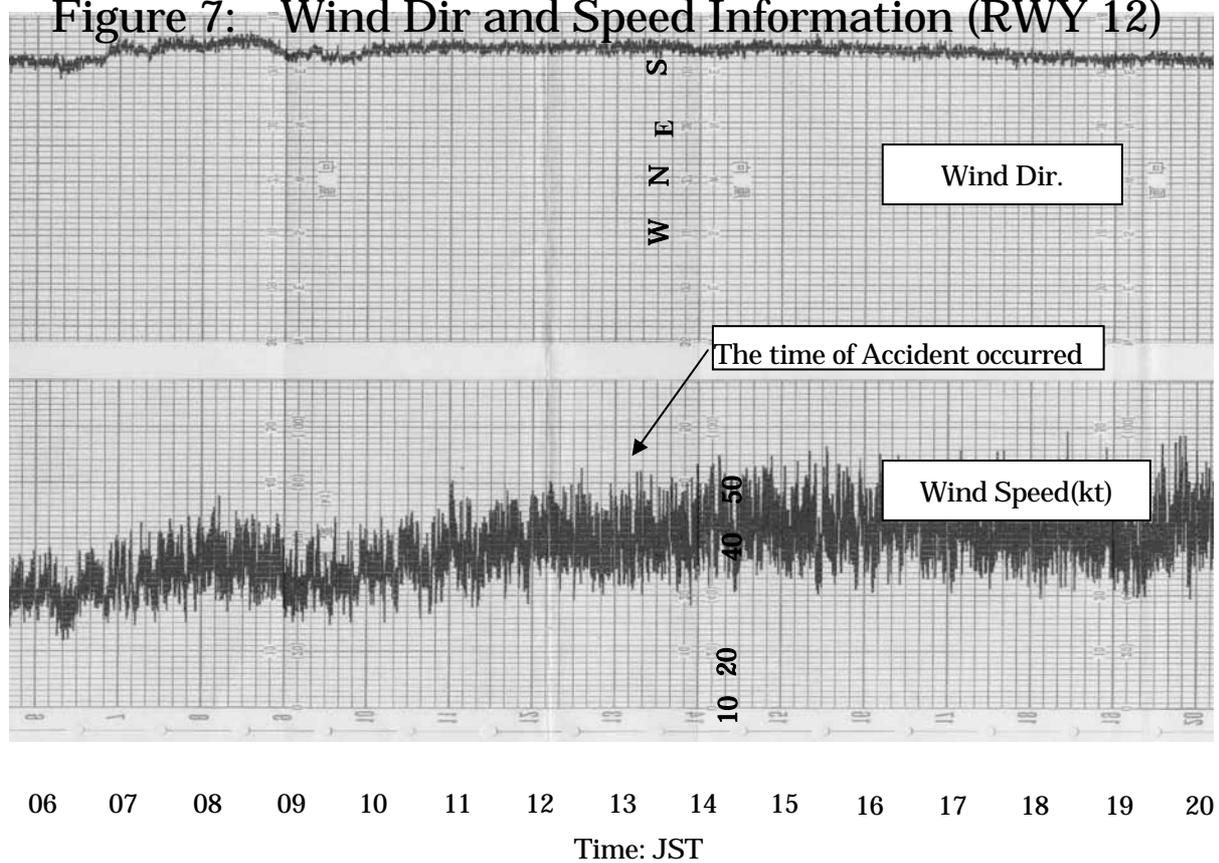
Figure 7: Wind Dir and Speed Information (RWY 12)

According to the wind condition chart shown in Figure 7, it is considered that this gusty strong wind condition was continued until evening of the day of the accident occurred.

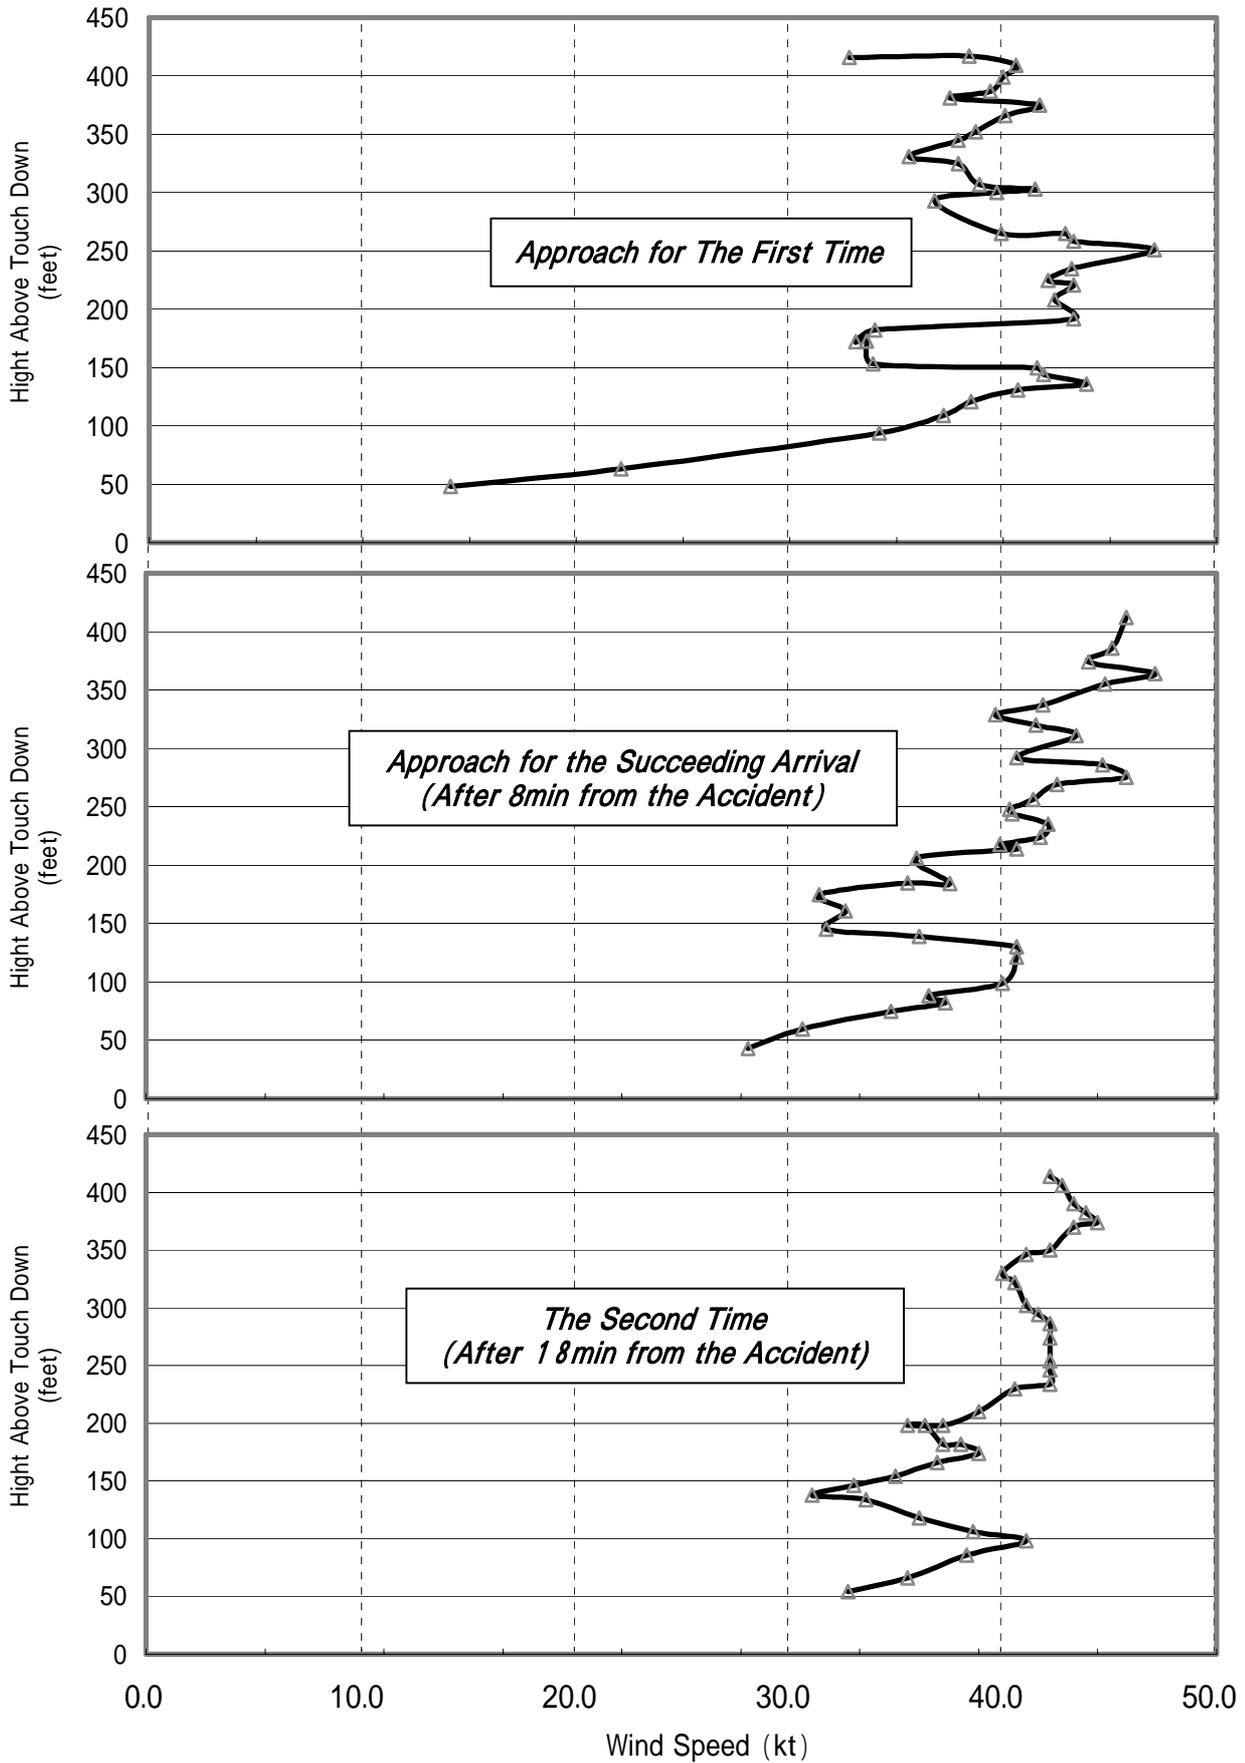
Figure-9 Wind Speed on the Final Approach

Judging from the near-ground wind speed measurements along the approach course to Hakodate Airport recorded between the approach on which the wind shear encounter occurred and the second approach of the same aircraft, shown in Figure 9, regarding wind conditions that would cause an aircraft to abruptly descend and trigger a wind shear warning, it is considered that there was localized air mass with a wind speed 10kt greater than the surroundings from 250–100ft above ground level, and below 100ft AGL there was a wind shear with a marked decrease in wind speed with decreasing altitude. It is considered possible that wind conditions like these arose due to a combination the strength and direction of a wind passing over the terrain in the vicinity of the airport at the time affecting the surface boundary layer that was developing along ground surfaces.

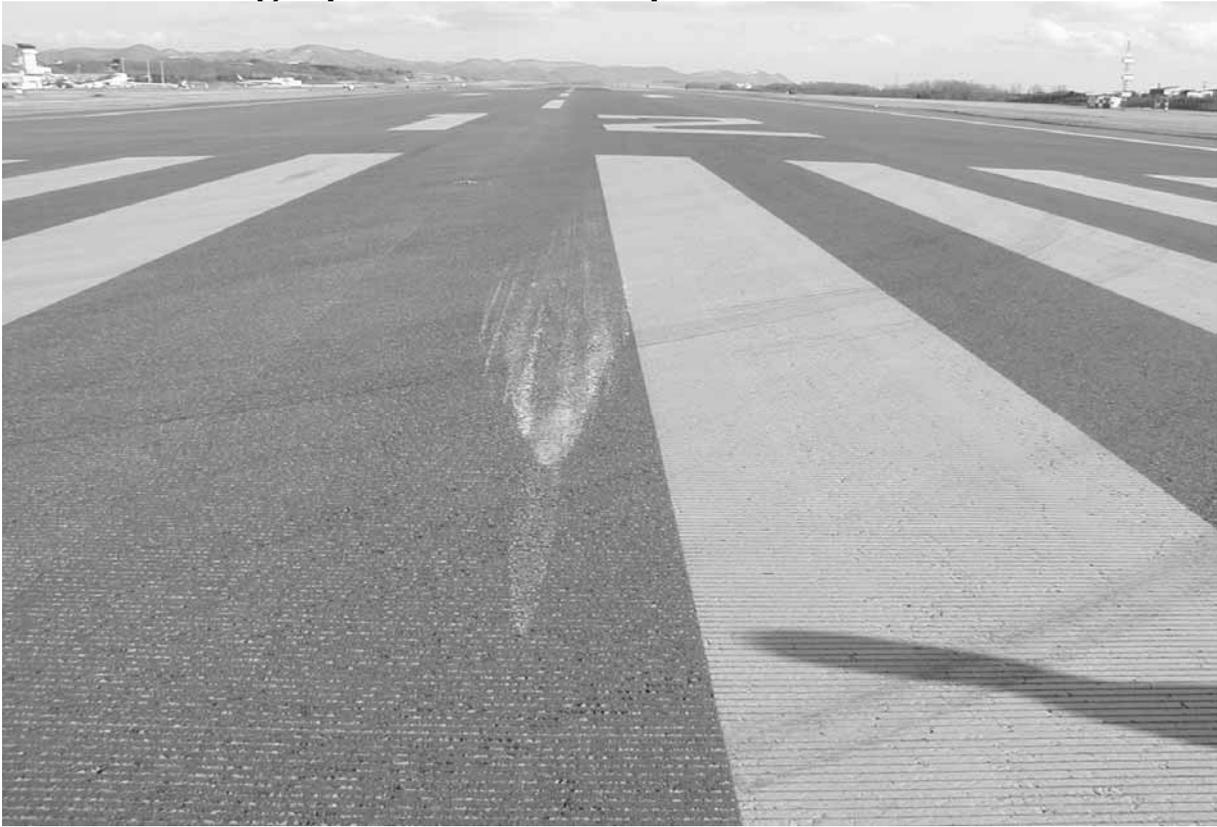
Markings with a width of approximately 80cm were found on the runway at Hakodate Airport, thought to have been left by the contact of the lower surface of the aft fuselage of the accident aircraft. These started at a point 14.0m along runway 12 from approach end threshold, continued along the runway for a length of 15.9m from the approach threshold. However, there was no damage to the runway.

Photograph-2: The scrape marks on RWY 12

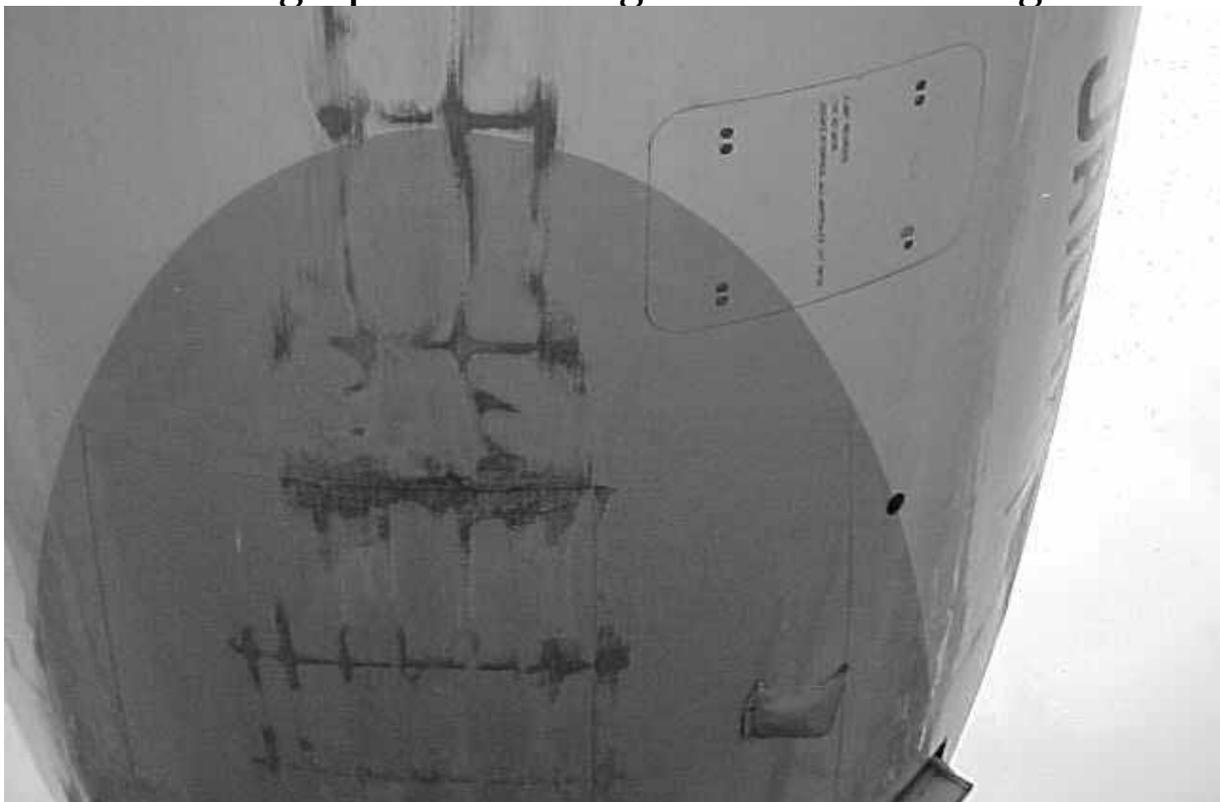
There was deformation of the ten frames (#63-#72) associated with the skin panels on which abrasions were found, and seven of these (#63, #65-#70) were found to have cracks. Four stringers that cross the cracked frames (stringer #: S41R-S39L) were also deformed.

Photograph-3: Damage of the Aft Fuselage

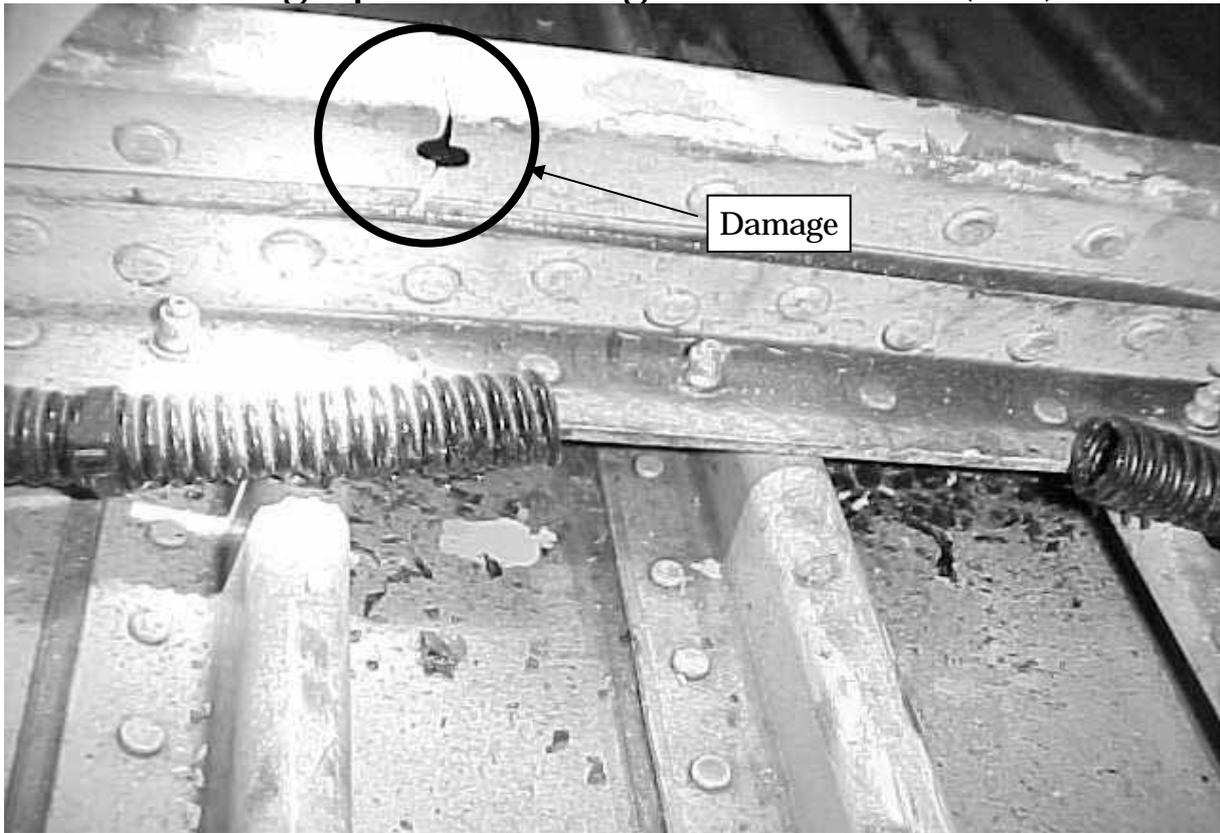
Photograph-4: Damage of the Frame (#67)

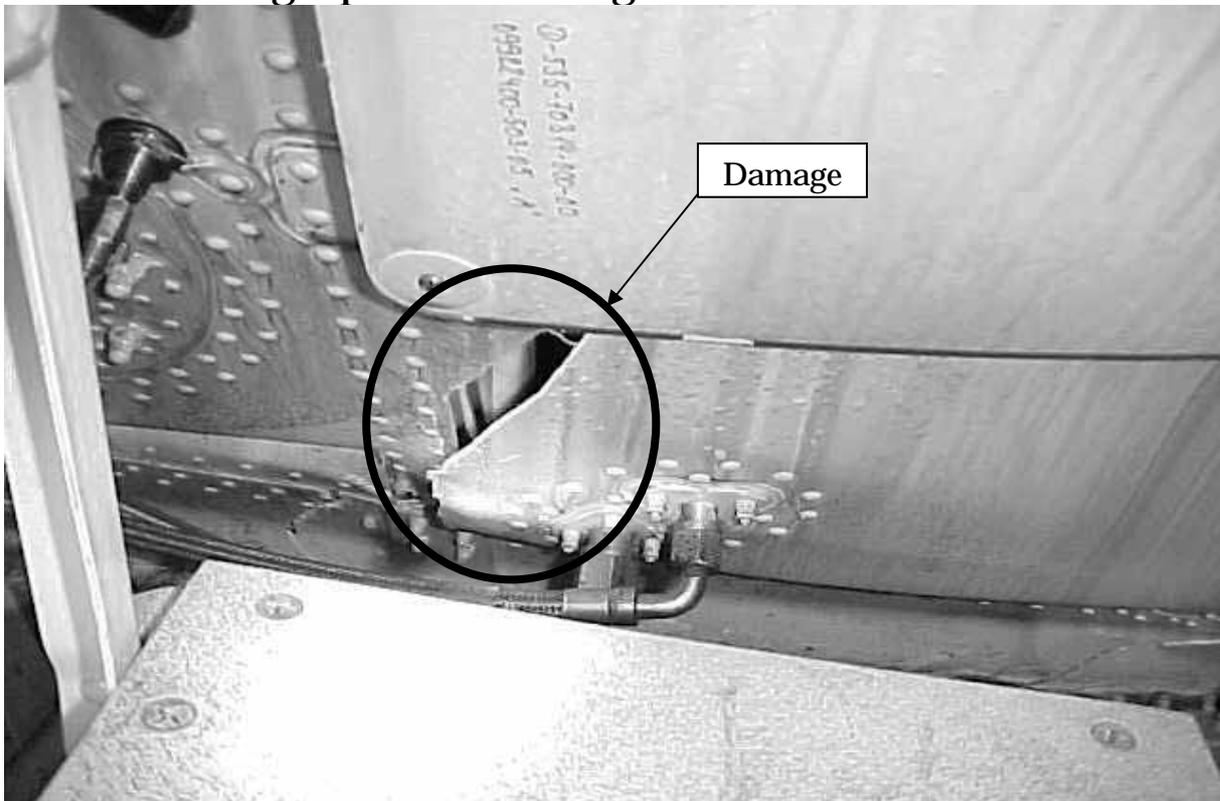
Cracks were found in two locations on the lower part of the aft pressure bulkhead.

Photograph-5: Damage of the Aft Bulkhead
