**AIRCRAFT ACCIDENT
INVESTIGATION REPORT**

**YAMANASHI PREFECTURAL
POLICE HEADQUARTERS
J A 1 1 0 Y**

FATAL ACCIDENT CAUSED BY THE AIRCRAFT DURING RESCUE ACTIVITIES TABAYAMA VILLAGE, KITATSURU-GUN, YAMANASHI PREFECTURE, JAPAN AT ABOUT 13:50 JST, MAY 14, 2017

YAMANASHI PREFECTURAL POLICE HEADQUARTERS BELL 412EP (ROTORCRAFT), JA110Y

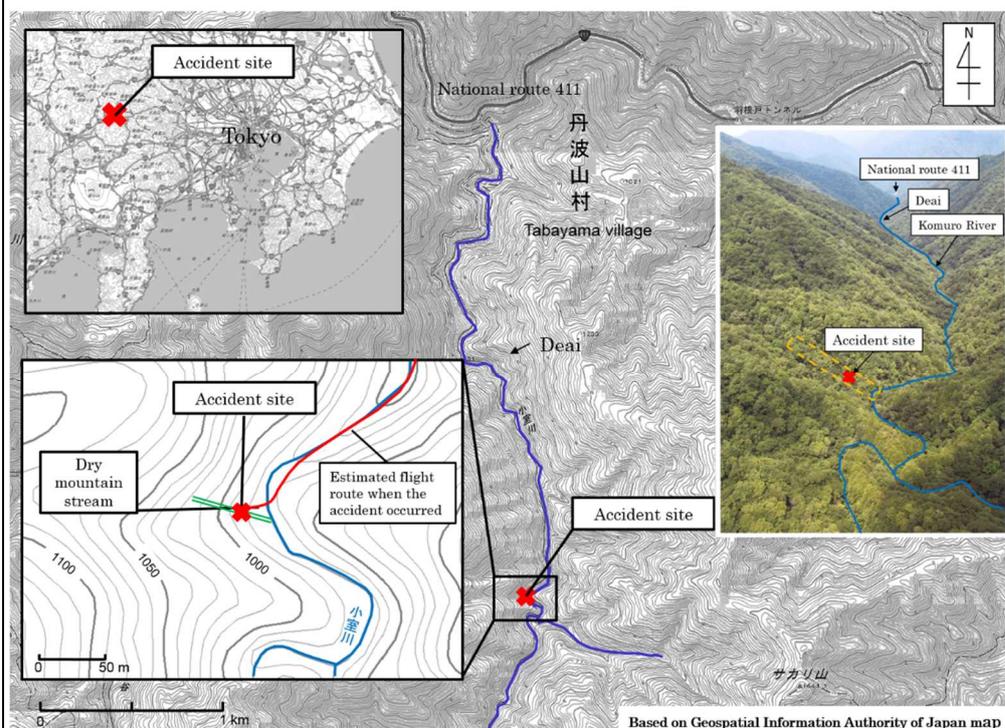
Figure1: Accident site

The helicopter flew over along the Komuro River to the site where the survivor was found. The PIC found the smoke emitted from near the site on his right side and turned the nose of the helicopter in the direction of the smoke. As the smoke was not streaming in the wind, the PIC judged that the wind was virtually calm around the target site. Although being unable to check visually the target site while hovering for five minutes in the vicinity of the site, the PIC could confirm the target with a flash light from a rescue worker on the ground. From the cockpit, both pilots were not able to find the possible position for the rescuer to descend by hoist, but the hoist operator found the possible position in the rear right direction, and the helicopter commenced to move to the right rear to fly toward the dry mountain stream under the guidance of the hoist operator.

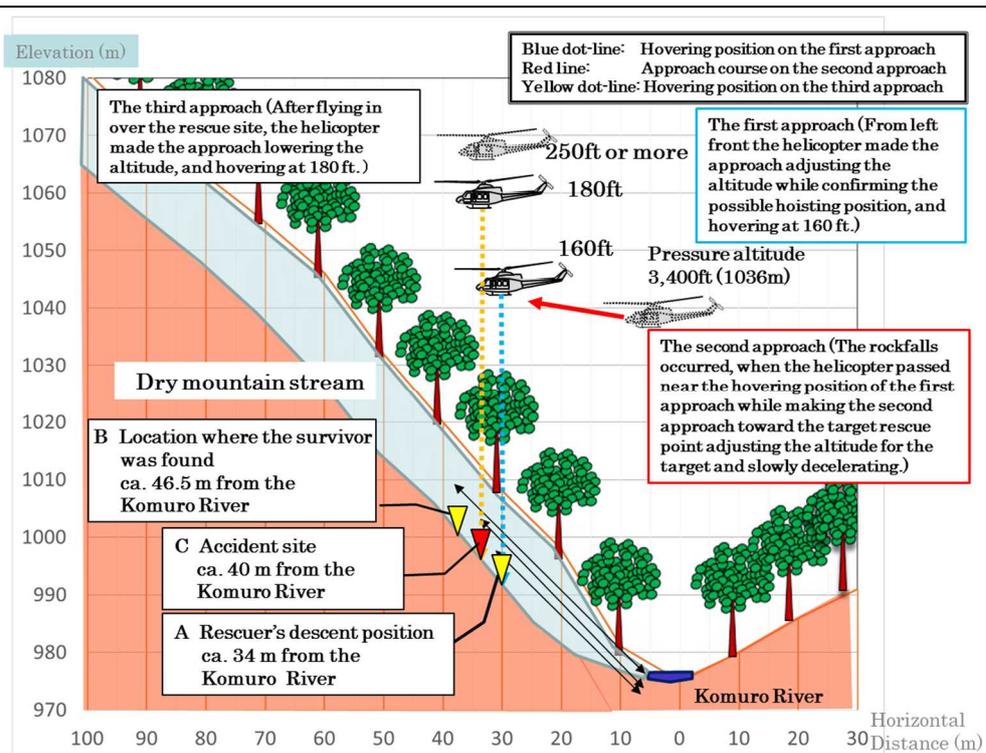
Figure2: Vertical cross section chart of the vicinity of the accident site and approach procedure taken by the helicopter

Adjusting the altitude for the target, the helicopter made the first approach from the west side at a low speed until it arrived over the dry mountain stream. At 49 m (160 ft) AGL, the helicopter kept hovering over the vicinity of about 34 m upward (upstream side) along the steep slope of the dry mountain stream (Figure 2, Point A) from the Komuro River, and about 12 m downward from the survivor. Although the surrounding area around the hovering point was covered with trees, the rescuer descended to the target point through the airspace between the trees, which was created by bending those trees with the wind pressure of the downwash². Afterward, the helicopter once disengaged from the hovering point and kept waiting over the target position. After descending, the rescuer found the survivor and rescue workers on the ground (Figure 2: Point B). The rescuer confirmed that the survivor had a clear consciousness, although his condition was frail with the left foot suspected to be broken. Therefore, the rescuer judged that it was possible to conduct a hoist rescue operation. But the location where the survivor was found was too narrow to conduct the hoist rescue operation, therefore the rescuer decided to hoist the survivor after moving the survivor six meters downward (Figure 2: Point C, about 40 m from the Komuro River).

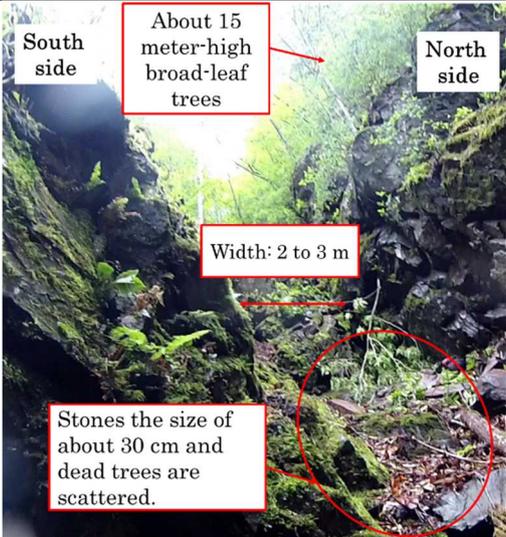
Photo 2: Upper side of the accident site

The dry mountain stream, the accident site, is a steep slope with about 50-degree average inclination (Vicinity of the accident site: 52-degree average inclination) at an elevation of about 1,000 m. And the stream is about two to three meters wide with a bank wall about 15 m in height on each side, forming V-shaped trough-like terrain. From geological point of view, rockfalls were likely to happen in this site where the stream was composed of mudstone in the southern part and sandstone in the north part, the upper part of those bank walls were covered with broad-leaf trees (approximately 15 to 30 meters high), and there were scattering stones the size of about 30 cm on its soft ground.

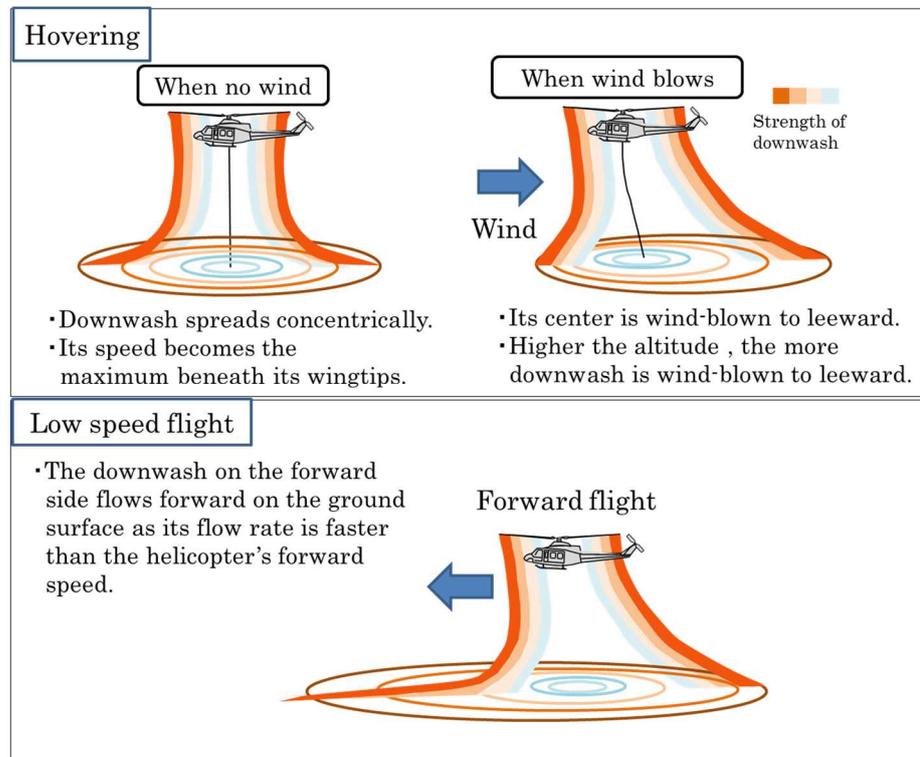
Figure 3: Image of spreading of downwash of the helicopter

As the flow speed of the downwash generated by the main rotors becomes the maximum beneath its wingtips, the downwash effect beneath the wingtips is greater than the effect just beneath the center position of the main rotors.

When the wind blows, all the airflow including downwash generated by hovering flows to leeward. But when no wind, there is no wind effect and the airflow is generated by downwash as if to flow along the ground surface. Therefore, the downwash has a reaching effect on the whole circumference immediately beneath the hovering position.

When a helicopter flies at a low speed in the range where the downwash reaches the ground surface, the downwash flows forward on the ground surface as its flow rate is faster than the forward speed of the helicopter.

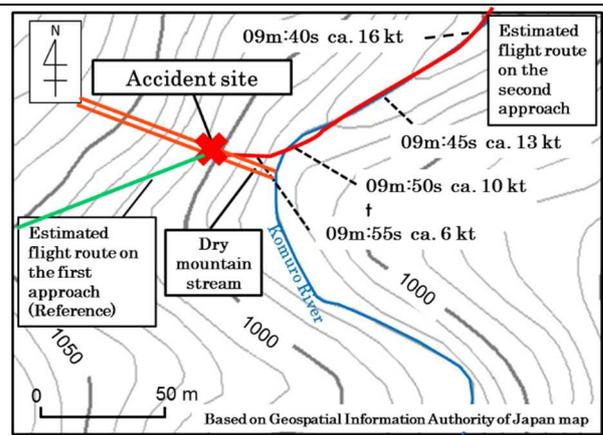
Figure 4: Position and velocity of the helicopter on the second approach

It is probable that according to the speed data obtained from the descriptions in 2.1 and 2.8 (1) and (2), the relation between the position and the speed of the helicopter on the approach to the dry mountain stream is, as shown in Figure 4, as follows:

At 09'50" after the video shooting started, the approach speed was at 10 kt, afterward, the helicopter flew at a low speed of the deceleration rate of less than 1 kt and got close to the rescue position. It is somewhat likely that this way of approach probably required the helicopter to keep a near-hovering status, and as a result, rescue workers on the ground felt strong downwash that was different from on the first approach.

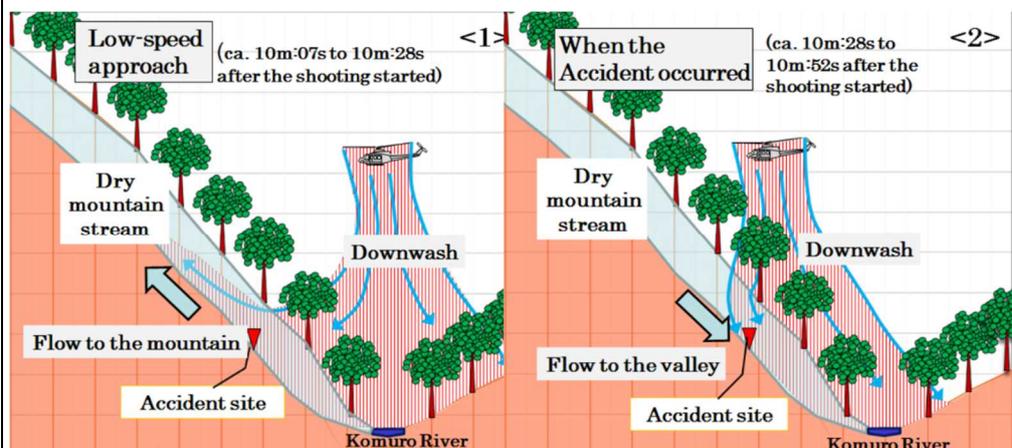
Figure 5: Image of the downwash of the helicopter

It is probable that as described in 2.8 (1), when the helicopter was on the approach at a low speed between 10'07" and 10'15" after the start, the downwash generated in the forward side of the helicopter was blowing through the dry mountain stream, as shown in Figure 5 <1>, from the valley to the mountain. It is also probable that at around 10'28" after the start, when the helicopter went forward and took roundabout toward the mountain, the downwash flow direction changed, and as shown in Figure 5 <2>, it was blowing down directly to the valley. It is somewhat likely that at about 10'38" after the start, as described in 2.8 (3), when the trees just above the site bent with the wind, the strong downwash flow from the wingtips of the main rotors reached the vicinity of the rockfalls occurrence site located upstream, and triggered the rockfalls.

In this accident, it is highly probable that when the helicopter made the approach to the survivor during rescue activities in the mountains, the tree branches were broken and the rockfalls occurred due to the downwash, and some of those falling trees and rocks hit the survivor and the SAR team members.

Regarding the occurrence of falling rocks and broken tree branches, it is somewhat likely that the those facts—which the rescue site was steep and narrow V-shaped trough-like terrain and the helicopter made the approach at a slow speed and at a shallow angle toward the rescue position—may have contributed to the situation where the flow direction and speed significantly changed.

At the time of the hoist rescue operation to lift a survivor from the forest, it is necessary to fully take into account the topographical specific features and winds in the vicinity of the rescue site in order that the downwash effect on the ground should be eased as much as possible.

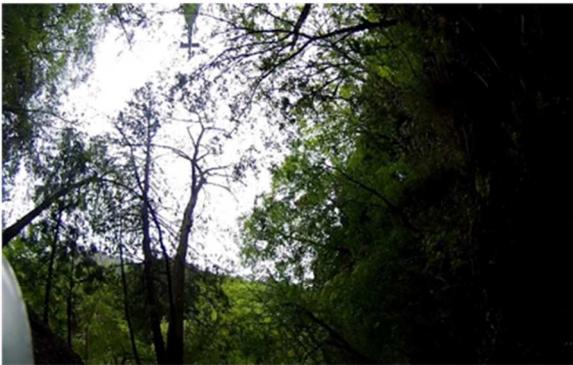
10'07" Hovering ahead of the accident site

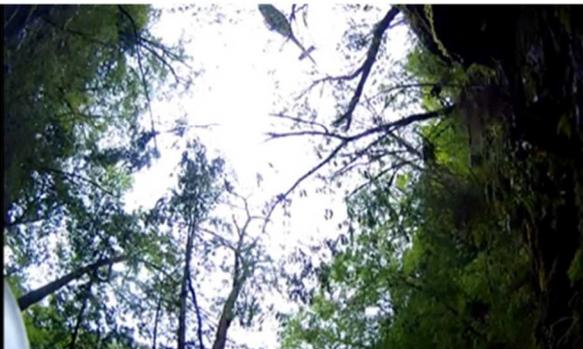
10'38" Approaching just above the site

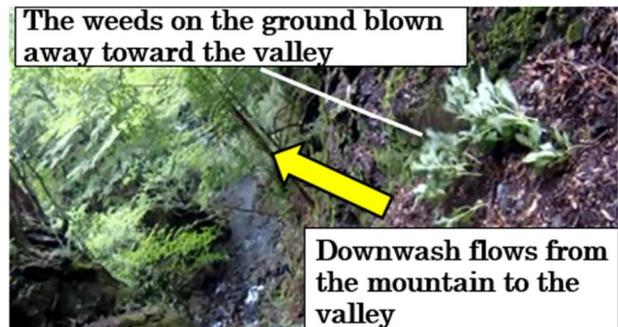
10'28" Approaching
