**AIRCRAFT ACCIDENT
INVESTIGATION REPORT**

**PRIVATELY OWNED
JA 111L**

DAMAGED TO AIRCRAFT DURING FORCED LANDING PRIVATELY OWNED

EXTRA EA300/L, JA111L

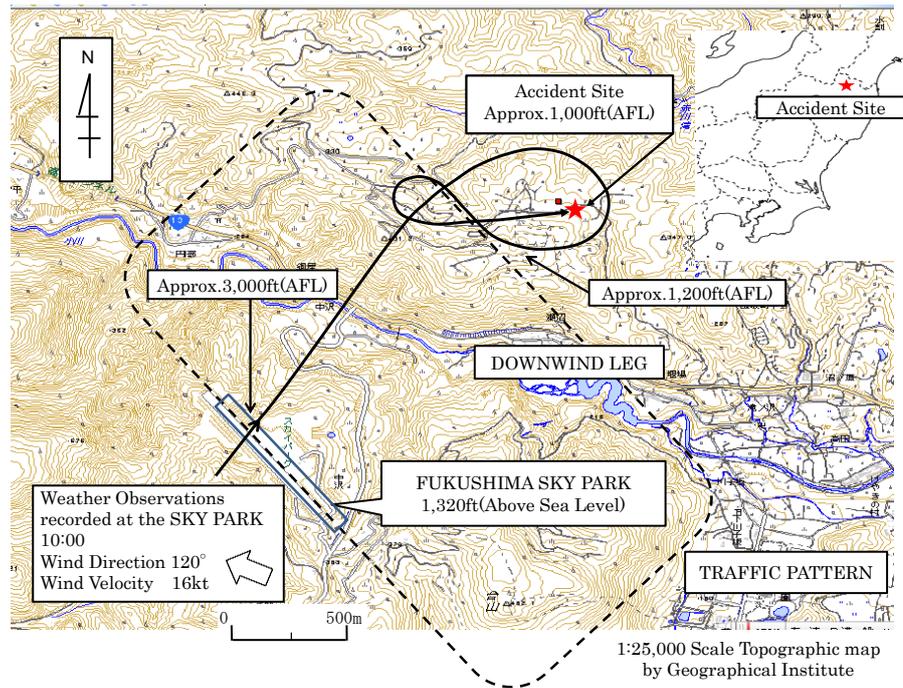
Figure1: Estimated Flight Route

After completing the sequence, the pilot closed the throttle and headed for the Sky Park while descending. (refer to Figure 1)

The calculated glide distance based on the aircraft's glide ratio "1 : 6.2" and the altitude at the downwind leg (approximately 1,200 ft (360 m) AFL) is approximately 2.2 km.

Therefore, it is highly probable that it was difficult for the aircraft to return back to the Sky Park with gliding even though it took the shortest course from the downwind leg to the Sky Park (approximately 2.8 km).

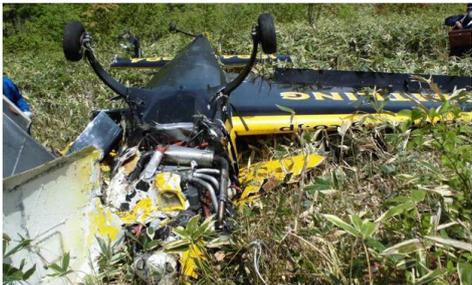
<p>Accident Aircraft</p> </div>

2.2 Injuries to the Persons	<p>Captain: slightly injured Pilot : seriously injured</p>																				
2.3 Damage to the Aircraft	<p>Extent of damage: Destroyed</p> <p>①The left wing was separated from the fuselage at its root and it was crushed under the fuselage. The left aileron was fallen in the peach orchard.</p> <p>②The engine was detached from its mount and it was in front of the aircraft. No anomalies were found in the spark plugs and the fuel filter.</p> <p>③All the three blades of the propeller were fractured at their shank.</p> <p>④The center tank was partly collapsed and cracked but no damage was found in the acro tank.</p> <div data-bbox="954 1032 1426 1317" style="text-align: center;">

It is highly probable that the aircraft was damaged while the aircraft made a forced landing on a bamboo grass field, after collided its left wing against the iron pole which stood at the border of a peach orchard and a bamboo grass field.

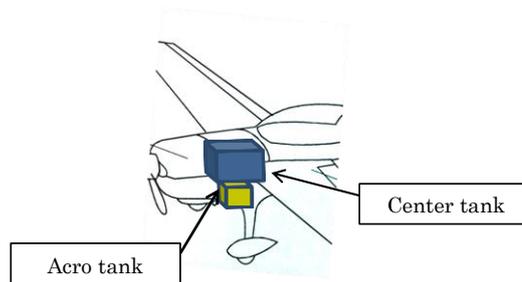
Figure 3: Fuel Tank

The fuel tanks of the aircraft consist of two wing tanks (60 L×2) located one in each wing, a center tank (42 L) and an acro tank (9 L) in front of the front seat .

The center tank and the acro tank are connected directly and the fuel is provided to the engine through the acro tank.

No fuel was observed in the center tank and only approximately 10 ml of fuel was observed in the acro tank.
