**AIRCRAFT SERIOUS INCIDENT
INVESTIGATION REPORT**

**FUJI DREAM AIRLINES CO., LTD.
J A 1 1 F J**

October 28, 2021

RUNNING OFF THE SIDE OF RUNWAY FUJI DREAM AIRLINES CO., LTD. EMBRAER ERJ 170-200 STD, JA11FJ YAMAGATA AIRPORT, JAPAN AROUND 16:46 JST, APRIL 23, 2019

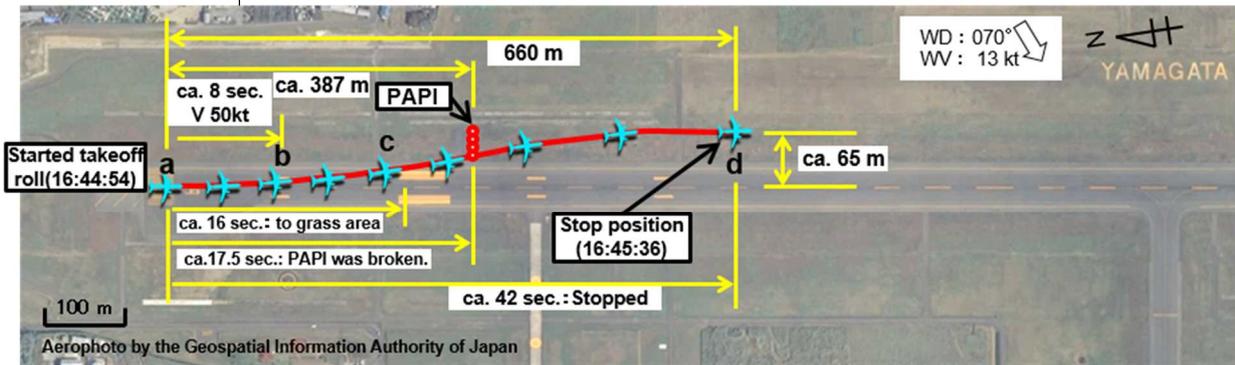
Figure 2: Estimated running track

Soon after starting takeoff roll, the Aircraft began to veer to the left of the runway centerline. The PIC thought that the Aircraft's nose would be going to veer to the left due to the weathercock effect as it was receiving the left tailwind, and tried to change the nose direction by applying the right rudder pedal, however, could not change the direction even with the maximum rudder pedal input.

The PIC decided to abort the takeoff about eight seconds after starting it, moved the thrust lever to the idle at about 50 kt (See Figure 2 b), then set it at the reverse position.

About 16 seconds after starting the takeoff, the Aircraft ran off the side of the runway (See Figure 2 c).

Because the PIC found the Precision Approach Path Indicator (PAPI) in the running direction, he tried to avoid a collision with it using the Handle, however, he felt an impact. After that, the Aircraft stopped in the grass field (See Figure 2 d).

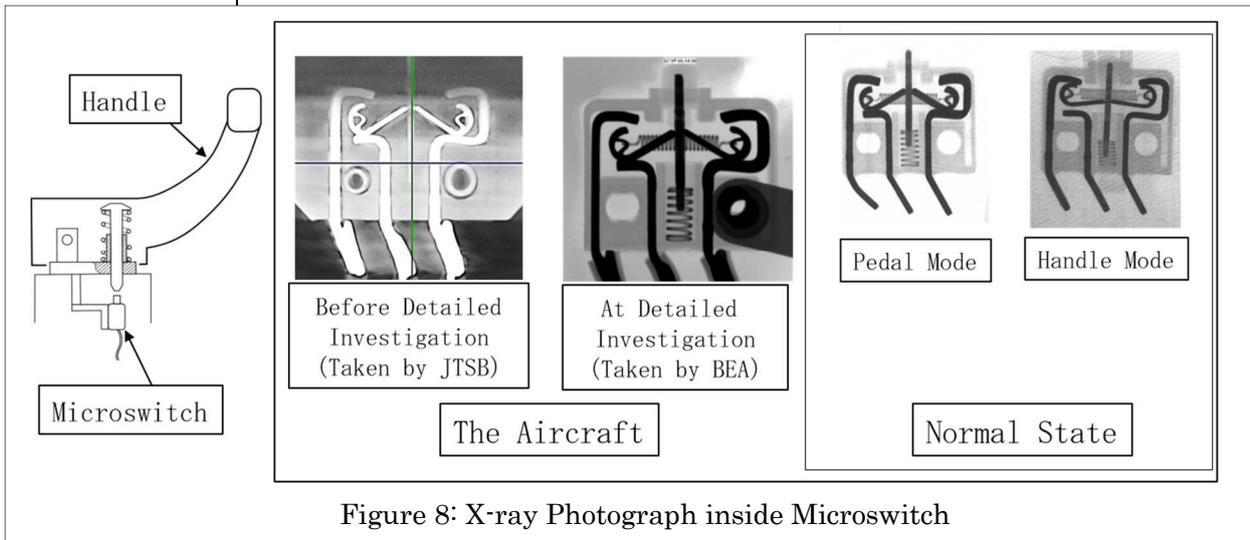
Figure 8: X-ray Photograph inside Microswitch

In the detailed investigation, although there was no abnormality on the Handle in appearance, it was identified that the microswitch stayed in the Handle mode even when the Handle was not pressed down in the continuity

After that, when performing the investigation regarding the state inside the Handle using X-ray photography, it was revealed that the microswitch of the Aircraft sent the signal electrically for the Handle mode, even though its internal state mechanically indicated the similarity with the state in the Pedal mode (See Figure 8), however, the cause couldn't be identified.

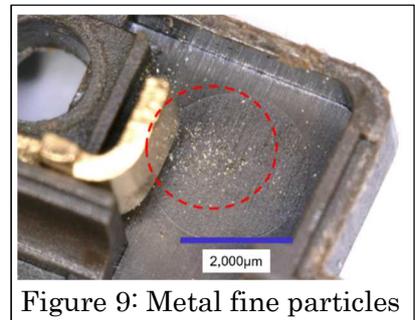
Figure 9: Metal fine particles

While at work for disassembly investigation of the microswitch that performed subsequently, the state where the Handle mode had been kept unchanged was eliminated, and after that, it was not reproduced. When observing the disassembled microswitch by a digital microscope, a very small amount of the metal fine particles and the fibrous material were observed near the contact points.

It is probable that the metal fine particles result from worn contact points inside the microswitch, however, the amount of metal fine particles was too small to determine the reason why the microswitch was in the Handle mode, in addition, it is highly probable that the fibrous material was low in the conductive property as a result of the investigation by a scanning electron microscope, therefore, neither was able to clarify the relationship to the fact that the microswitch had been in the Handle mode.
