AI2020-6

**AIRCRAFT SERIOUS INCIDENT
INVESTIGATION REPORT**

**PRIVATELY OWNED
JA121C**

RUNWAY OVERRUNNING PRIVATELY OWNED PIPER PA-46-350P, JA121C, AT OSHIMA AIRPORT, JAPAN AROUND 10:08 JST, MAY 4, 2019

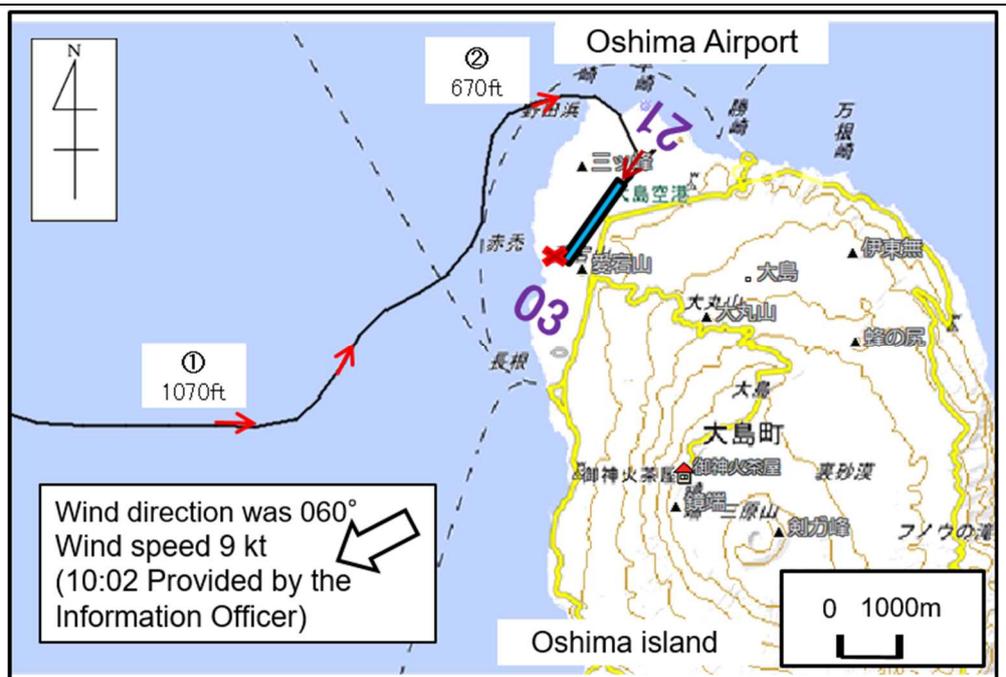
Figure 1: Estimated flight route (according to radar track records and ATC communication records)

At around 10:05 the Information Officer informed that there was no obstruction on Runway 03, and the captain read it back. (See Figure 1: Estimated flight route ①)

After that, at around 10:07, the Information Officer sighted the Aircraft, and informed the Aircraft saying “Are you sure that is Runway 21? Wind direction is 070°, and wind velocity is 7 kt, it’s a tail wind” because the Aircraft seemed to be going to land on Runway 21. As the Aircraft reported saying “Roger, We go on to land Runway 21”, the Information Officer informed the Aircraft saying “There is no obstruction on Runway 21.” (See Figure 1: Estimated flight route ②)

It is probable that because the captain initiated a base turn earlier and the Aircraft was affected by the northeastern wind, the base leg got close to the runway, which resulted in shorter final leg. For this reason, it is highly probable that the captain could not afford to perform flight maneuvers, could not reduce the speed, could not extend the landing gears until the warning alarmed around when the Aircraft was lined up with the final leg, in addition, the flap setting remained at 20° as he could not able to change the flap setting in time, and in this way, he failed to conduct operation required for a safety landing and continued to approach.

It is probable that the Aircraft should have made a go-around because the Aircraft's approach was not stable for landing.

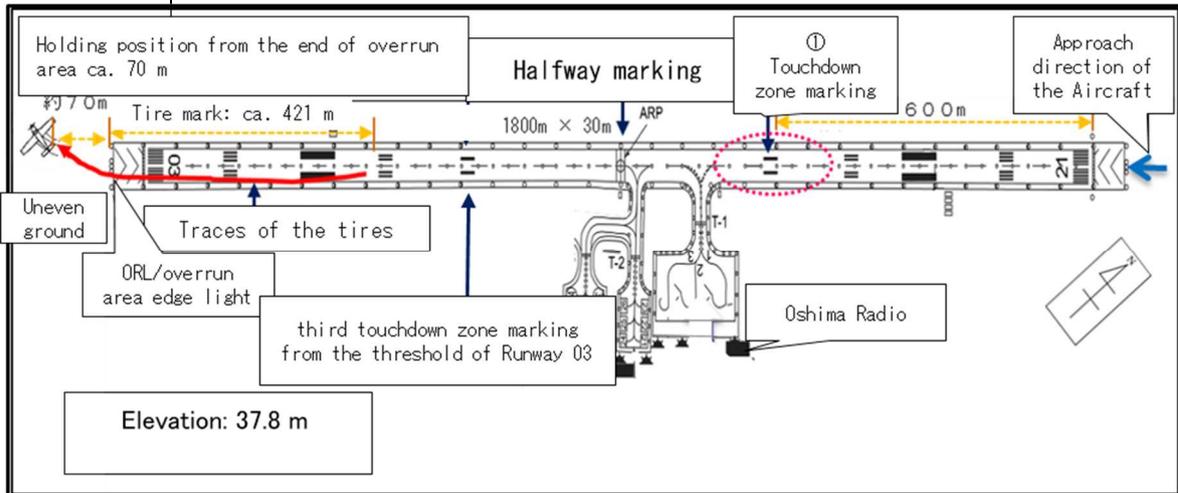
Figure 2: Runway plan view

Besides, the captain thought the Aircraft touched down beyond the third touchdown zone marking from the threshold of Runway 21, and applied the brakes normally, however, it is probable that the Aircraft touched down at the point beyond the halfway marking based on the report submitted by the captain and the statements of eyewitnesses. As shown in Figure 2, the same touchdown zone marking as the third touchdown zone marking from the threshold of Runway 21 is installed in the west side of the runway beyond the halfway marking as the third touchdown zone marking from the threshold of Runway 03. Furthermore, the captain stated that he did not applied maximum braking for a while after touchdown, taking into consideration the burst of tires, however, as the Aircraft was approaching the runway end, he applied maximum braking, and therefore, it is probable that the tire mark put in Figure 2 was the one that was made when the captain applied maximum braking. Based on these, it is somewhat likely that

the place where the Aircraft touched down was at the third touchdown zone marking from the threshold of Runway 03, beyond the halfway marking on the runway. In case that the Aircraft touched down in a tail wind of 5 kt, at the point about 600 m from the threshold of Runway 03, the landing ground roll distance is estimated to have been approximately 700 m when calculated based on the values obtained from the flight manual, and therefore, it is somewhat likely that the Aircraft was not able to stop within the runway length.

As mentioned above, it is probable that the Aircraft overran the runway because it touched down at an excess approach speed at the point beyond the halfway marking.

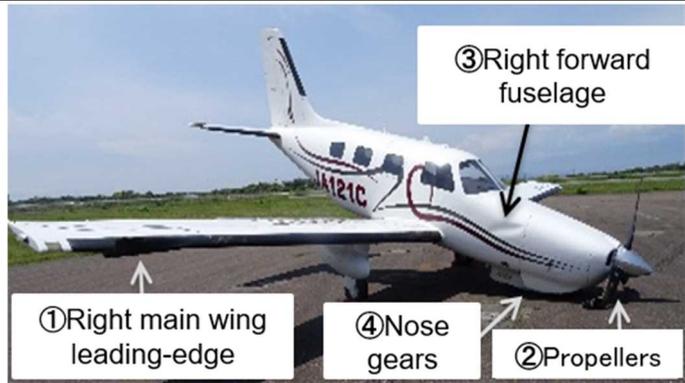
Figure 3: Serious incident aircraft

(1) Extent of damage:
Slightly damaged

- Aircraft damage
 - ① Right main wing leading-edge: Impact damage, bent
 - ② Propellers: Scratch marks
 - ③ Right forward fuselage: Outer skin dented
 - ④ Nose gears: Actuator damaged, scratch marks on the door
There was no abnormality in the brake system.

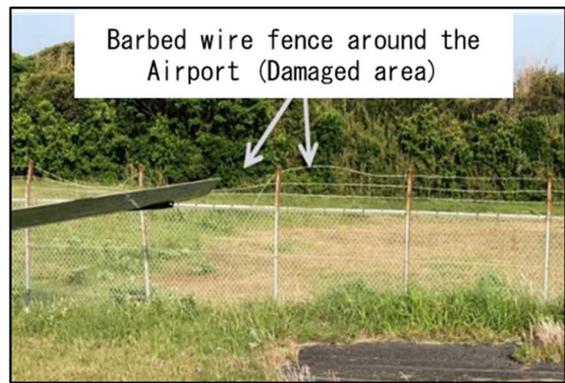
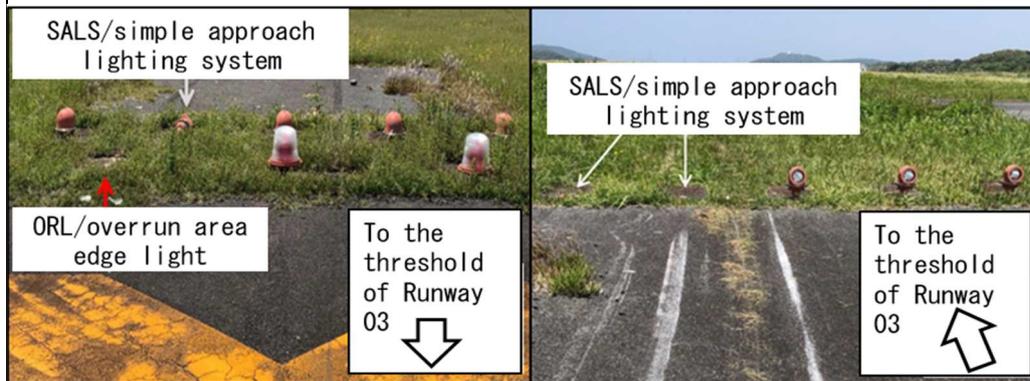
Figure 4: Damaged ground facilities

- ① Barbed wire fence around the Airport: Broken
- ② ORL/overrun area edge lights: One light broken
- ③ SALS/simple approach lighting system: Three lights broken
