AI2021-3

**AIRCRAFT SERIOUS INCIDENT
INVESTIGATION REPORT**

RUNWAY INCURSION SHANGHAI DEER JET CO., LTD. GULFSTREAM AEROSPACE G-VI, B-3276, ON RUNWAY 22 ENGAGED BY CESSNA 510, JA123F AT TOKYO INTERNATIONAL AIRPORT, JAPAN AROUND 12:38 JST, OCTOBER 27, 2018

February 5, 2021

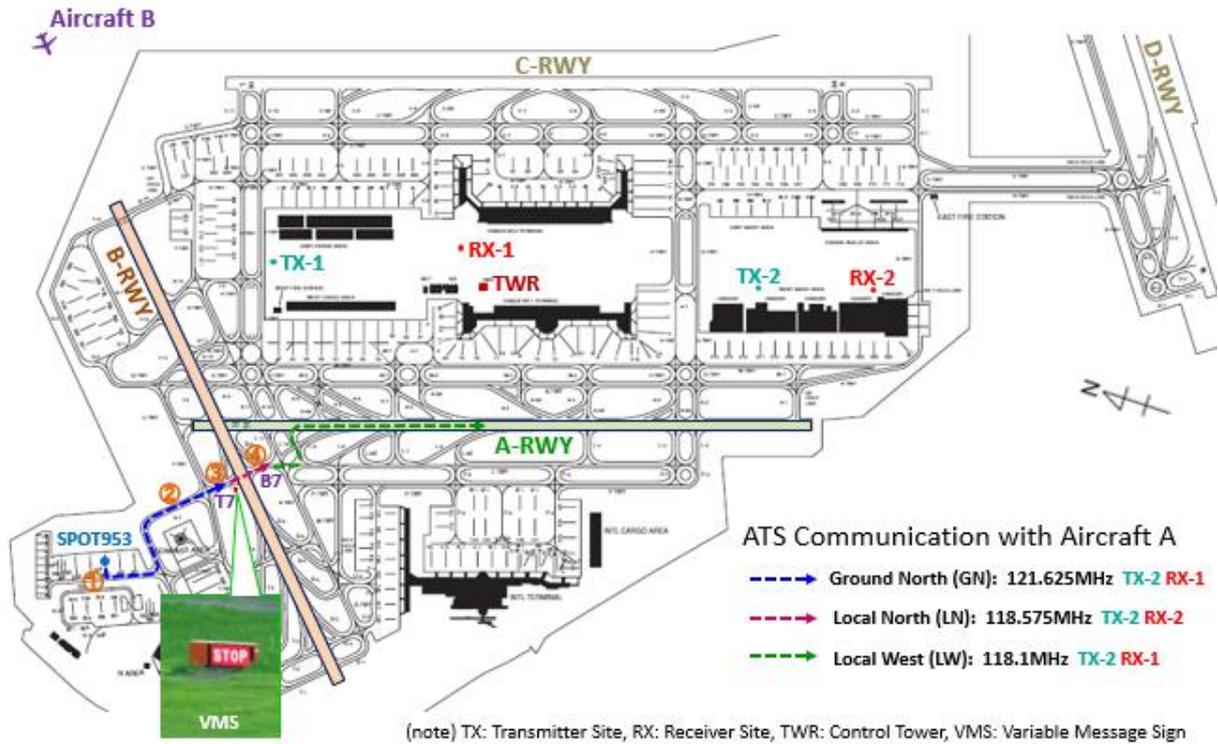
Figure 2: Taxiing route of Aircraft A, location of transmitter/receiver sites and VMS for Taxiway T7 at Tokyo International Airport

commenced taxiing from Spot 953, where it had been parked, to Departure Runway 16R (hereinafter referred to as “A-RWY”) at Tokyo International Airport for the flight to Wuxi Airport, People’s Republic of China (See ① in Figure 2). There were a total of ten persons on board Aircraft A, consisting of a captain, three crewmembers, one mechanic, and five passengers. The captain was sitting in the left pilot’s seat as PF*¹ and the FO in the right pilot’s seat as PM*¹ in the cockpit. At 12:35:25, Aircraft A

was instructed by GN to taxi to the runway-holding position markings on Taxiway T7 and hold short of Runway 22 (hereinafter referred to as “B-RWY”) (See ② in Figure 2).

GN instructed Aircraft A to change the radio frequency to LN (See ③ in Figure 2). Aircraft A immediately changed the radio frequency and called LN to establish communication*2. However, there was no trace of voice message that Aircraft A had called LN in the record of ATS communication, and the transmission from Aircraft A did not reach LN. At around 12:37:00, LN transmitted instructions to Aircraft A saying “B3276, TOKYO TOWER, HOLD SHORT OF RUNWAY 22 AT T7, STAND BY FURTHER INSTRUCTION DUE TO SEQUENCE”. The captain and the FO of Aircraft A heard LN call their call sign saying “B3276.....”, however, they

Runway status light (RWSL) system is an automated warning system that provides runway status information to aircraft and vehicles that the runway is in use by other aircraft or vehicle so that runway incursion can be prevented. The operation of RWSL system is independent of instructions from air traffic controllers. At Tokyo International Airport, the operation of RWSL is provided by using VMS. Taxiway T7 where Aircraft A was holding short before crossing B-RWY had VMS installed in the grassy area on the right side facing B-RWY. (See Figure 2)

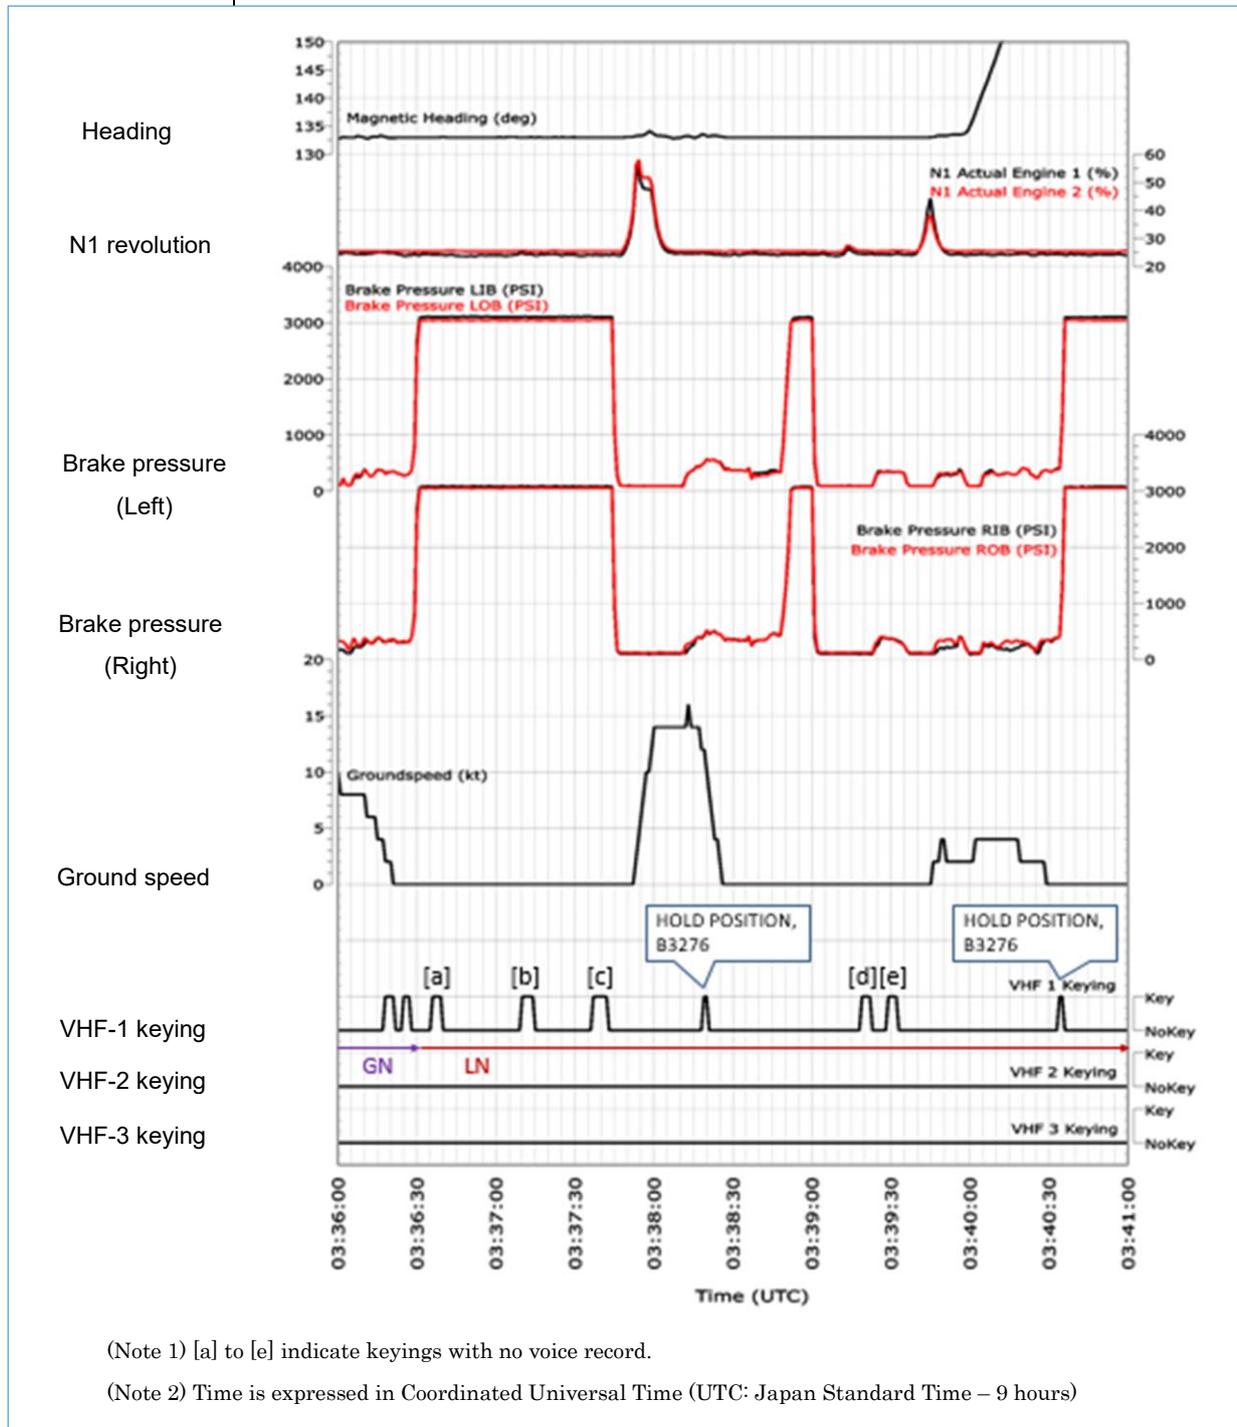
Figure 4: Recorded Data in the DFDR of Aircraft A

communications, respectively. By comparing the keying*³ record of VHF-1 radio kept stored in Digital Flight Data Recorder (DFDR) of Aircraft A with the voice record of ATS communications kept stored in the Digital Recording/Playback Equipment of Tokyo Airport Traffic Control Tower, it was revealed that receiving conditions of voice messages transmitted from Aircraft A to air traffic controllers around the time of the serious incident were as follows:

- Transmission to GN: Keying record: 10 times, Voice record: 10 times
- Transmission to LN: Keying record: 8 times, Voice record: 3 times
- Transmission to LW: Keying record: 6 times, Voice record: 6 times

According to the flight crew of Aircraft A, radio communication on the frequency of LN was good enough to hear; however, as is shown by the discrepancy between keying record and voice record above, transmission from Aircraft A to LN was sometimes received and sometimes not received. Besides, Aircraft A was equipped with cockpit voice recorder (CVR) capable of recording for two hours; however, the record at the occurrence of the serious incident was overwritten because Aircraft A continued flight until notice of the occurrence of this serious incident was delivered to the Company, and therefore, voice messages in keying could not be confirmed from CVR records. The FO of Aircraft A, who was in charge of ATS communication as PM, wore headset equipped in the aircraft. Besides, he only pressed PTT button with his right hand to communicate with LN, and did not touch a headset plug, a boom microphone or control panel of radio equipment. On the other hand, with regard to radio communication between Aircraft A and GN/LW, the number of times of keying and that of ATS voice recording were matched, and the timings of them were synchronized. Besides, as shown in Figure 4, there was no record of keying in VHF-2 radio and VHF-3 radio at the time of the occurrence of the serious incident. According to the Company, there was no record of malfunction in the radio equipment of Aircraft A or there was no malfunction reported from pilots.

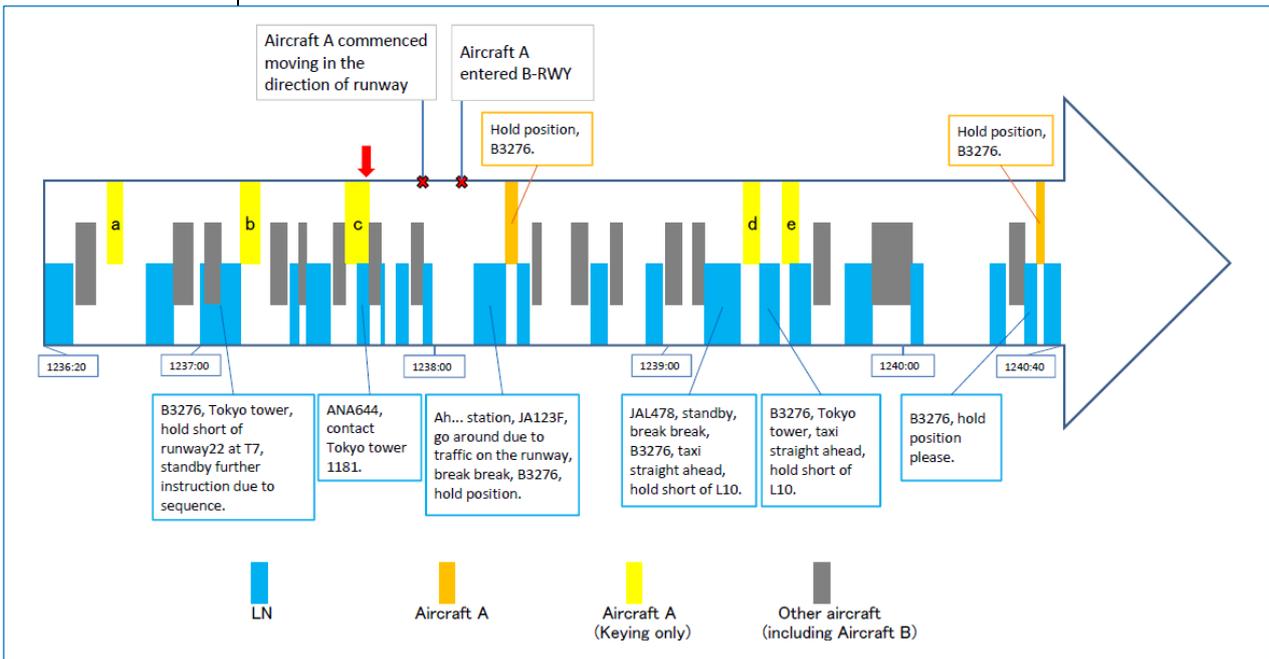
Figure 5: ATS Communication Record of LN and the Keying of Aircraft A

Aircraft A performed keying for approximately four seconds (Keying [a]) from about 12:36:36 after Aircraft A made the last communication with GN. Although there was no trace of voice transmission from Aircraft A in ATS communication record, and this voice transmission did not reach LN, it is probable that Keying [a] was made by Aircraft A with intention to establish communication with LN because it was recorded approximately eight seconds after Aircraft A read back the frequency change to GN.

After that, the captain and the FO of Aircraft A heard LN called the call sign of Aircraft A saying “B3276.....”, however, they could not hear the voice message following their call sign due to interfered transmission from other aircraft. Accordingly, the FO of Aircraft A stated that he transmitted to LN in order to confirm what the message was, however, there was no trace of voice transmission from Aircraft A in ATS communication record, and this voice transmission did not reach LN. The keying of Aircraft A for approximately five seconds (Keying [b]) from around 12:37:10 was performed immediately after the transmission of LN that is considered to have been interfered, therefore, it is probable that Keying [b] was performed with intention to confirm the transmitted message from LN.

Because there was no response from LN, the FO of Aircraft A transmitted the message again saying “CONFIRM, YOU ARE CALLING B3276, CLEARED TO CROSS RUNWAY 22 VIA T7, B7?” to LN, then, the flight crew of Aircraft A stated that they received the response of “AFFIRM” from LN. However, ATS communication record did not store such a voice message from Aircraft A nor the response from LN. On the other hand, the keying was

performed for approximately six seconds (Keying [c]) from around 12:37:37. It is probable that Keying [c] was performed in order to confirm again the transmitted message from LN because Keying [c] was recorded immediately after LN finished the communication with other aircraft following Keying [b].

Besides, LN transmitted a message to communicate with other aircraft for approximately three seconds from 12:37:40 when Aircraft A was performing Keying [c] because the voice message of the FO of Aircraft A, which is considered to have been transmitted in Keying [c], did not reach LN. While it is highly probable that both the transmission by LN and Keying [c] were completed about 12:37:43, it is somewhat likely that voice message of LN before completing the transmission was heard depending on the timing of releasing PTT button by the FO of Aircraft A. According to the communication record, the transmission by LN ended with "...one one eight one". By the way, "AFFIRM" is normally pronounced "əf æ:m" and is occasionally pronounced "éif æ:m" depending on pilots or air traffic controllers. It is somewhat likely that the captain and the FO of Aircraft A misheard the last two words of "eight one" in the transmission by LN as "éif æ:m", accordingly, they misunderstood that crossing B-RWY was cleared. (See red arrow in Figure 5)

It is probable that because the transmitted voice messages intended by Aircraft A in Keying [a], [b] and [c] did not reach LN, which caused a situation where the communications between Aircraft A and LN were not established. Besides, it is probable that Aircraft A heard part of voice messages intended for other aircraft transmitted by LN and misunderstood that crossing runway was cleared, Aircraft A entered the runway which Aircraft B was approaching for landing.
