AA2019-4

**AIRCRAFT ACCIDENT
INVESTIGATION REPORT**

**VANIRA AIR INC.
JA14VA**

FLIGHT ATTENDANT INJURY
BY THE SHAKING OF THE AIRCRAFT
VANILLA AIR INC.
AIRBUS A320-214, JA14VA
AT AN ALTITUDE OF ABOUT 9,100 M (FL300)
OVER THE SEA ABOUT 45 KM EAST OF
MIYAZAKI AIRPORT, JAPAN
AT ABOUT 10:35 JST, AUGUST 27, 2018

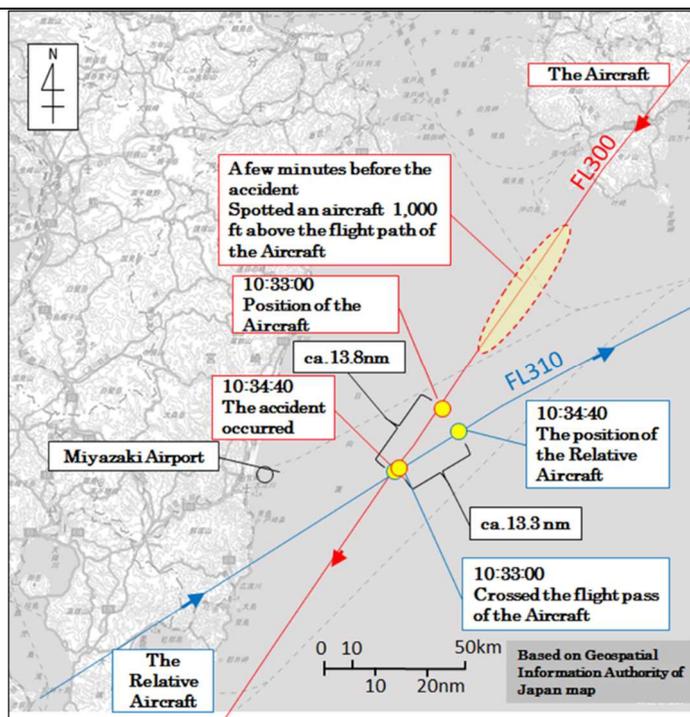
Figure 1: Estimated flight routes of the Aircraft and the Relevant Aircraft

According to the radar track records, about one minute 40 seconds before the accident, a Boeing 747-400F (CAL5254) was flying at FL310 from southwest to northeast in such a way as to cross the flight path of the Aircraft. The horizontal distance between the Aircraft and the Relevant Aircraft was about 13.3 nm when the accident occurred.

crossed 1,000 ft above the flight path of the Aircraft, and the Aircraft was flying 13.3 nm behind the Relevant Aircraft, when the Aircraft was shaken.

As described in the SIB issued by the European Aviation Safety Agency, on a flight at an altitude of 1,000 ft lower than the wake generating aircraft, it is possible to encounter wake turbulence up to 25 nm behind the wake generating aircraft, and the most significant encounters are reported within a distance of 15 nm. Judging from the fact that at the time of the accident, the winds were weak and the atmosphere was stable in the vicinity of the accident site, it is probable that wake turbulence from the Relevant Aircraft was not moved by wind but remained along the flight path of the Aircraft as it sank about 1,000 ft in about one minute and 40 seconds.

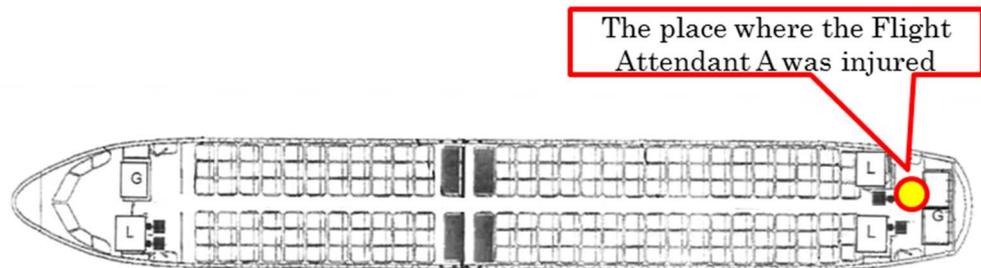
Figure 2: The place where the Flight Attendant A was injured

At 10:33:00, a few minutes after the PIC and the FO had spotted the Relevant Aircraft, it crossed in front of the Aircraft, and at 10:34:40, the Aircraft was suddenly shaken as if to be knocked up from below. At this time, the flight attendant (hereinafter referred to as “the Flight Attendant A”), who was preparing for cleaning in the aft galley after finishing in-flight services, had no time to grab something around her due to a sudden vertical shaking, fell down feeling as if her both feet floated in the air, and hit hard her buttock against the floor. The PIC and the FO felt that the shaking at this time was about the level of the light turbulence*3.

It is probable that because the winds were weak and the atmosphere was stable condition in the vicinity of the accident site, the weather conditions can be excluded from the factor that had triggered the shaking of the Aircraft that occurred only once; and the shaking of the Aircraft resulted from the Aircraft crossing through the Relevant Aircraft's wake turbulence which remained along the flight path of the Aircraft. It is also probable that the shaking of the Aircraft caused the Flight Attendant A to lose her balance, fall down and get injured in her buttock.

- a. The lessons learned from the accident
- b. How to response when encountering turbulence
- c. If falling down or having any body part hit against something, report immediately to the Senior Flight Attendant and confirm continuously whether or not there would be no injury or pain during the debriefing.

- a. There is a possibility that the aircraft would be shaken suddenly even if turbulence is not expected.
- b. If losing balance, they should prepare for unexpected turbulence by grabbing something to hold and others.
- c. From the past accidents related to turbulence, the flight attendants working in the aft cabin tend to suffer an injury in relation to a moment.

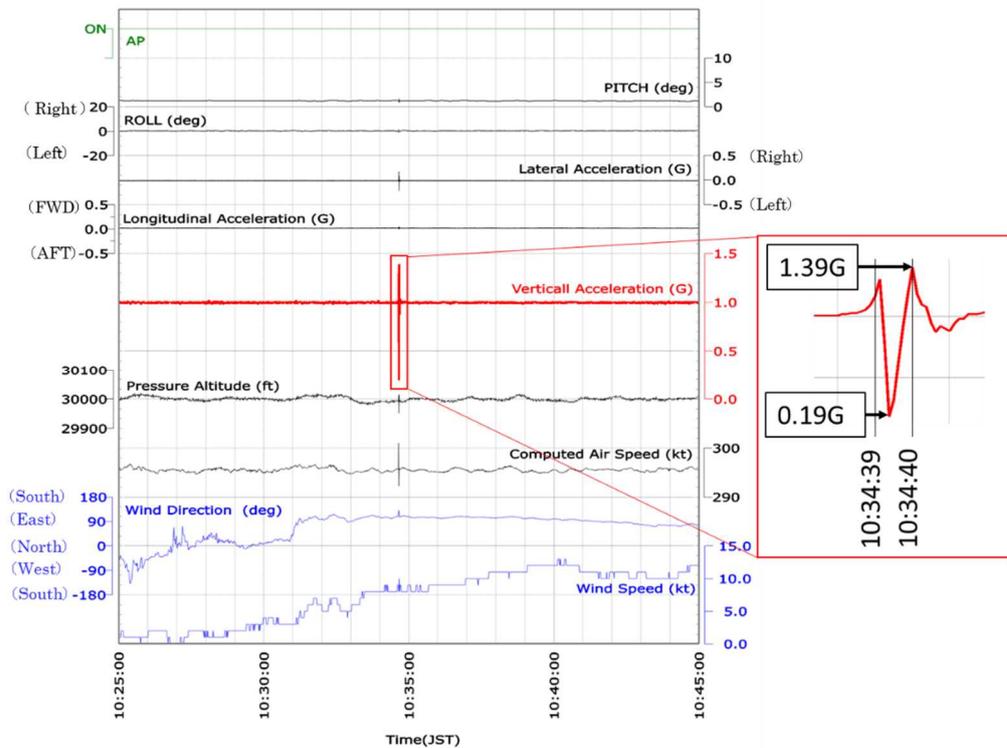
Figure 3: QAR records

According to the QAR records, from 10:34:39 to 10:32:40, the vertical acceleration fluctuated momentarily in the range between +0.19 G and +1.39 G. When the vertical acceleration fluctuated, there was little change in the attitude of the Aircraft.

It is probable that the timing of the Aircraft's shaking corresponded to the instantaneous fluctuation in vertical acceleration that was recorded on QAR.

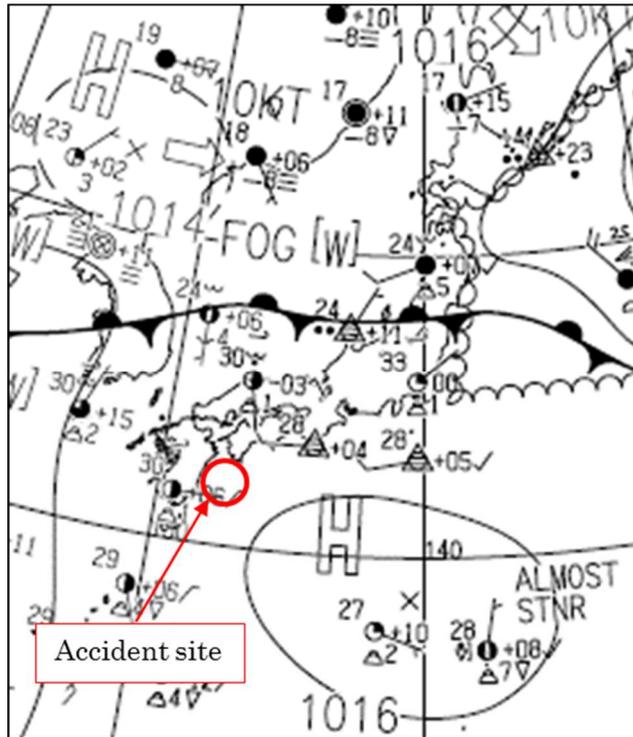
Figure 4: Asia-Pacific Surface Weather Chart (excerpt) at 09:00 JST on August 27, 2018

2.6 Meteorological Information	<p>According to the Asia-Pacific Surface Weather Chart for 09:00 and the Domestic Significant Weather Prognostic Chart for 10:00 issued by the Japan Meteorological Agency (JMA) on August 27, 2018, The airspace in the vicinity of the accident site was covered with high pressure located in the south of Japan, and no clouds accompanying significant weather were observed.</p> <p>In addition, there were no pilot reports (PIREP) on turbulence within one hours before as well as after the accident in the vicinity of the accident site, also according to the Hourly-Analysis Chart for 10:00, the winds were weak at 5 to 10 kt, and windshear indicating a change in wind direction and wind speed was not observed in the vicinity of the accident site.</p>
