**AIRCRAFT SERIOUS INCIDENT
INVESTIGATION REPORT**

**SAPPORO CITY FIRE DEPARTMENT AIR CORPS
J A 1 7 A R**

February 18, 2021

Company Name	Sapporo City Fire Department Air Corps
Type, Registration Mark	Agusta AW139 (Rotorcraft) JA17AR
Incident Class	Unintentional Drop of Object suspended to the Rotorcraft exterior. Article 166-4, item (xv), of the Ordinance for Enforcement of the Civil Aeronautics Act (Ordinance of Ministry of Transport No. 56 of 1952) prior to revision by the Ministerial Ordinance on Partial Revision of the Ordinance for Enforcement of Civil Aeronautics Act (Ordinance of Ministry of Land, Infrastructure, Transport and Tourism No. 88 of 2020)
Date and Time of the Occurrence	February 16, 2020 around 15:54 JST (JST: UTC+9 hours; unless otherwise stated, all times are indicated in JST in this report on a 24-hour clock)
Site of the Incident	Ishikari City in Hokkaido (43°12' 38" N, 141°18' 53" E)

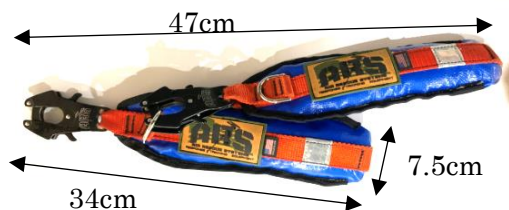
Fig. 2: Fallen weights

Weights are used to prevent unwanted swing when lowering the hoist hook. They weigh 2.27 kg each and two weights (total 4.54 kg) were stacked and used.

After the serious incident, it was confirmed that there were no damage to hoist hook and weight hook and functioned normally.

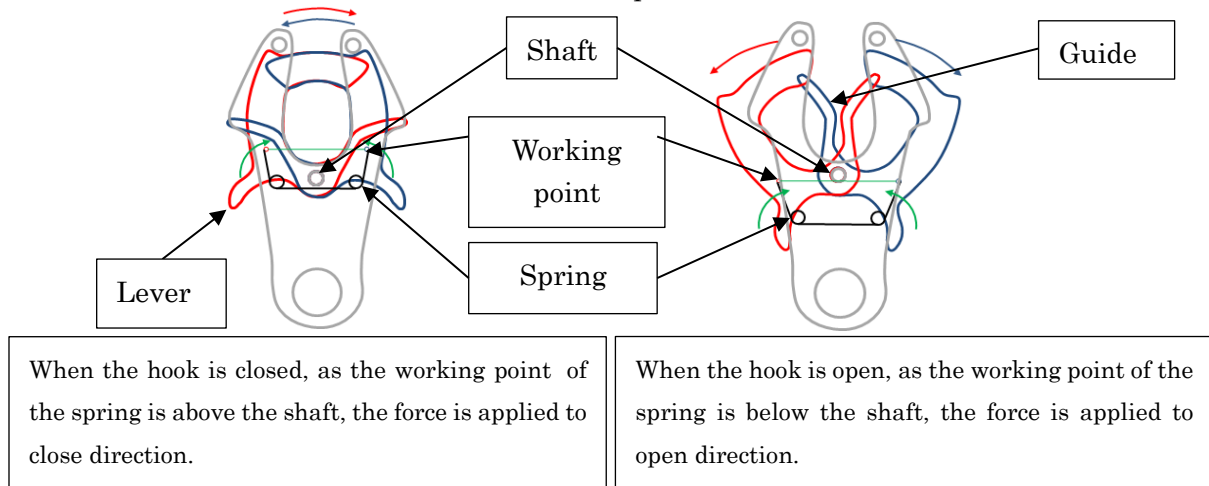
Fig. 5: Mechanism of the weight hook

The weight hook can be opened by squeezing levers on the both side and remains open. When you insert object to hook, the object pushes the guide and close the hook. The weight hook consists of two hook-shaped parts that are overlapped symmetrically and attached with a shaft, and the spring is pushing the two parts to close from both sides. As seen in Fig. 5, when the hook is closed, the spring force is applied in a direction to close, and when it is open, the force is applied in a direction to open. When you connect the weight to the hoist hole it is difficult to visually confirm situation of the weight hook whether it is open or closed for the weight hook works inside the hole.

The weight hook is mainly used as mountain-climbing gear, a weight manufacturer apart from the hook manufacturer used the hook in their product.

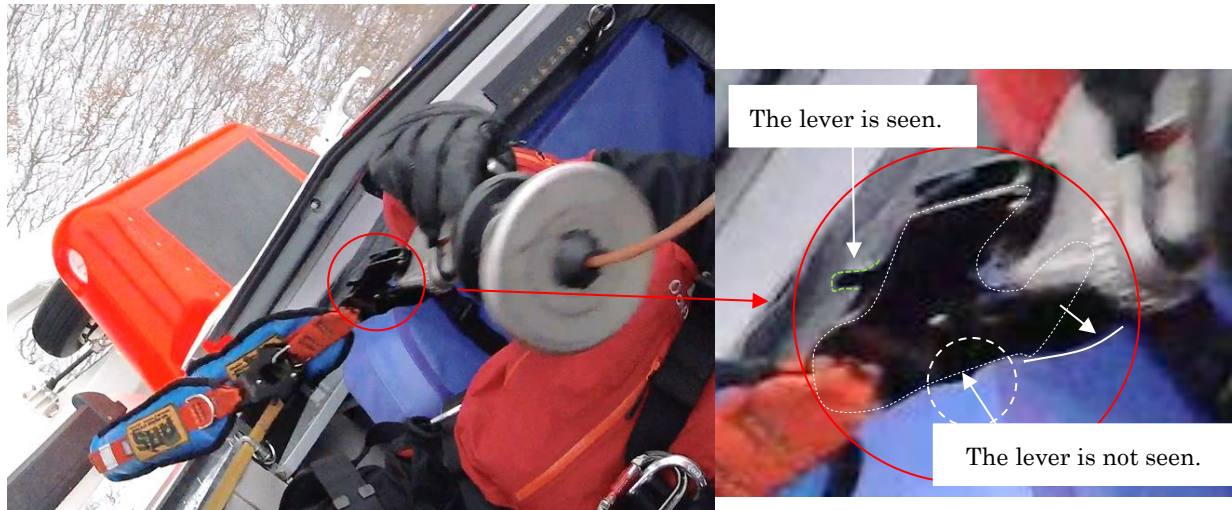
Fig.6: Condition of the hook just before being released

When the serious incident occurred, video was recording how the weights were released. Fig. 6 shows the situation just before the hoist hook and the weights were released outside of the Rotorcraft. The enlarged weight hook shows that the lever on one side can be seen, but the other side cannot. In addition, the black upper part of the hook seems to be open on its right side. From this, it was confirmed that one side of the hook was open when the weights were released.

When the rescue member hooked weights on the hoist hook, almost certainly one side of the weight hook was open. And when weights were released to the outside of the Rotorcraft, it is presumed that the turning force applied to the weight hook as the weights swayed, and the both sides of the weight hook opened and weights dropped.

The JTSCB concludes that the probable cause of this serious incident was the weight hook was almost certainly not properly closed when attached on the hoist hook, and at the timing weights with the hoist hook were released outside of the Rotorcraft, the hook opened and weights dropped.

- They suspended to use this weight.
- Revised the confirmation procedures when positioning the weight on the hoist hook as follows.
 - 1) The weight installation work shall be done inside the aircraft by the jumpmaster.
 - 2) After the weight installation, it shall be confirmed by applying tension
 - 3) The connection state of weights shall be double-checked by the jumpmaster and the hoist operator, and fall prevention rope shall be removed after this check and weight to be released outside of the Rotorcraft.

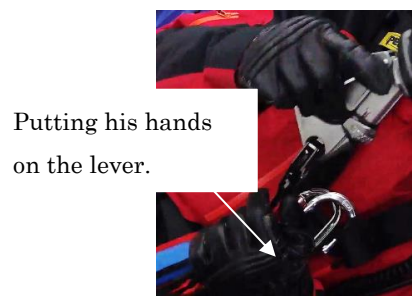
Fig. 7: Situation at weight installation

Fig. 7 show that the rescue member was putting his hands on the lever when hooking the weights to the hole. The instruction manual of the hook manufacturer, describes a warning that it should never hold the lever during connection. However, when they purchased the weight, no manual was attached.

As the rescue member had his hands on the lever when he hooked weights on the hoist hook, may contributed to the fact that weights hung on the hoist hook with the one side of the hook open, and he did not confirm whether the hook was certainly closed.

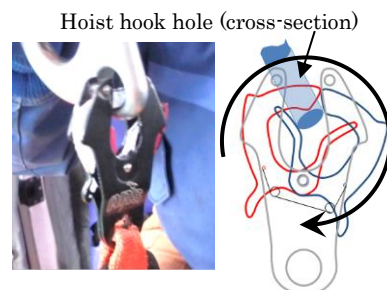
Fig. 8: Hook condition at verification

Based on the video, checking whether the weights may hang with right side hook open, it was found that weights were able to hang as seen in Fig. 8. If the weight was put outside in this state, weights would sway to the left, and therefore, the weight hook would turn clockwise as arrow indicates. It was confirmed due to the shape of the hook tip, the hoist hook opened the left side of the weight hook, so both sides of the hook were opened, and weights were unhooked.
