**AIRCRAFT SERIOUS INCIDENT
INVESTIGATION REPORT**

**SAPPORO CITY FIRE DEPARTMENT AIR CORPS
J A 1 7 A R**

February 18, 2021

Company Name	Sapporo City Fire Department Air Corps
Type, Registration Mark	Agusta AW139 (Rotorcraft) JA17AR
Incident Class	Unintentional Drop of Object suspended to the Rotorcraft exterior. Article 166-4, item (xv), of the Ordinance for Enforcement of the Civil Aeronautics Act (Ordinance of Ministry of Transport No. 56 of 1952) prior to revision by the Ministerial Ordinance on Partial Revision of the Ordinance for Enforcement of Civil Aeronautics Act (Ordinance of Ministry of Land, Infrastructure, Transport and Tourism No. 88 of 2020)
Date and Time of the Occurrence	February 16, 2020 around 15:54 JST (JST: UTC+9 hours; unless otherwise stated, all times are indicated in JST in this report on a 24-hour clock)
Site of the Incident	Ishikari City in Hokkaido (43°12' 38" N, 141°18' 53" E)

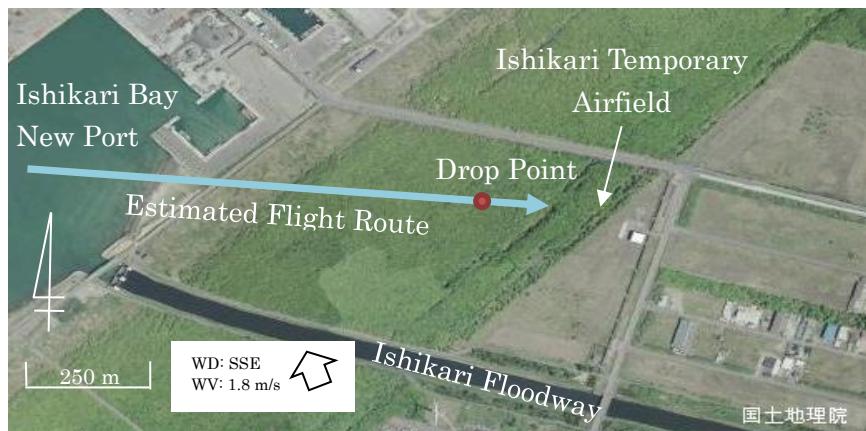
Fig. 1: Estimated flight route

The Rotorcraft took off from the Ishikari Temporary Airfield and conducted hoist rescue training simulating Airfield as a rescue site. It was scheduled to conduct six hoist trainings, and at its sixth run, on the approach from the west, Rotorcraft opened the right

cabin door, and when rescue member positioned weights on the hoist hook hole and released them outside, weights came off from hoist hook hole and dropped from altitude 180 ft (55 m). The weights were found in the national forest located about 250m on the west side of the Airfield. There were no damage to human or any object on the ground.

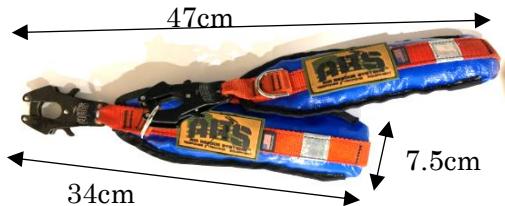
Fig. 2: Fallen weights

Weights are used to prevent unwanted swing when lowering the hoist hook. They weigh 2.27 kg each and two weights (total 4.54 kg) were stacked and used.

After the serious incident, it was confirmed that there were no damage to hoist hook and weight hook and functioned normally.

- They suspended to use this weight.
- Revised the confirmation procedures when positioning the weight on the hoist hook as follows.
 - 1) The weight installation work shall be done inside the aircraft by the jumpmaster.
 - 2) After the weight installation, it shall be confirmed by applying tension
 - 3) The connection state of weights shall be double-checked by the jumpmaster and the hoist operator, and fall prevention rope shall be removed after this check and weight to be released outside of the Rotorcraft.

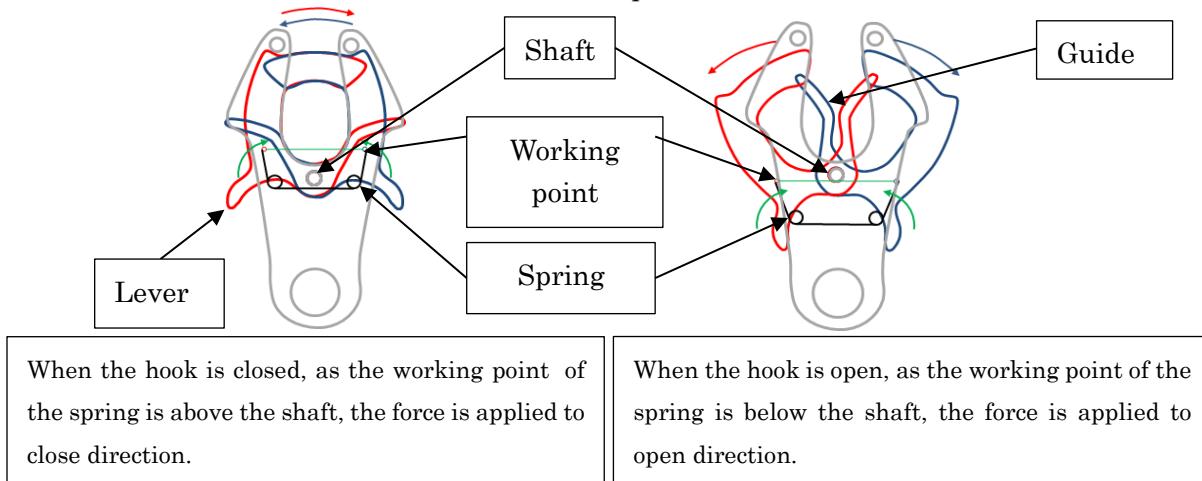
Fig. 5: Mechanism of the weight hook

The weight hook can be opened by squeezing levers on the both side and remains open. When you insert object to hook, the object pushes the guide and close the hook. The weight hook consists of two hook-shaped parts that are overlapped symmetrically and attached with a shaft, and the spring is pushing the two parts to close from both sides. As seen in Fig. 5, when the hook is closed, the spring force is applied in a direction to close, and when it is open, the force is applied in a direction to open. When you connect the weight to the hoist hole it is difficult to visually confirm situation of the weight hook whether it is open or closed for the weight hook works inside the hole.

The weight hook is mainly used as mountain-climbing gear, a weight manufacturer apart from the hook manufacturer used the hook in their product.

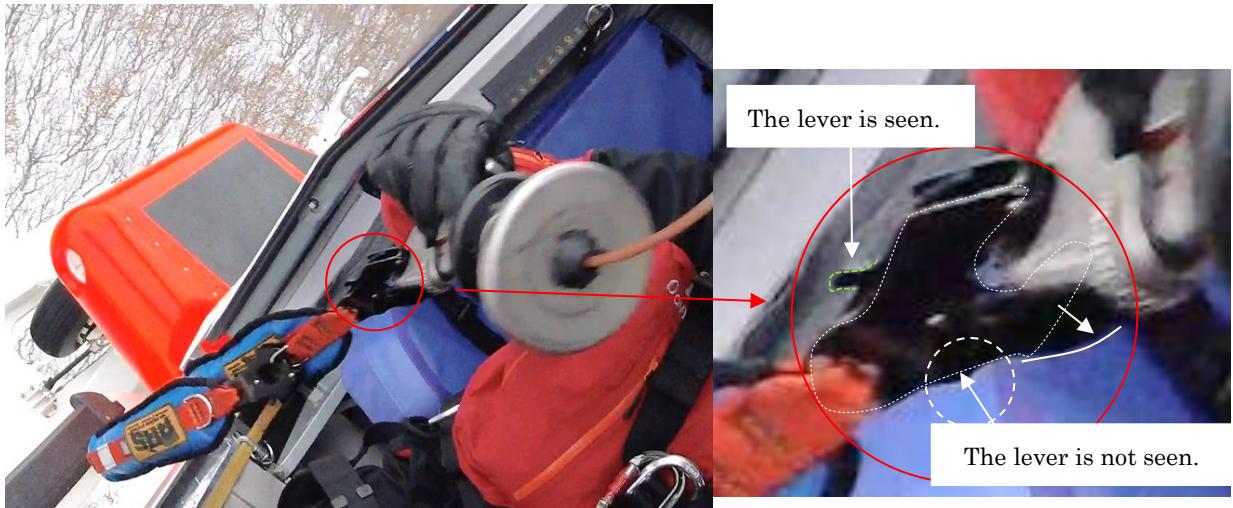
Fig.6: Condition of the hook just before being released

When the serious incident occurred, video was recording how the weights were released. Fig. 6 shows the situation just before the hoist hook and the weights were released outside of the Rotorcraft. The enlarged weight hook shows that the lever on one side can be seen, but the other side cannot. In addition, the black upper part of the hook seems to be open on its right side. From this, it was confirmed that one side of the hook was open when the weights were released.

In addition, it was confirmed from the video, when the rescue member hooked the weight and released outside, he did not make sure that the weights were certainly hooked on the hoist hook hole.

When the rescue member hooked weights on the hoist hook, almost certainly one side of the weight hook was open. And when weights were released to the outside of the Rotorcraft, it is presumed that the turning force applied to the weight hook as the weights swayed, and the both sides of the weight hook opened and weights dropped.

It is difficult to visually confirm the open/close state of the weight hook; therefore, it is necessary to ensure that the hook is closed by applying tension to the weight.

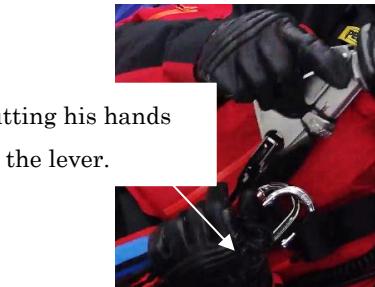
Fig. 7: Situation at weight installation

Fig. 7 show that the rescue member was putting his hands on the lever when hooking the weights to the hole. The instruction manual of the hook manufacturer, describes a warning that it should never hold the lever during connection. However, when they purchased the weight, no manual was attached.

As the rescue member had his hands on the lever when he hooked weights on the hoist hook, may contributed to the fact that weights hung on the hoist hook with the one side of the hook open, and he did not confirm whether the hook was certainly closed.

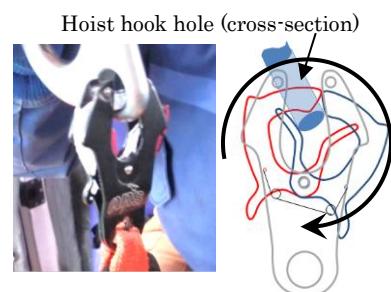
Fig. 8: Hook condition at verification

Based on the video, checking whether the weights may hang with right side hook open, it was found that weights were able to hang as seen in Fig. 8. If the weight was put outside in this state, weights would sway to the left, and therefore, the weight hook would turn clockwise as arrow indicates. It was confirmed due to the shape of the hook tip, the hoist hook opened the left side of the weight hook, so both sides of the hook were opened, and weights were unhooked.
