**AIRCRAFT ACCIDENT
INVESTIGATION REPORT**

**GUNMA PREFECTURAL DISASTER PREVENTION AVIATION UNIT
J A 2 0 0 G**

**CRASH INTO MOUNTAIN SLOPE
GUNMA PREFECTURAL
DISASTER PREVENTION AVIATION UNIT
BELL 412EP (ROTORCRAFT), REGISTERED JA200G,
IN THE VICINITY OF ABOUT 2 KM NORTHEAST OF
MT. YOKOTE IN NAKANOJO TOWN,
AGATSUMA COUNTY, GUNMA PREFECTURE, JAPAN
AROUND 10:01 JST ON AUGUST 10, 2018**

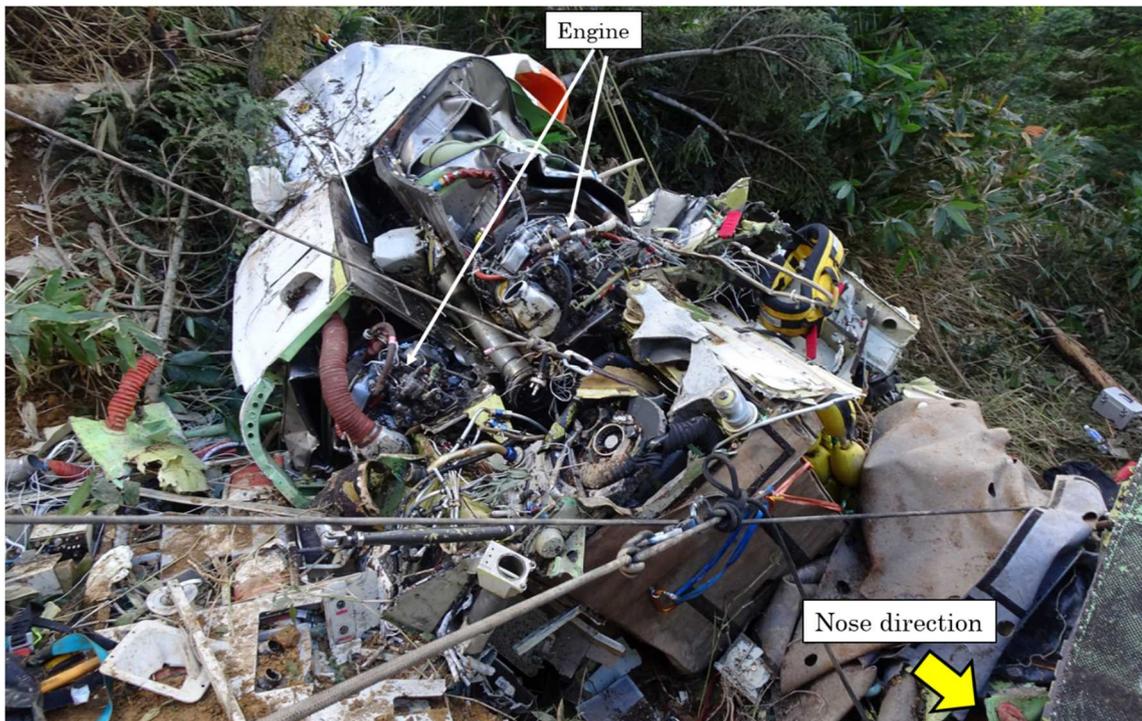
Figure 6: Damaged condition of the airframe at the accident site

- (1) Fuselage: deformed and destroyed
- (2) Empennage: separated and damaged
- (3) Engines: damaged
- (4) Rotor system: damaged and destroyed
- (5) Control system: deformed and destroyed

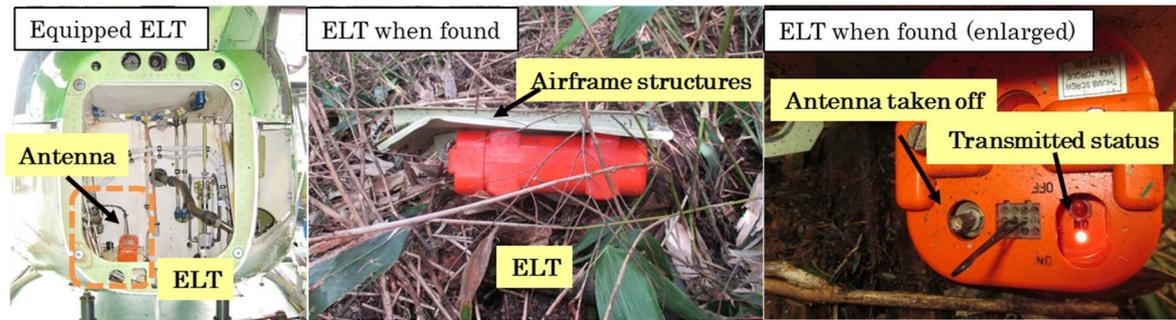
Figure 11: Position of installed ELT and the condition of ELT when found

Emergency Locator Transmitter (ELT) was installed in the airframe structures of aft fuselage and was found together with the fractured airframe structures at about 20 m short of the wreckage of the main airframe at the accident site. Distress signal was transmitted from the ELT main body, however, rescuing aircraft and so on were unable to receive ELT signal because ELT had been disconnected from the antenna on the aircraft.

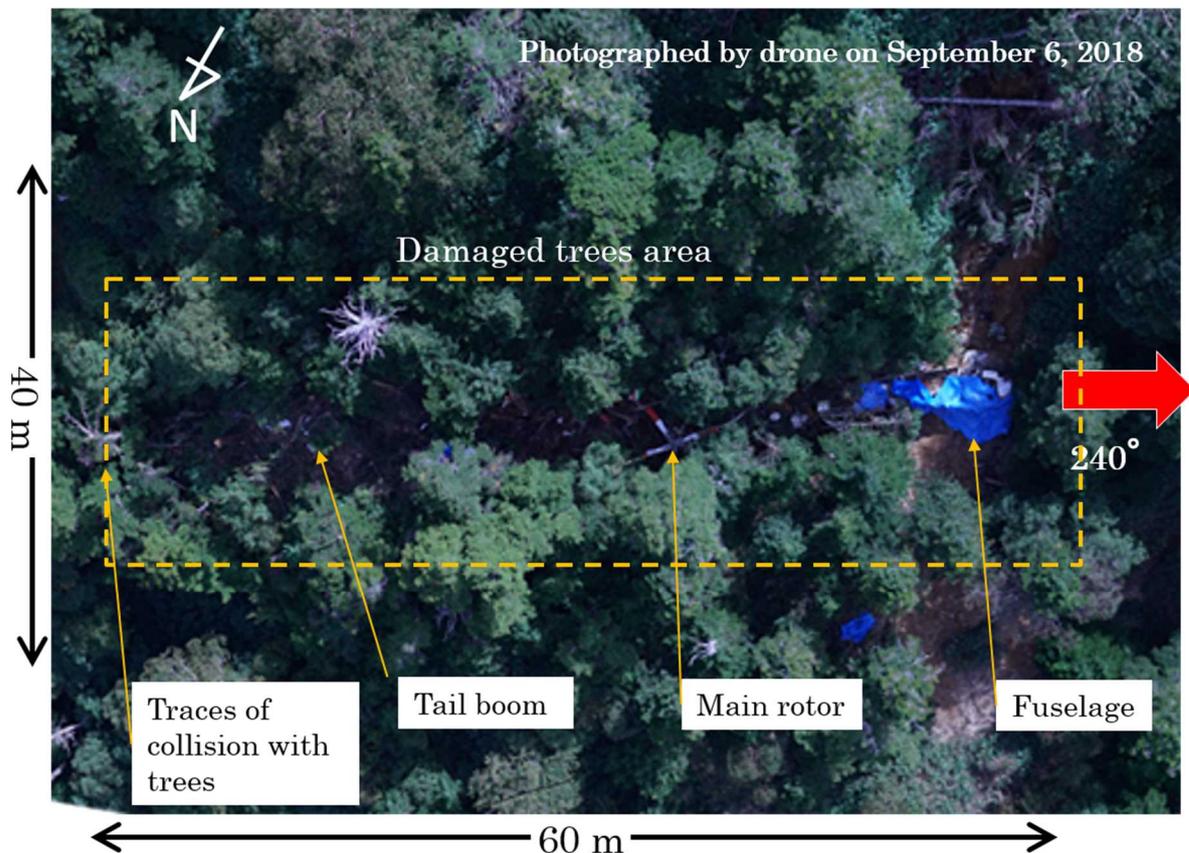
Figure 12: Scattered airframe at the accident site

The accident site was the northern slope located 2 km northeast from the summit of Mt. Yokote and coniferous trees with a height over 10 m grew there. The wreckage was scattered in an area of about 40 m longitudinally and about 60 m laterally.

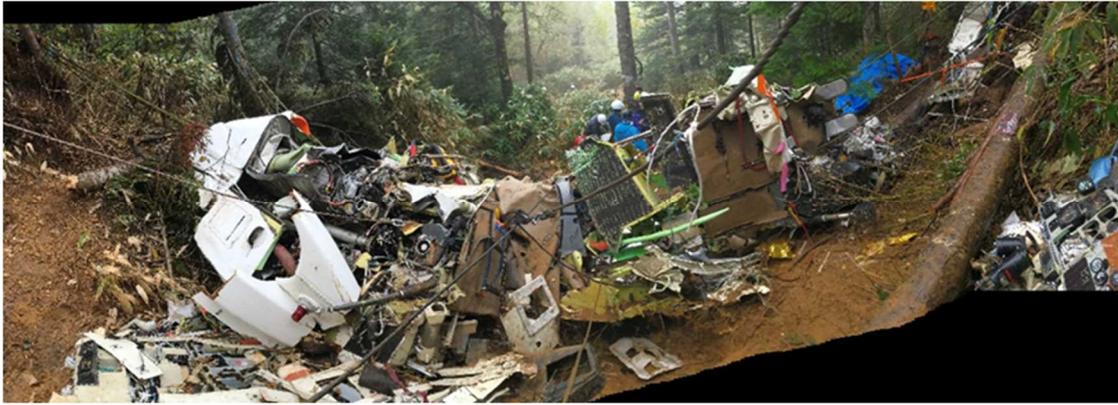
Figure 15: Damage from nose to aft fuselage

Main rotor, transmission, tail pylon and fuselage were separated and scattered. Fuselage from nose to cabin was severely deformed and destroyed in a vertical direction. Two engines remained in the upper fuselage in a deformed condition. Damage to the lower part of the forward fuselage was severe and the panels on the lower part were damaged and scattered.

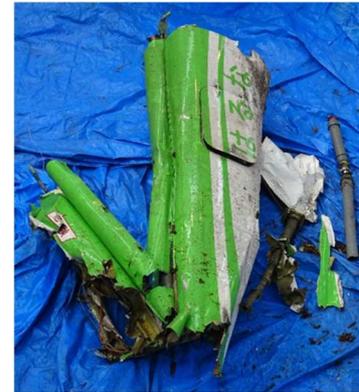
Figure 18: Tail boom

Tail boom was fractured and separated at the attached section connected by bolts and aft side was bent to the left with traces of collision with trees remained.

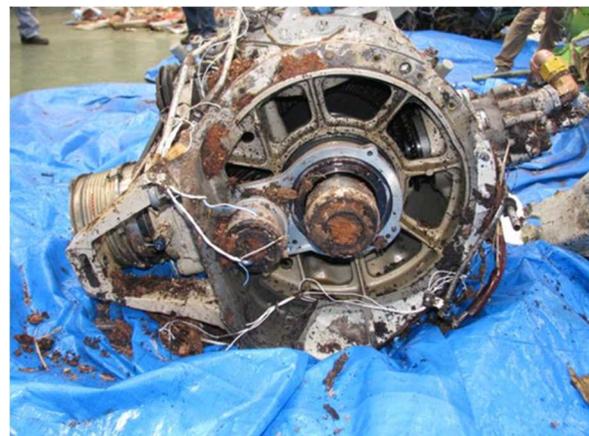
Figure 19: Main transmission

The main transmission and the main rotor head were separated from the airframe and dropped in connected condition 20 m short of the fuselage. The main transmission was deformed and did not show abnormality other than one caused by the crash. The hubs in blue and yellow colors of the main rotor head, to which

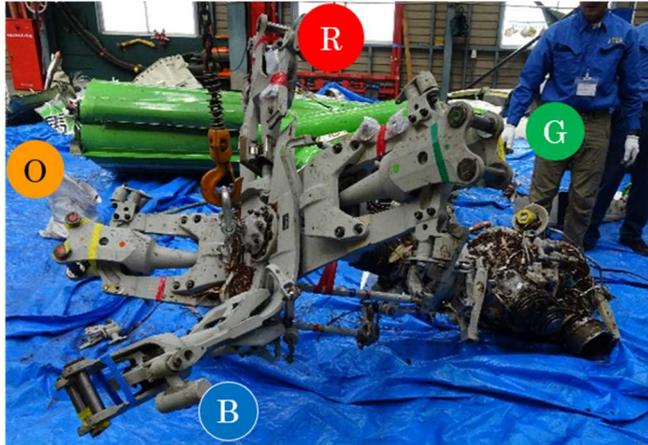
Figure 20: Main rotor head

four color coded main rotor blades in red, green, blue and yellow were attached, were severely deformed.

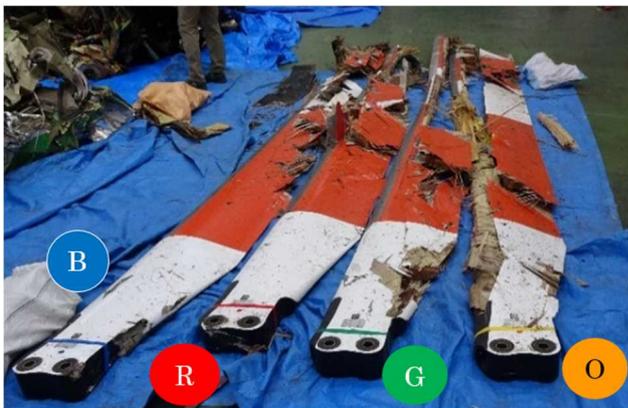
Figure 21: Main rotor blades

The main rotor blades were fractured from near one third of the attached section of the blades to the tip of the blades. The tail rotor had its blades fractured, and was able to rotate by manual operations.

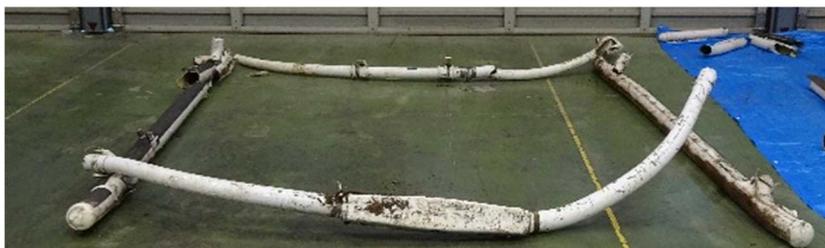
Figure 23: Cross tube

The cross tube was severely deformed and the tip of the left skid was fractured as if it had been smashed. Some part of the fractured left skid could not be found.

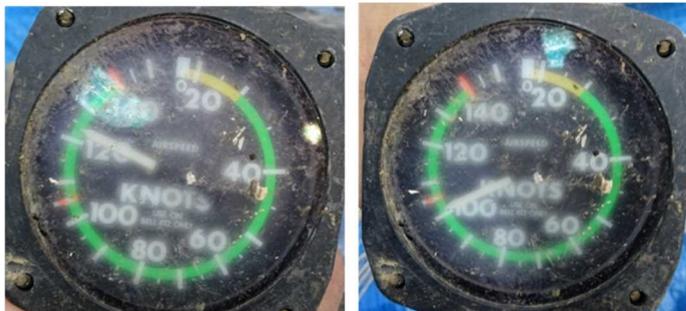
Figure 25: Airspeed indicator in the left seat

Instrument panel in the pilot seat was destroyed in a smashed condition. The airspeed indicator in the left seat was found in the condition of being detached from the instrument panel and the needle moved between 101 kt and 123 kt when it was shaken.

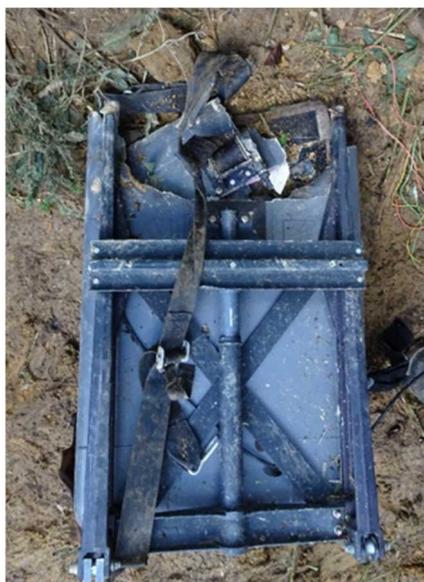
Figure 26: Right pilot's seat

The shoulder harness equipped in the right pilot seat was movable and the upper portion of the backrest was fractured. The left pilot seat was deformed and the backrest did not suffer a severe damage.

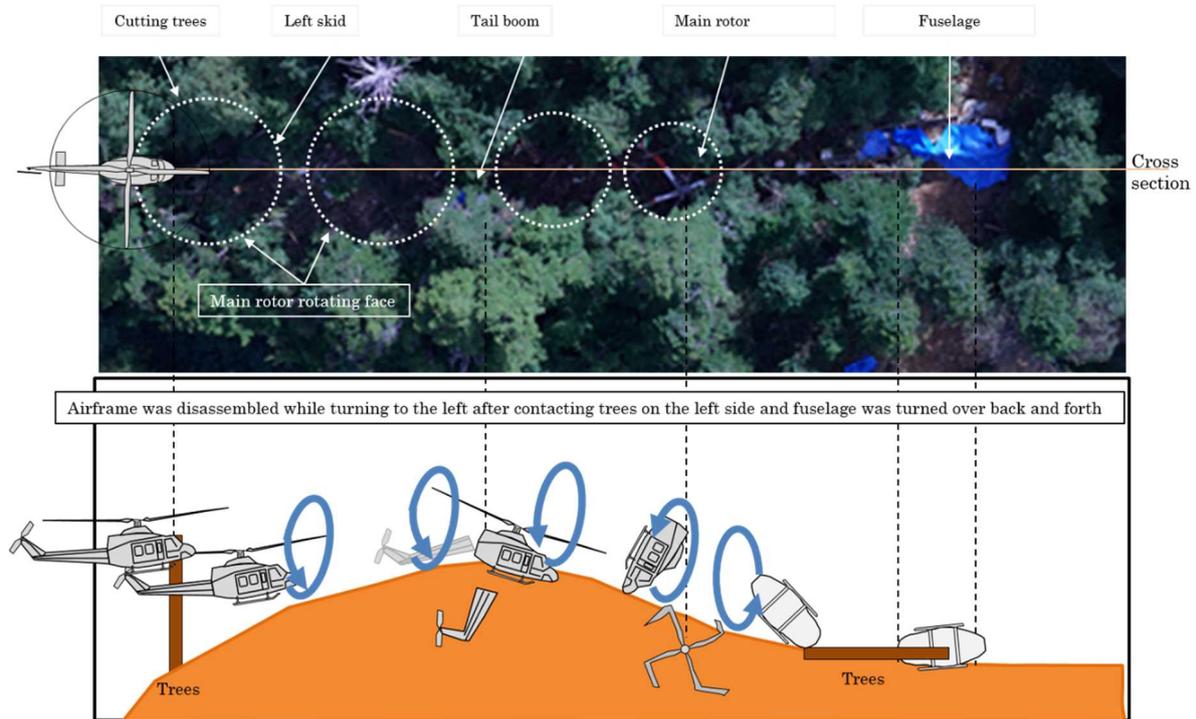
Figure 39: Figure showing inverted airframe when crashed

antenna being separated after the main rotor and transmissions were separated from the aircraft and was inverted with the front reversed to the rear.
