**AIRCRAFT ACCIDENT
INVESTIGATION REPORT**

**FIRST FLYING CO., LTD.
J A 2 0 1 D**

AIRCRAFT DAMAGE DUE TO RUNWAY SIDE EXCURSION DURING LANDING

VIKING DHC-6-400, JA201D

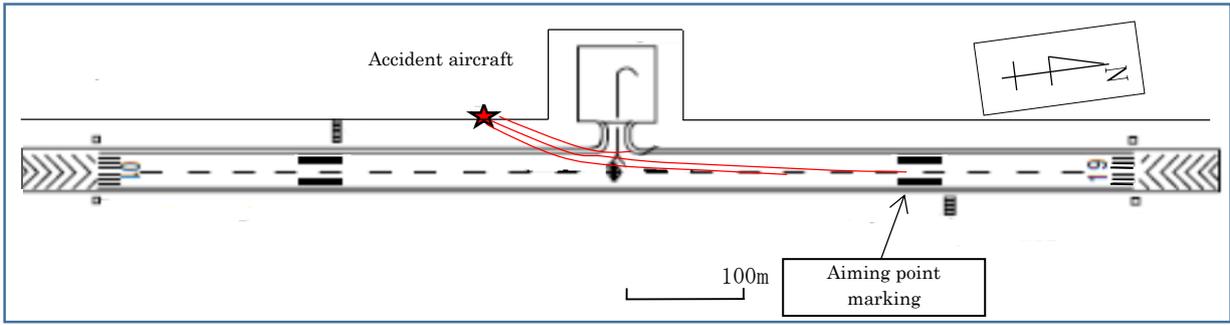
Fig. A State of tire marks

The tire marks of the nose wheel extended from near the aiming point marking on Runway 19 where the Aircraft touched down, the tire marks of the left main wheel extended from near the runway centerline marker about 90 m south from the south end of the aiming point marking, and the heavy tire marks of the right main wheel extended from near the runway deviation location (north end of the taxiway), respectively, to the stop position of the Aircraft. As shown in Fig.A, the tire marks of the nose wheel and left main wheel remained as gentle curves that looked like straight lines (angle of deflection to the right about 4°: deflection of about 13 m to the right while traveling about 207 m) up to near the north end of the taxiway where the thick tire marks of the right main wheel started. From that point on, the degree of deflection to the right of marks of the nose wheel and both main wheels gradually increased; moreover, after entering the grass area about 420 m from the Runway 19 threshold, the tire marks of the left main wheel also became thick and deep with continuous gouge marks on the grass so that the ground underneath was visible, and the nose wheel tire marks were wider than they had been on touchdown. Furthermore, the gap between marks of the nose wheel and both main wheels just before entering the grass area was wider on the left side than on the right, showing that the longitudinal axis was pointing further to the right than the direction of travel.

In view of these facts, it is probable that the tire marks of the left main wheel remained on the runway surface as a result of friction with the runway arising while traveling, because it became the main wheel on the outside of the turn supporting the centrifugal force that arose when the Aircraft turned slowly to the right while inclining to the left. Moreover, the continuous tire scuff marks of the nose wheel, which are not seen when landing normally, started from near the touchdown point; therefore, it is probable that the marks resulted from friction with the runway arising because the nose wheel deflected somewhat to the right and had an angle of intersection vis-à-vis the direction of travel of the Aircraft when the nose wheel touched down. Furthermore, it is probable that the thick tire marks of the right main wheel starting from just before the deviation from the runway were brake marks caused by friction with the runway due to the activation of the hard right brake.

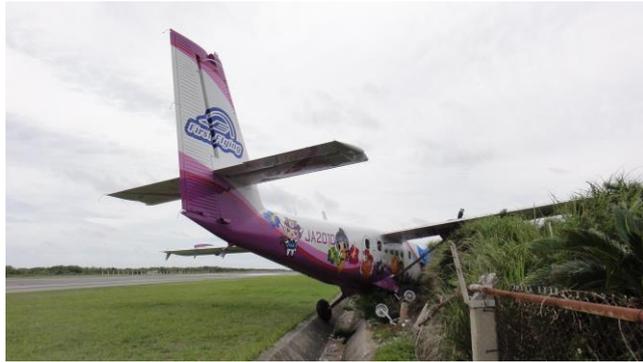
Photo B Situation when the Aircraft stopped

The Aircraft crossed the lateral groove on the inside of the Perimeter Fence at a position about 510 m from the Runway 19 threshold, and came to a halt on the Perimeter Fence with its nose pointing south-southwest.

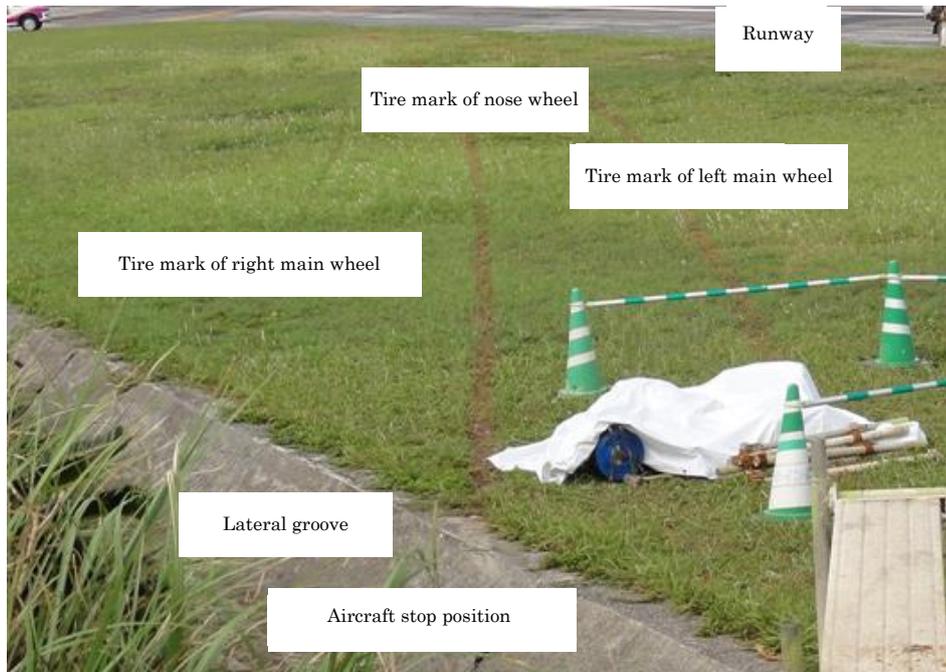
Photo D Tire marks just before the collision with the Perimeter Fence
(See Annex Fig.1: Estimated Flight Route and Accident Site, Photo: Accident Aircraft)

Moreover, because the touchdown marks of the nose wheel grew wider and thick after the Aircraft entered the grass area, it is probable that the angular difference between the direction of its travel and the direction of the nose wheel gradually widened while rolling on the grass. It is probable that the nose wheel, having been significantly damaged by the collision with the lateral groove and the Perimeter Fence, thereafter finally deflected by up to about 31.5° to the right as a result of the impact at

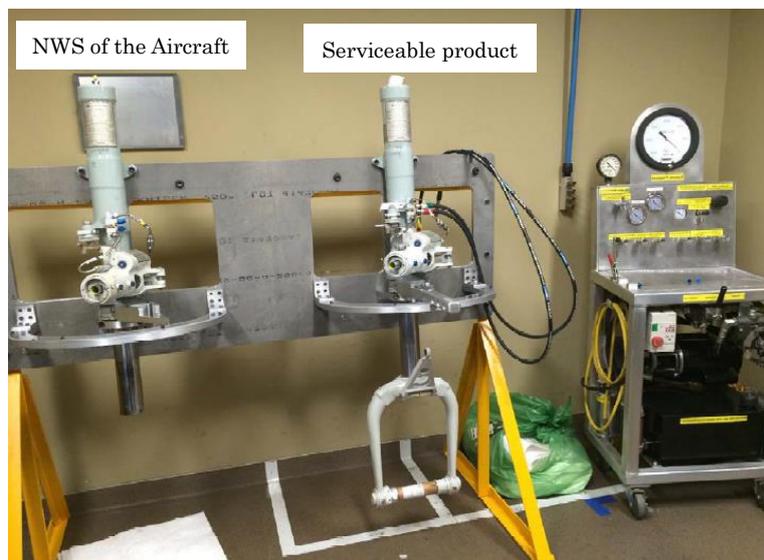
Photo E Situation of the NWS functional test

- (1) The deflection angle to the right by the NWS, which was removed from the Aircraft after the accident, was about 31.5°.
- (2) In the functional test conducted under the provisions of the Maintenance Manual while supplying hydraulic pressure from a test device and comparing with a serviceable product, the following facts were found.

- 2) When the prescribed force was applied in the direction for turning the nose wheel to right and left, and then released without steering command input, the serviceable product retained that position; however a phenomenon of a creep which swing gently was observed in the Aircraft NWS.

It is probable that the cause of a creep phenomenon was internal damage to the hydraulic pressure working mechanism, but this could not be identified during this test.

Since the phenomenon of a creep seen after applying force without steering commands input only arose when the nose wheel was not subject to force, and the extent was very limited and not uniform, it is probable that there is no problem in the directional control mechanism after landing.

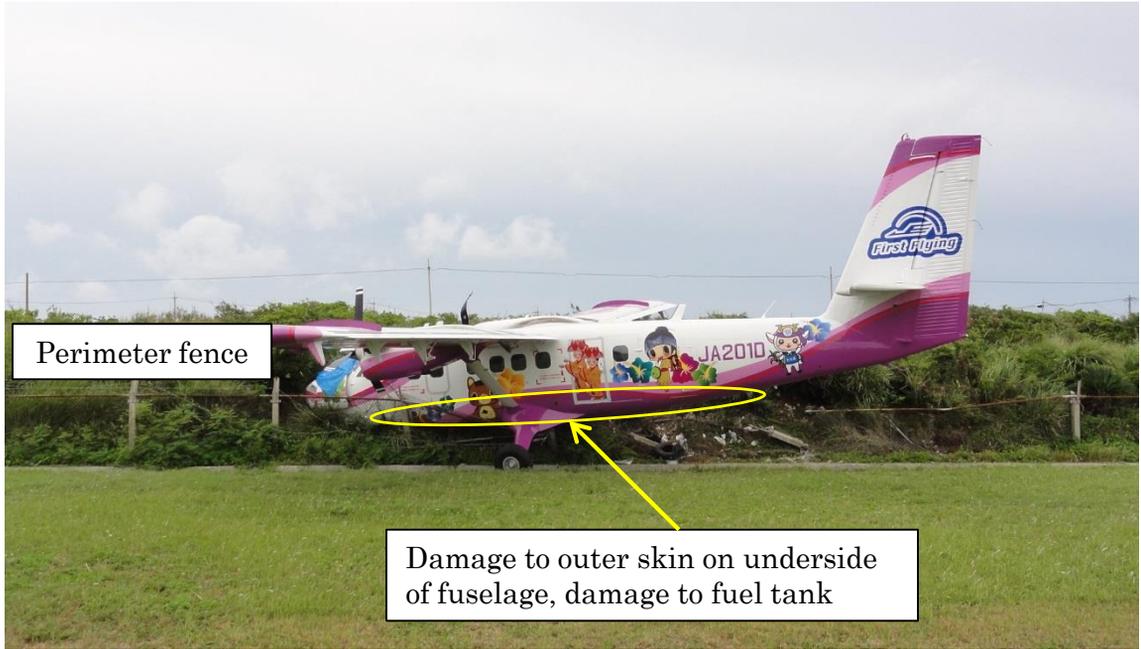
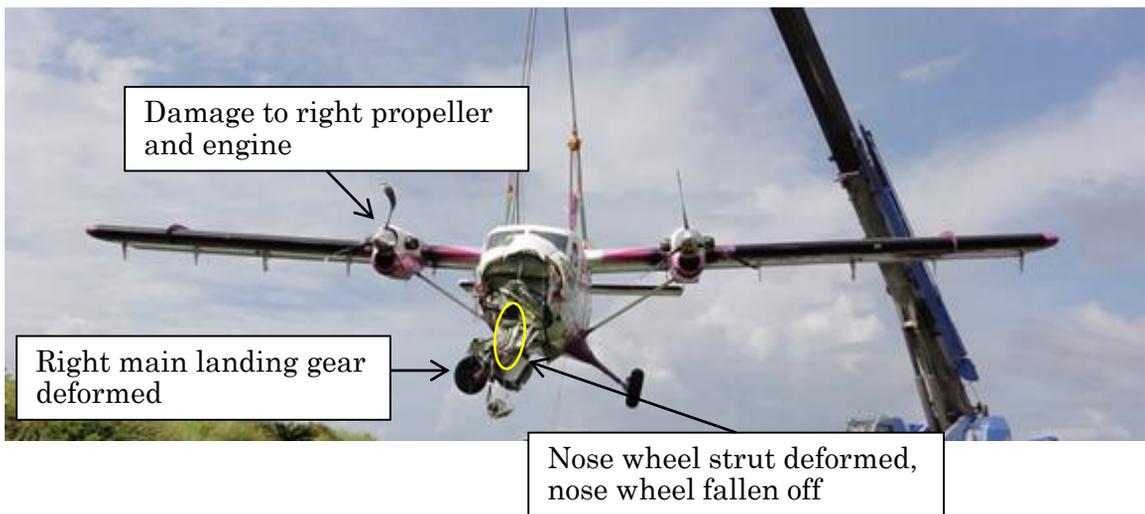
Photo Accident Aircraft

- (1) Underside of nose: Damaged
 - (2) Right engine: Damaged
 - (3) Right propeller: Blades deformed and damaged
 - (4) Nose landing gear: Strut deformed and nose wheel fallen off
 - (5) Right main landing gear: Strut deformed and right main wheel damaged
 - (6) Underside of fuselage: Outer skin damaged and fuel tank damaged
- (See Photo: Accident Aircraft)

Part of the Perimeter Fence on the west side of the runway (length about 20m) was damaged. (See Photo: Accident Aircraft)

In the collision of the Aircraft and the lateral groove and the Perimeter Fence, the nose landing gear became deformed from the strut mounting, external damage and deformity was visible on the NWS, and the nose wheel had fallen off.

The strut of the right main landing gear was significantly deformed in the collision with lateral groove, and the main wheel was damaged.

No external abnormality was visible on the left engine. The right engine had been damaged in the collision with the Perimeter Fence, and the propeller was jammed.

Due to the collision with the Perimeter Fence, cracks and deformity had appeared in the outer skin on the underside of the fuselage, and the fuel tank was damaged.

Based on the aircraft examination described in 2.10, it is highly probable that the damage to the Aircraft described in 2.3 occurred when it collided with the Perimeter Fence and lateral groove.
