**AIRCRAFT SERIOUS INCIDENT
INVESTIGATION REPORT**

**PRIVATELY OWNED
J A 2 0 1 M**

March 24, 2022

Company	Privately owned
Type, Registration Mark	Piper PA28RT-201T JA201M
Incident Class	Runway excursion (when an aircraft is disabled to perform taxiing) Article 166-4, item (iv) of the Ordinance for Enforcement of the Civil Aeronautics Act of Japan
Date and Time of the Occurrence	At about 11:26 Japan Standard Time (JST: UTC + 9 hours, unless otherwise noted, all times are indicated in JST in this report on a 24-hour clock), July 18, 2021
Site of the Serious Incident	Niigata Airport (37°57'23 N, 139°06'51 E)

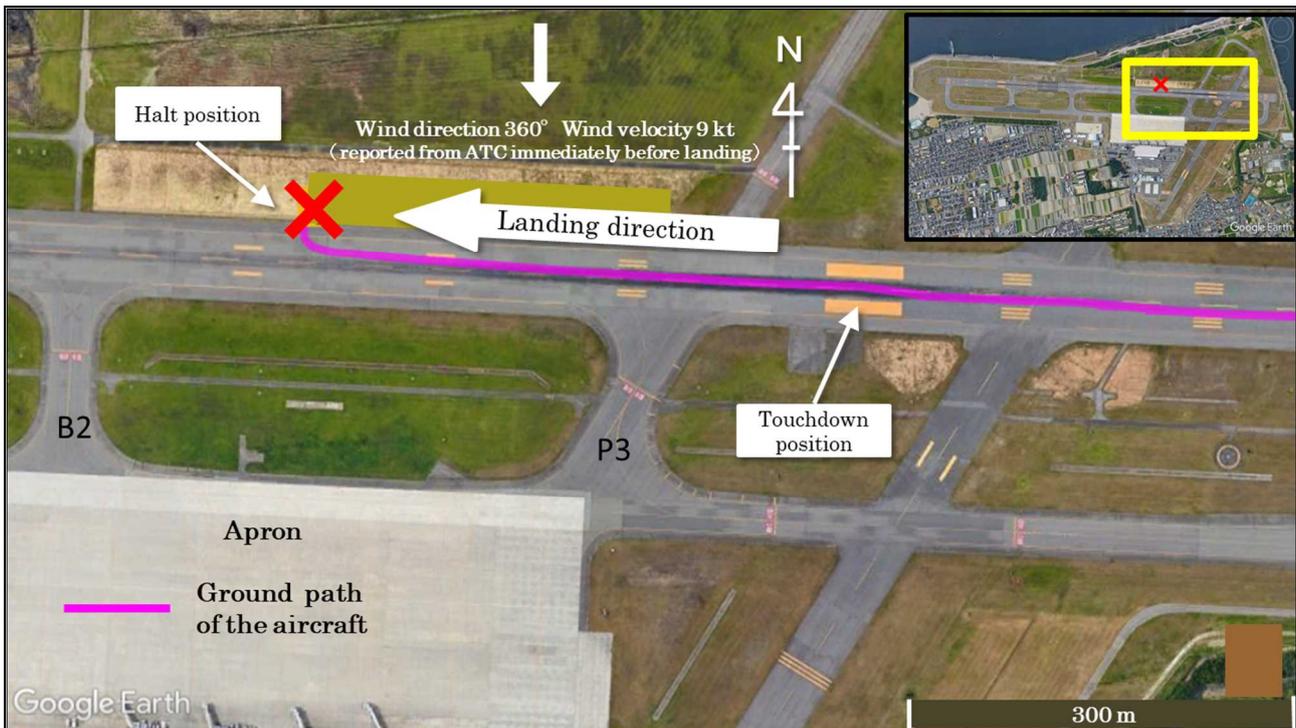
Figure 1 Estimated taxiing ground path of JA201M

There was no abnormality recognized in the aircraft at the beginning of landing roll. The aircraft slowed down by the engine thrust set at idle position without applying brakes. While decelerating, the captain applied the left rudder to enter the B2 on the left after passing the junction to the P3 taxiway, the captain felt that the response of the aircraft to the rudder steering was slow. As this situation was quite similar to the punctured tire during taxiing the captain had once experienced, the captain judged that the right tire punctured. Because the captain wanted to avoid highly possible damage to the right main landing gear wheel that might occur if taxiing in such condition continued up to the taxiway on the left side of the course. In addition, the captain thought that deviating the runway could avoid runway closure and thereby did not hinder operations of scheduled flights, the captain decided to deviate to the grassy area on the right side (the north side of the runway). The captain notified the decision to the air traffic controller at Niigata Aerodrome Control Facility, changed the course to the right after decelerating to approximately 5 kt, and ran off the runway proceeding at almost right angles to the longer side of the runway. After entering the grassy area, the aircraft continued taxiing changing the course further to the right and came to a halt near 41 m in the north of the runway centerline with the nose facing east-northeast, almost reverse direction to the landing direction. After the aircraft halted, the captain shut down the engine at that position since the aircraft was in condition of being disabled to perform taxiing.

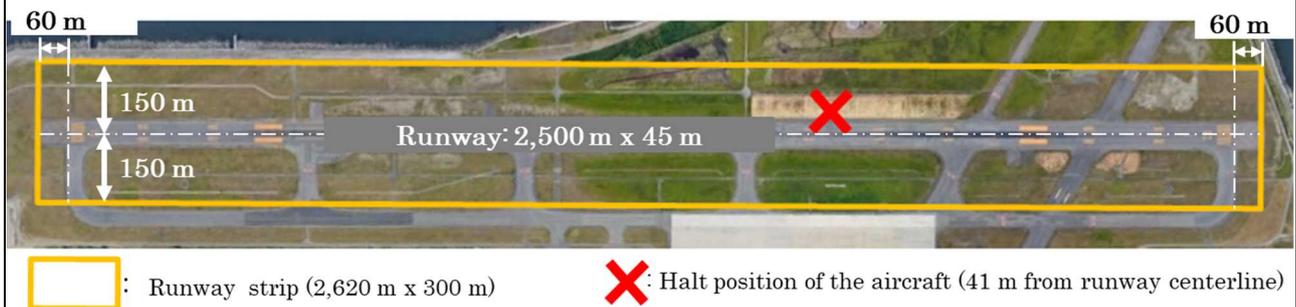
Figure 2 Runway strip of runway 10/28 at Niigata Airport (aerial photograph of Google Earth with some explanatory modifications added)

The position where the aircraft halted (the location 41 m away from the centerline of runway 28) was inside the area designated as a runway strip ^{*1} pertaining to runway 28 (see Figure 2).

Besides, when a disabled aircraft halts in a runway strip, a runway is forced to be closed by “Guidelines for runway operations when a disabled aircraft exists” (KOKU-KU-AN-HO No. 933 dated March 28, 2014), which forced the runway to be closed until the aircraft was cleared off.

However, the location where the aircraft halted and could not perform taxiing was inside the runway strip of runway 28 at the airport that forced the runway to be closed until a disabled aircraft was cleared off. It is highly probable that the recognition of the captain that, "Deviation from the runway could avoid the runway closure," was due to his or her insufficient understanding of the extent and operations of the runway strip.
